On-Site Child Safety Seat Investigation
Dynamic Science, Inc. (DSI) / Case Number: DS07004
2005 Dodge Grand Caravan
Oregon
January 2007

1. Report No. DS07004	2. Government Accession No.		3. Recipient Catalog No.	
4. Title and Subtitle On-Site Child Safety Seat Investigation			5. Report Date May 8, 2008

Dynamic Science, Inc.
Crash Investigation
Case Number: DS07004

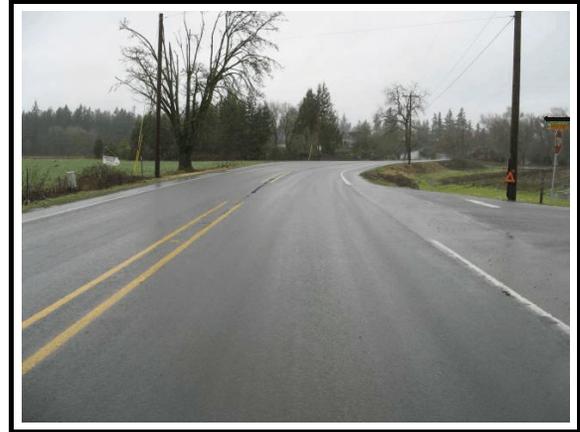
Figure 3. Approach of Ford F350 to area of impact (north)

The Dodge Caravan was traveling in the southbound lane at a driver estimated speed of 56 km/h (35 mph). The Ford F350 was traveling in the northbound lane (**Figure 3**) at a driver estimated speed of approximately 32 km/h (20 mph). The driver of the Dodge was negotiating a slight left-hand curve when she contacted an ice patch and lost control of the vehicle. The Dodge rotated counterclockwise and slid into the northbound travel lane. The Ford reportedly braked but could not avoid contact with the Dodge.

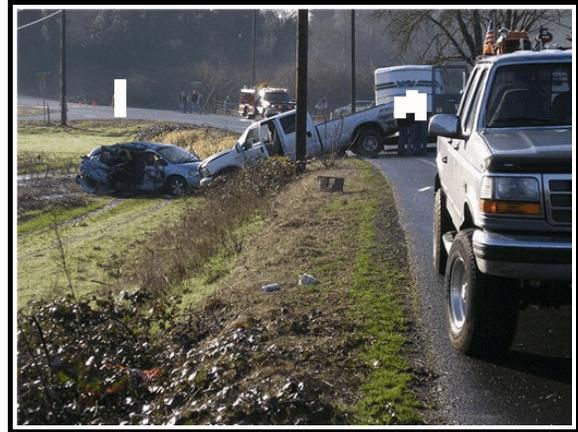
The front end of the Ford contacted the right side of the Dodge. There was intra-unit contact between the Ford and the horse trailer. The Dodge sustained undercarriage damage from contact with the ground. The Dodge came to rest off the highway, facing west. The Ford came to rest facing east with its front end on the sloped shoulder and its rear tires and trailer on the roadway (**Figure 4**). The impact resulted in sufficient longitudinal deceleration of the Dodge to command the deployment of the driver's front air bag and inflatable knee bolster. The Ford's driver and passenger front air bags also deployed during the impact.

Figure 4. Vehicles at final rest (police photo)

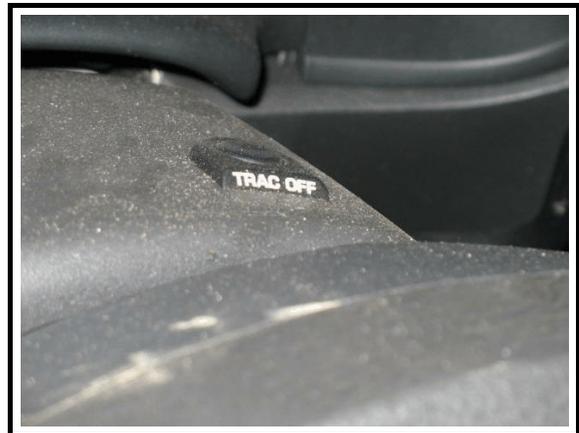
Figure 5. TRAC stability control Override switch (located on top of steering column)

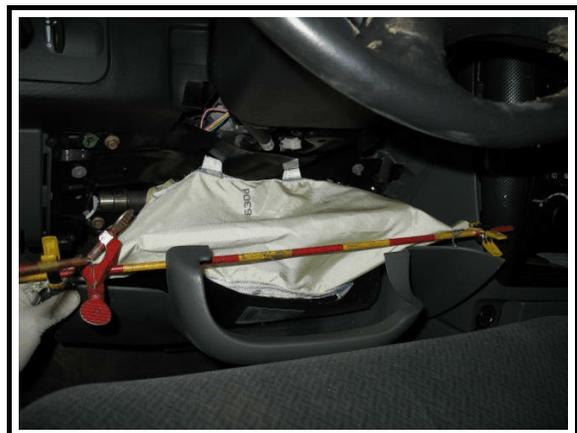
Figure 14. Inflatable knee bolster top tether attachment points

The driver's inflatable knee bolster was mounted below the steering column. As it inflated, the bolster knocked the plastic cover 32.0 cm (12.6 in) into the driver's lower leg area (**Figure 13**). The air bag was rectangular in shape and measured 48.0 cm (18.9 in) wide by 36.0 cm (14.2 in) high. The top of the knee bolster was attached to the base of the steering column by two tether straps (**Figure 14**) and the bottom of the bolster was attached to the lower left instrument panel plastic cover by two tether straps. There was no damage or sign of occupant contact to the inflatable knee bolster.

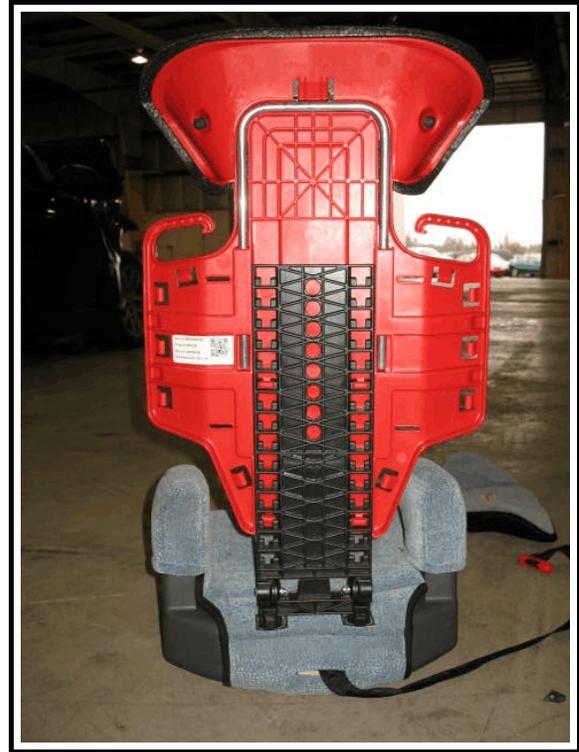
Figure 16. Seat back structure (padding removed)

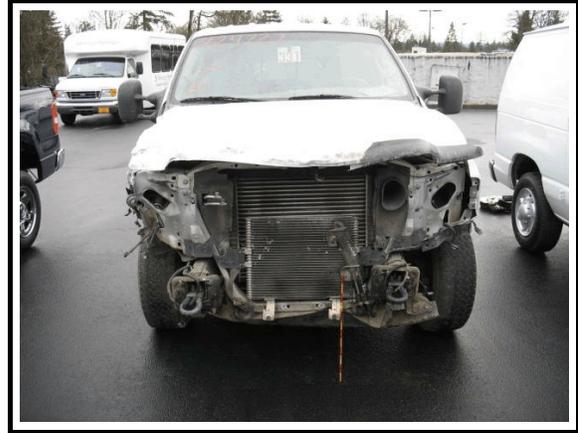
The 2004 Ford F350 Super Duty crew pickup was identified by the Vehicle Identification Number (VIN): 1FTSW31P94Exxxxxx (**Figure 20**).

Figure 20. 2004 Ford F350, partially torn down at repair facility
