ON-SITE CHILD SAFETY SEAT INVESTIGATION

CASE NUMBER - IN07032
LOCATION - ILLINOIS
VEHICLE - 2006 HYUNDAI SONATA GL
CRASH DATE - August 2007

September 30, 2008

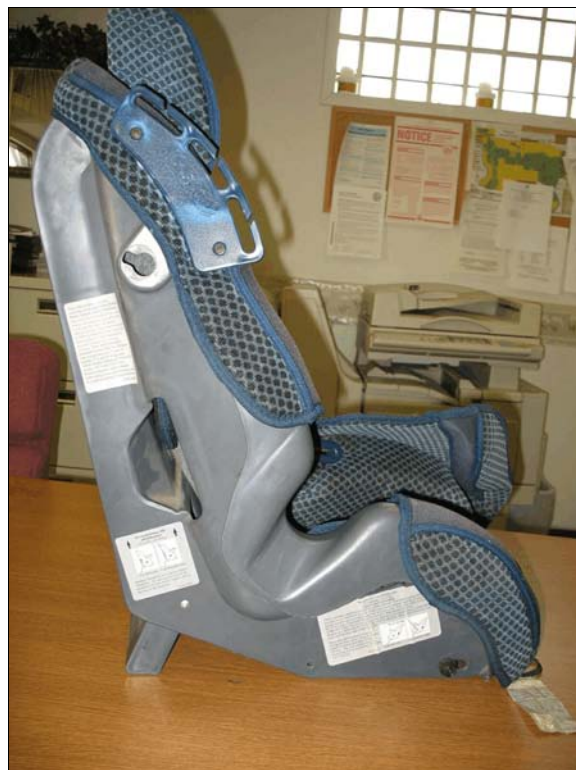
An inspection of the CSS revealed no apparent fractures to the seat's shell, but there was damage (stress marks indicating buckling of the plastic) on the seat's left lap belt guide (**Figures 23 through Figure 26**). Furthermore, there was loading evidence (belt scrapes) on the right lap belt guide (**Figures 27 and 28**). In addition, there was damage to the right shoulder belt guide (stress marks indicating buckling of the plastic-**Figure 29**), and one of the guide's fastening screws had been pulled out of its attachment point on the shell (**Figure 30**).

Figure 27: Right (outboard) side of CSS used by second row right passenger
