On Site ODI Tire Tread Separation / Rollover Investigation
Dynamic Science, Inc. (DSI), Case Number DS08003
1999 Ford Explorer XLT
Arizona
May 2007

1. Report No. DS08003		2. Government Accession No.		3. Recipient Catalog No.	
4. Title and Subtitle ODI Tire Tread Separation / Rollover Investigation				5. Report Date March 11, 2009

Dynamic Science, Inc.
Crash Investigation
Case Number: DS08003

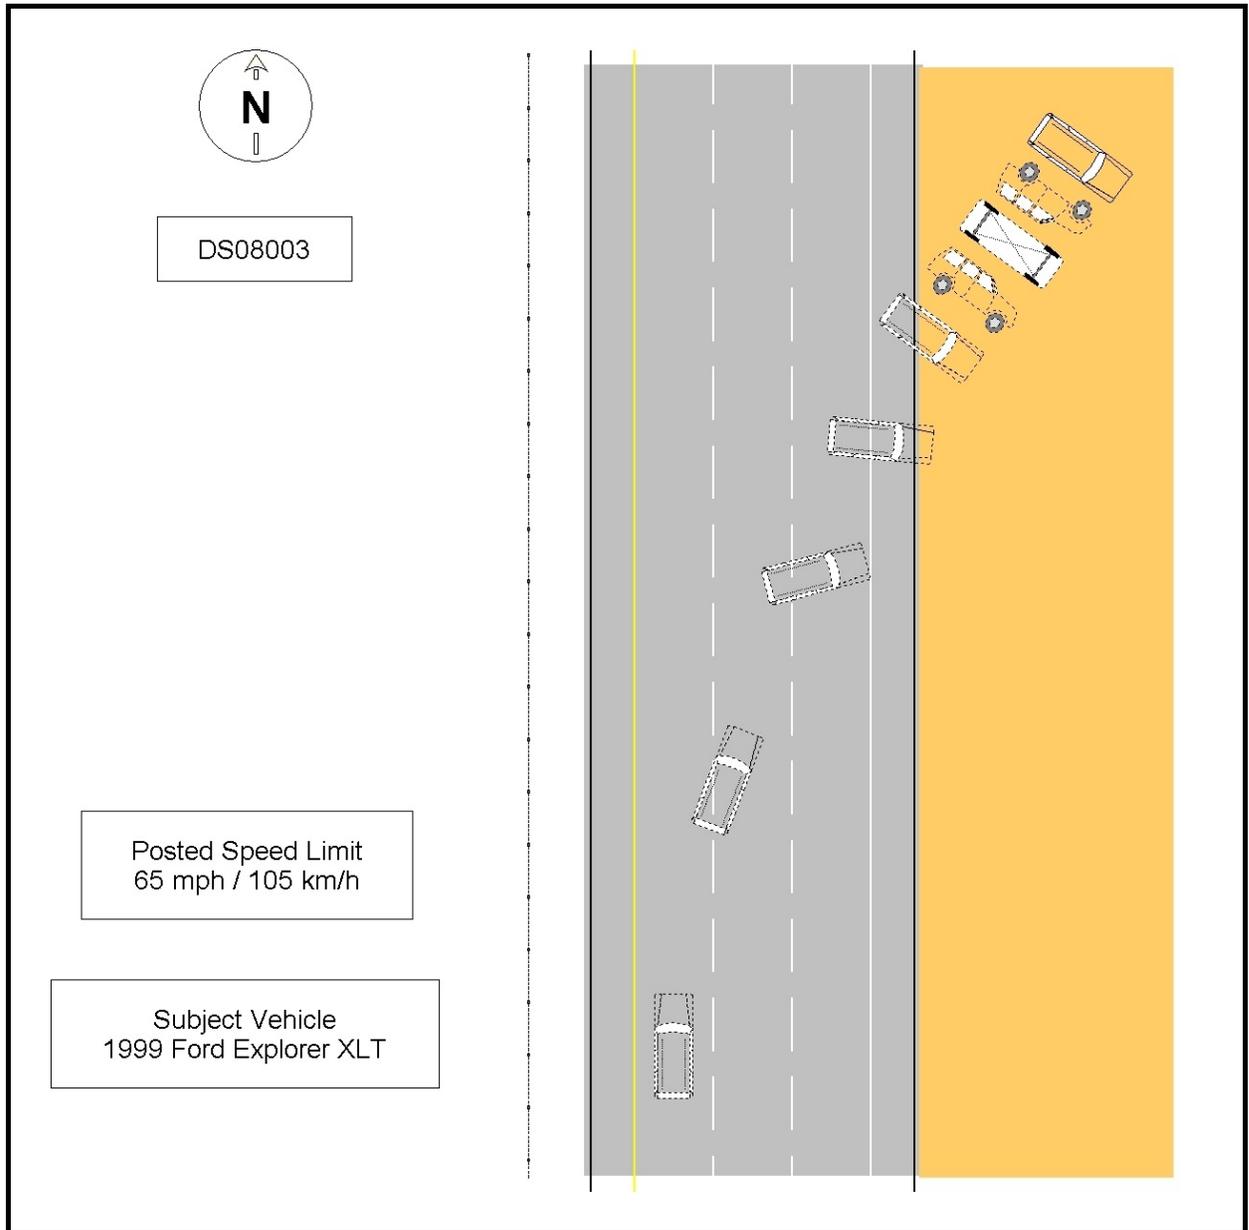
Attachment 1. Scene Diagram

After the tread separated from the left rear tire, the Ford began a clockwise rotation. The vehicle crossed the adjacent travel lanes and departed the roadway on the right side. The driver's ability to steer the vehicle was compromised due to the rapid deflation and tread loss of the left rear tire. As the left side tires and rims engaged and dug into the sand, dirt and loose gravel along the roadside, the vehicle tripped and rolled with its left side leading. The vehicle rolled four quarter turns and came to final rest on its wheels on the roadside.
