ON-SITE SCHOOL BUS INVESTIGATION

CASE NUMBER - IN08008
LOCATION - Minnesota
VEHICLE - 1999 THOMAS BUILT SCHOOL BUS
(ON AN INTERNATIONAL 3800 BUS CHASSIS)
CRASH DATE - February 2008

January 6, 2009

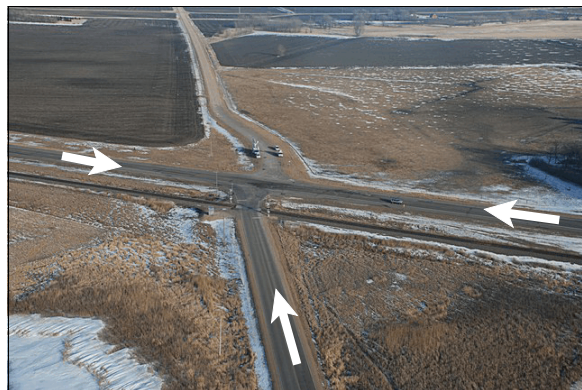
Figure 2: Police aerial photo showing view east along county roadway; left arrow shows Thomas bus' southwest approach to intersection, middle arrow shows Plymouth Voyager's east approach to intersection, right arrow shows Chevrolet Silverado's northeast approach to intersection

2% positive on the west side grade crossing and 3.6% negative on the east side of the grade crossing. The roadway grade then became 1.4% positive on the vehicle's easterly approach to the highway intersection. The mouth of the east leg of the county roadway was offset to the south (**Figure 2**). The posted speed limit for the school bus and the Chevrolet was 97 km.p.h. (60 m.p.h.). There was no posted speed limit for the Plymouth, but the statutory speed limit for rural Minnesota roadways was 89km/h (55 mph). At the time of the crash the light condition was daylight, the atmospheric condition was clear, and the roadway pavement was dry. Traffic density was light, and the site of the crash was rural. See the Crash Diagram on page 21 of this report.

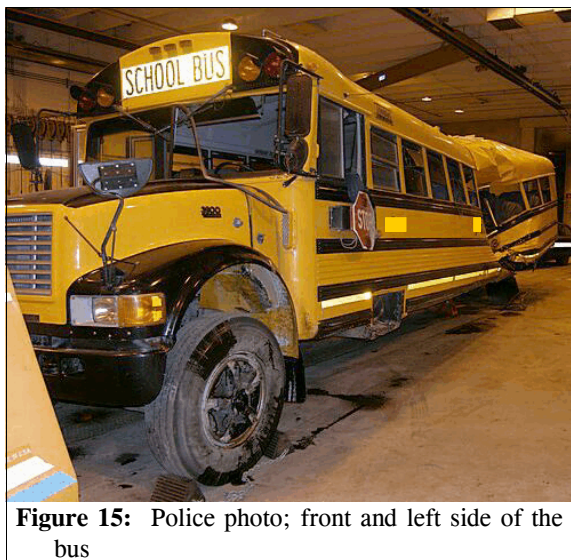
The school bus was manufactured by Thomas Built Buses Inc., in April 1999. The chassis was manufactured in 1999 by International (VIN: 1HVBBABPXXH-----), and the model was a 3800 4x2 FBC bus chassis (**Figure 15**). The bus was equipped with a NAVISTAR 446

Figure 15: Police photo; front and left side of the bus
