On-Site Rollover Investigation
Dynamic Science, Inc. (DSI), Case Number DS08015
2006 Ford Explorer
Washington
April 2008

Dynamic Science, Inc.
Crash Investigation
Case Number: DS08015

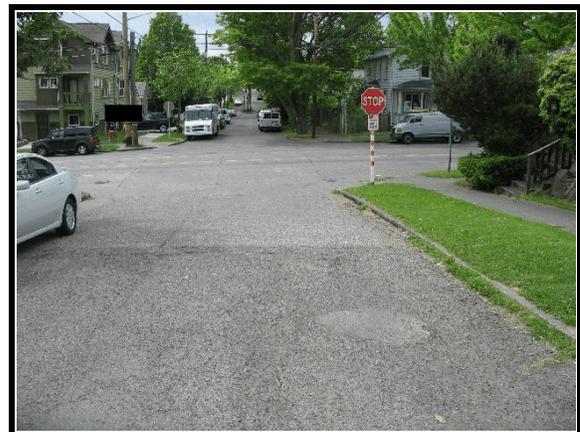
Figure 2. Westbound approach

This crash occurred within a 4-leg intersection which was controlled by stop signs for east and westbound traffic. The east leg of the intersection was comprised of two travel lanes (**Figure 2**). The asphalt roadway was dry at the time of the crash and had an 8.8% negative grade for westbound traffic. The roadway was bordered by low profile curbs. Parking was permitted on the south side of the roadway. The speed limit was 40 km/h (25 mph). The south leg of the intersection was comprised of two northbound travel lanes, two southbound travel lanes, and a center turn lane (**Figure 3**). The outboard lanes were separated from the inboard lanes by a solid white line.

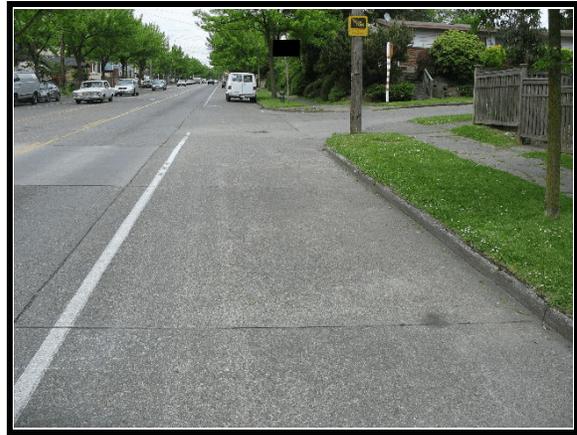
Figure 3. Northbound approach

The observed common practice was to use the outboard northbound lane as a travel lane when there were no vehicles parked in the lane. The inboard travel lanes were separated from the turn lane by a solid yellow line, followed by a dashed yellow line. The northbound lanes had a 5% positive grade. The speed limit for the south leg of the intersection was 48 km/h (30 mph).

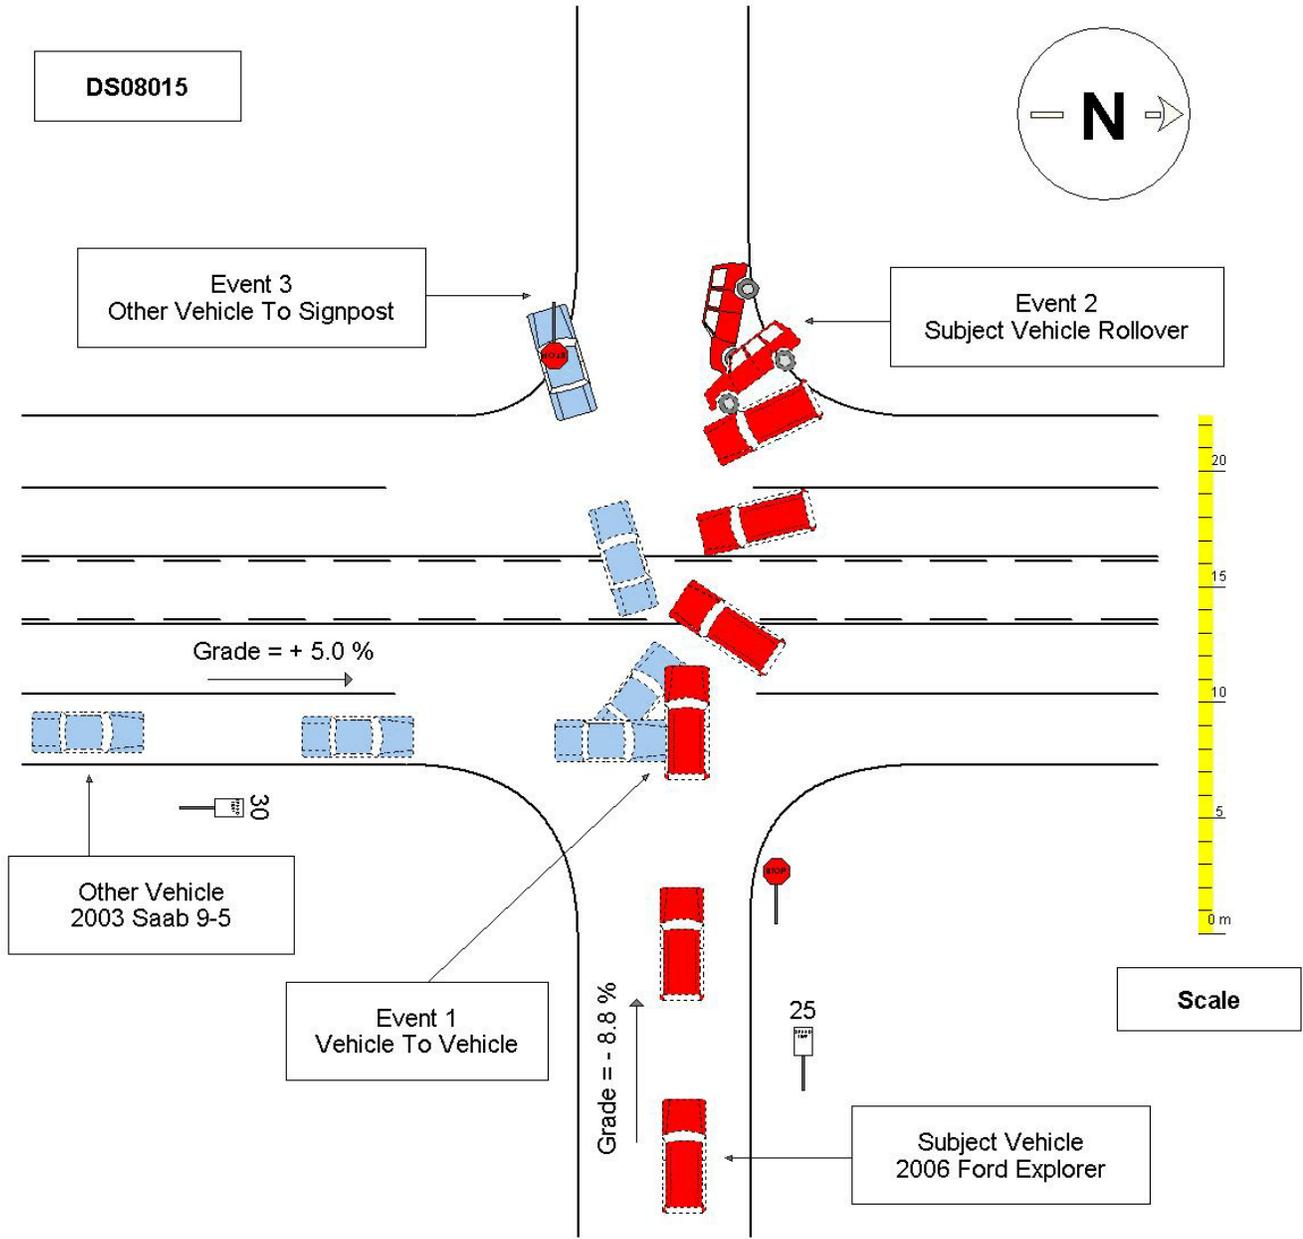
Attachment 1. Scene Diagram

The driver of the Ford disregarded the stop sign, entered the intersection, and crossed the path of the Saab. The frontal plane of the Saab impacted the left side of the Ford. The impact severity to the Ford was minor and resulted in the deployment of the driver's seat-mounted side air bag and the actuation of the driver's seat belt pretensioner. The Missing Vehicle algorithm of the WinSmash program computed a total Delta V of 9 km/h (5.6 mph) based on the Ford's left side crush profile. The longitudinal and lateral components were -6 km/h (-3.6 mph) and 7 km/h (4.3 mph), respectively. The Ford was displaced to the right and initiated a counterclockwise rotation. The vehicle rotated approximately 90 degrees before it contacted a 5 cm (2 in) curb with its right rear tire (**Figure 4**). The contact along the curb edge measured 50 cm (19.6 in) in length by 12 cm (4.7 in) in width. The vehicle tripped on the curb and began a right side leading rollover. The Ford rolled one quarter turn before coming to rest on its right side facing east. The Saab was redirected in a westbound counterclockwise rotation after the impact. The vehicle departed the roadway at the southwest corner of the intersection and impacted a sign post with its front end.
