Certified Advanced 208 Compliant Air Bag Investigation
Dynamic Science, Inc. (DSI), Case Number DS08024
2006 Chevrolet Silverado C1500
Oregon
July 2008

**Dynamic Science, Inc.
Crash Investigation
Case Number: DS08024**

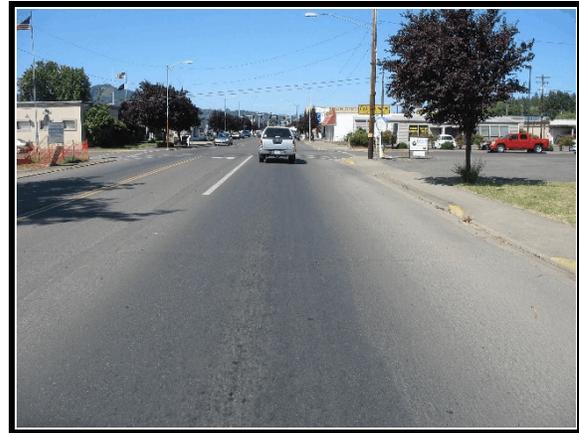
Figure 2. Westbound approach for the 2006 Chevrolet Silverado

As the Silverado crossed the driveway, the vehicle struck a curb on the western edge of the driveway. The curb was broken away. The vehicle continued traveling westbound and impacted some bushes and shrubbery. The Silverado continued west and entered a second driveway, where the vehicle's undercarriage contacted the ground and curb resulting in undercarriage damage (**Figure 4**). A 91 cm (36 in) long gouge was located on the driveway, 122 cm (48 in) east of the driveway curb. The Silverado continued forward and struck the 13 cm (5.1 in) high concrete curb with the both front tires and the undercarriage. A 91 cm (36 in) long segment of the curb was broken away. The vehicle continued past the curb, struck two wooden sign posts, and then struck a concrete building where it came to rest. The barrier routine of the WinSmash program computed a total delta V of 56 km/h (34.8 mph) for the impact with the building, based on Silverado's front end crush profile. The longitudinal and lateral components were -56 km/h (-34.8 mph) and 0 km/h (0 mph), respectively.

It is this investigator's opinion that the impact with second driveway curb caused the deployment event. The distance from the initial roadway departure and the second driveway curb impact was

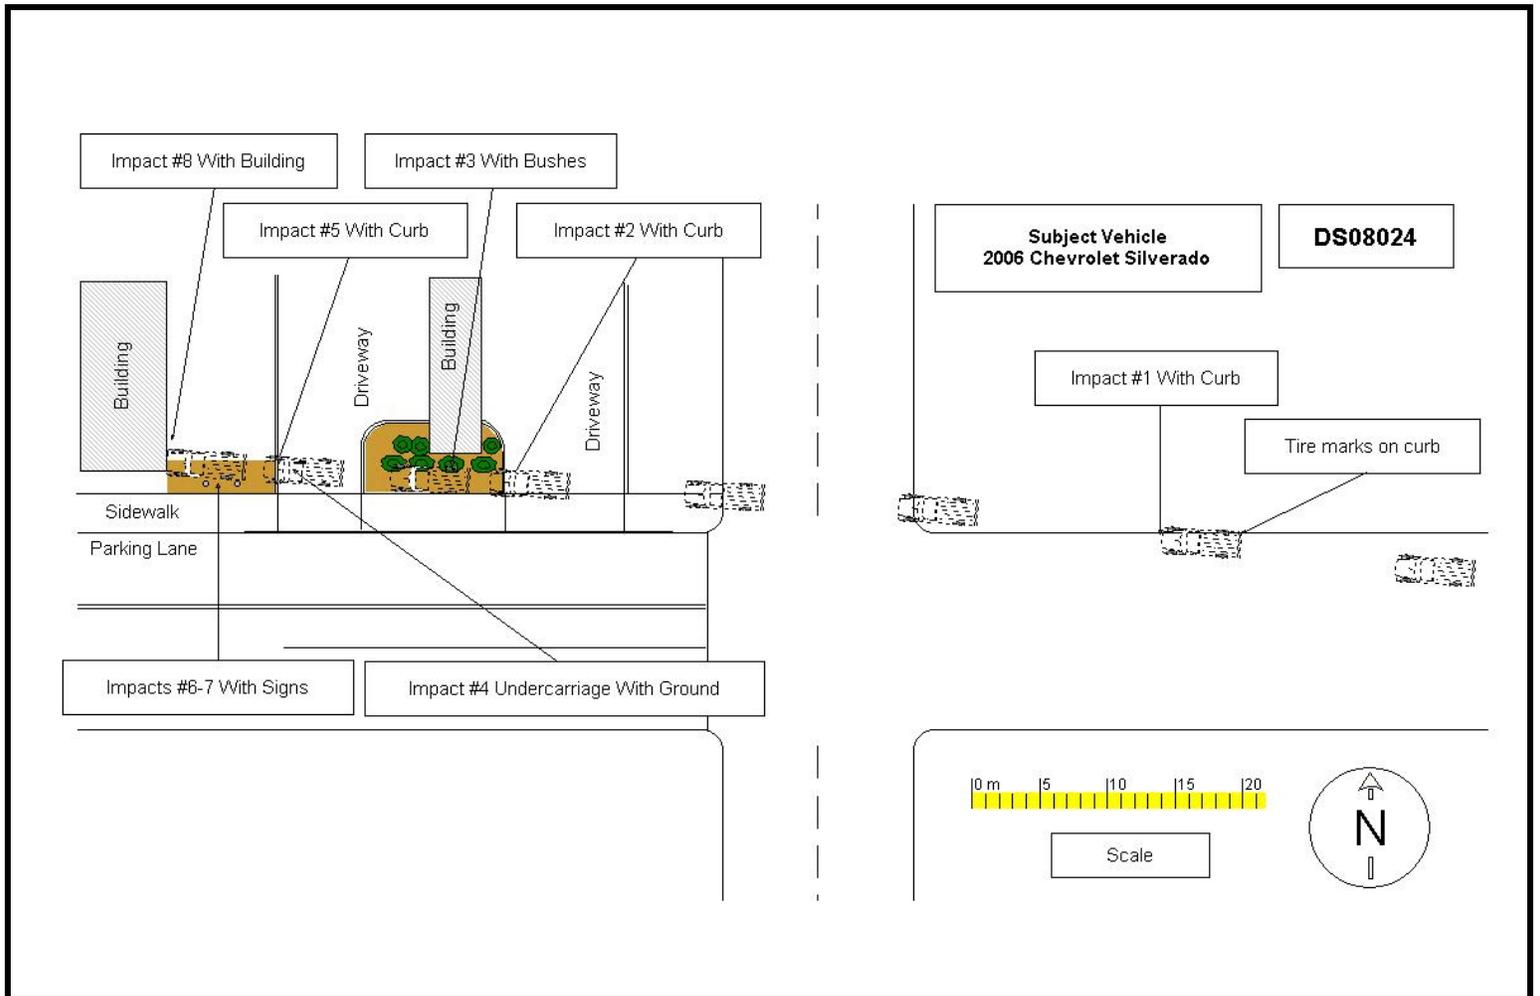
Attachment 1. Scene Diagram

This single vehicle crash occurred off-road near a four-leg intersection of two local roadways in July 2008 at 0930 hours. At the time of the crash, there were no adverse weather conditions and the asphalt roadway was dry. The subject vehicle initially departed the roadway east of the intersection. The west leg of the intersection was configured with a westbound travel lane, a left turn lane, and an eastbound travel lane (**Figure 2**). The turn lane was separated from the westbound travel lane by a solid white line. The east leg of the intersection was configured with an eastbound travel lane, a left turn lane, and a westbound travel lane. There were several businesses to the north of the roadway. Two north/south driveways provided access to the businesses. The second driveway had curbed edges. The struck building was located 41.1 m (135 ft) west of the intersection and 4.6 m

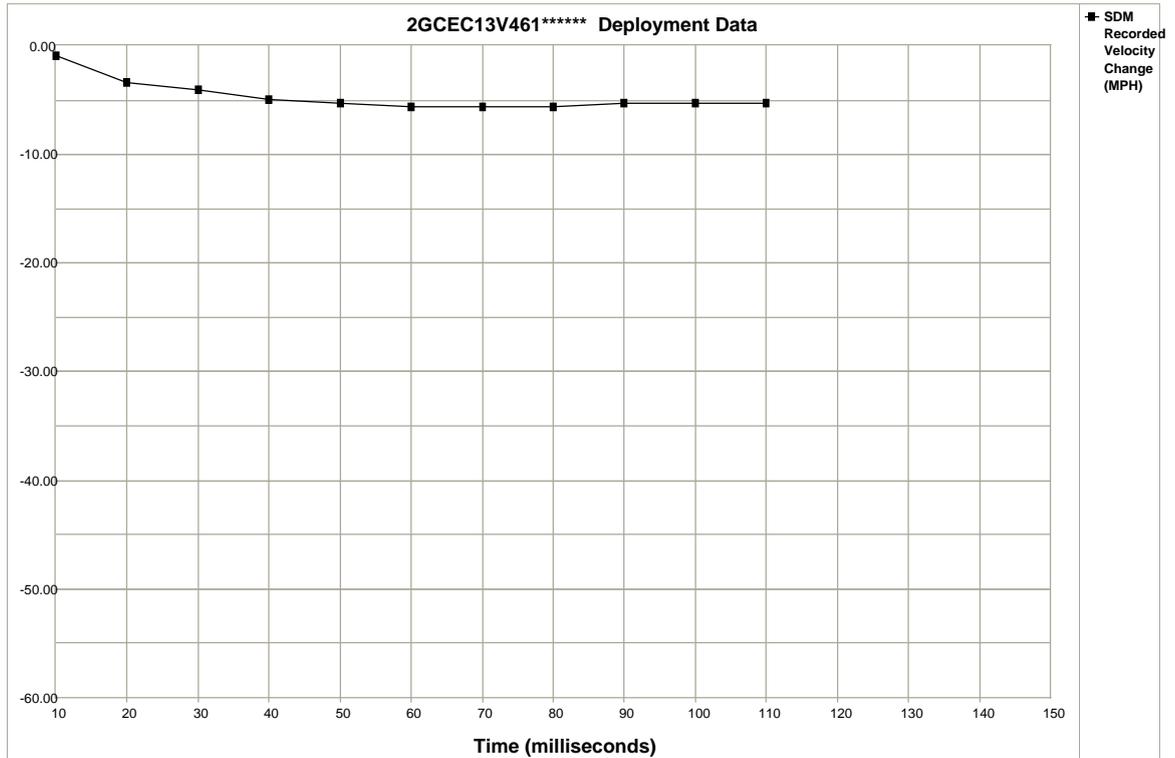
Time (milliseconds)	10	20	30	40	50	60	70	80	90	100	110	120	130	140	150
Recorded Velocity Change (MPH)	-0.93	-3.41	-4.03	-4.96	-5.27	-5.58	-5.58	-5.58	-5.27	-5.27	-5.27	N/A	N/A	N/A	N/A

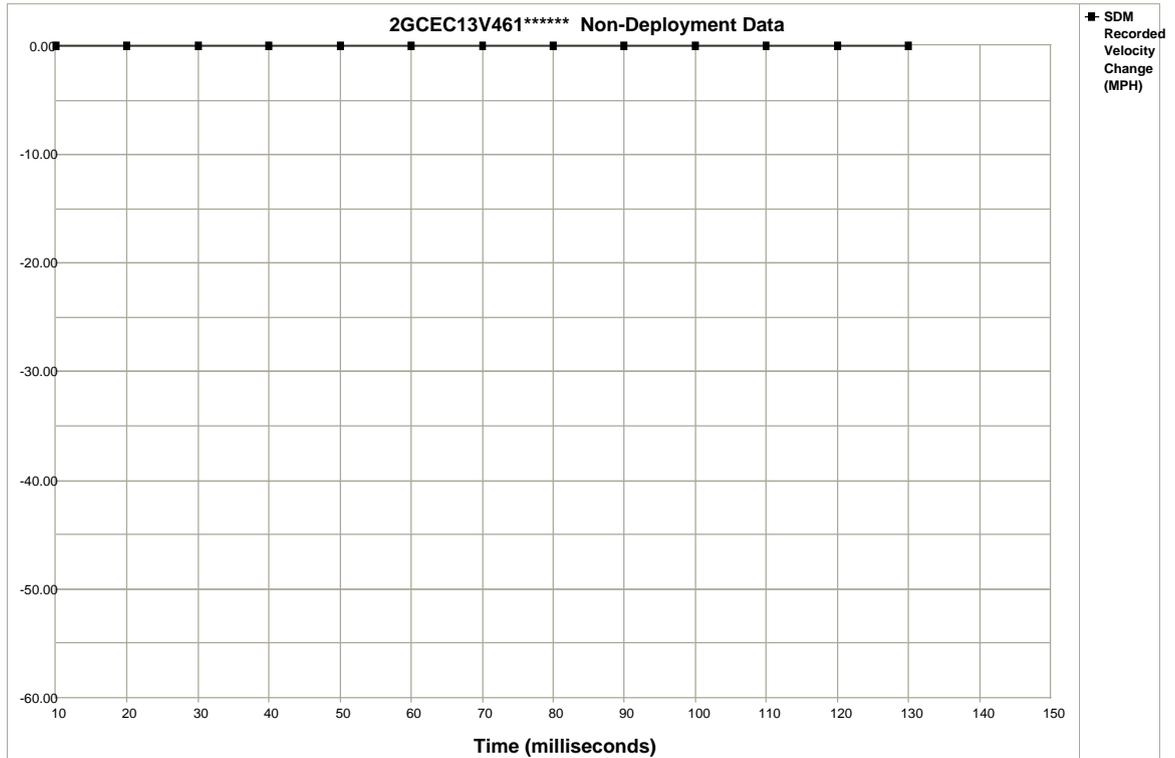
Time (milliseconds)	10	20	30	40	50	60	70	80	90	100	110	120	130	140	150
Recorded Velocity Change (MPH)	0.00	0.00	0.00	0.00	0.00	0.00	0.00	0.00	0.00	0.00	0.00	0.00	0.00	N/A	N/A
