INDIANA UNIVERSITY

ON-SITE CHILD SAFETY SEAT INVESTIGATION

CASE NUMBER - IN08046
LOCATION - OHIO
VEHICLE - 1998 CHEVROLET MALIBU LS
CRASH DATE - November 2008

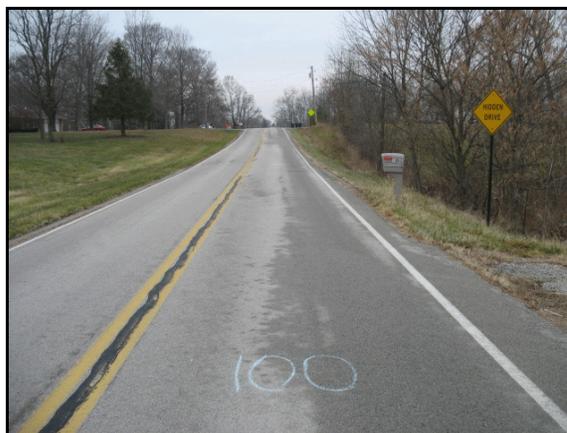
Figure 2: Chevrolet's approach to the impact area

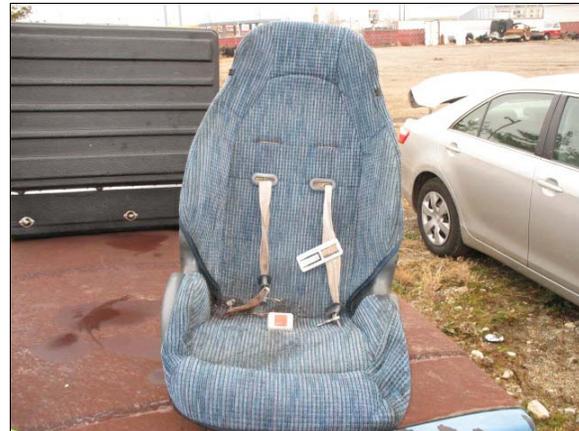
Second Row Left Child Safety Seat: The Chevrolet's second row left passenger [3-year-old, female; 97 cm and 17 kg (38 in and 38 lbs)] was seated in a Cosco Juvenile Booster Car Seat (**Figure 14**), which was designed to be used as a High Back Booster Seat or an FSS. It was used as an FSS in this crash. The FSS was manufactured on January 6, 2000 and the model number was 02-442-PRI. When used with the 5-point harness, the FFS was designed for children who

At the SCI vehicle inspection, the FFS was located on the second row unsecured by the vehicle's second row left seat belt. The police photographs showed that the FFS had been removed from the vehicle at some point, either at the crash scene or during the subsequent police inspection of the vehicle. The SCI inspection of the FFS revealed load abrasions on both seat belt guides located on the back of the FFS. A significant accumulation of blood was present under the pad and on the lower portion of the right harness strap. The harness straps were twisted and the left harness strap was routed through the harness retainer clip. The FFS was not damaged and no load marks were present on the plastic shell. A determination of the distance between the FFS and the driver's seat back could not be made since the driver's seat back had been cut out of the vehicle.

Figure 14: The second row left passenger's FFS

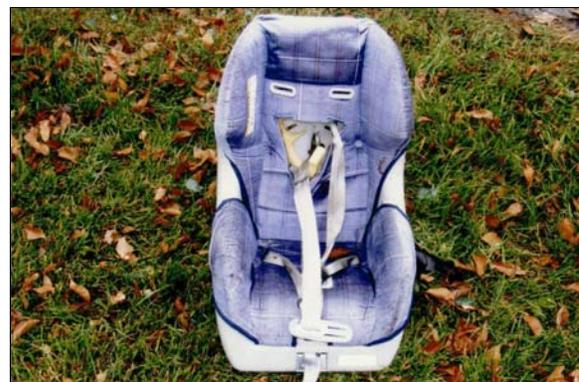
Second Row Right Child Safety Seat: The forward facing convertible CSS (**Figure 15**) used by the second row right passenger [10-month-old, male; 79 cm and 11 kg (31 in and 24 lbs)] was not available for inspection and all information contained herein was obtained from photographs provided by the police. The CSS was an Evenflo Tribute, but the date of manufacture could not be determined. The CSS was constructed of a one-piece plastic shell that was fitted with a cloth

Figure 15: The second row right CSS
