ROLLOVER CRASH INVESTIGATION

SCI CASE NO. - CA09001

VEHICLE – 2007 FORD F150 CREW CAB PICKUP TRUCK

CRASH DATE – APRIL 2008

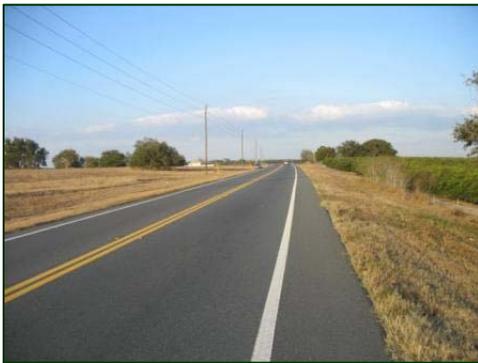
The crash occurred off-road of a two-lane State route during daylight hours in April 2008. In the vicinity of the crash site, the roadway was oriented in a north/south direction with a slight left curve with a positive grade of less than two-percent for northbound traffic (**Figure 2**). The asphalt road surface was in good condition with paved shoulders bordering both travel lanes. The off-road area to the west of the roadway consisted of a graded road edge that transitioned to a shallow drainage ditch that was centered approximately 4.6 m (15') outboard of the shoulder edge (**Figure 3**). The slopes that formed the ditch were less than 10 percent. Tall cut grass was present over the sandy soil. Utility poles were positioned beyond the ditch. It should be noted that guy wires were installed on the poles after the crash and were present in the images obtained during this SCI investigation. These guy wires were positioned in the path of the Ford F150. Several images of the counterclockwise yaw marks of the F150 across the grassy area were provided by the driver to the SCI investigator; however, these tire marks were no longer present at the time of the scene inspection that occurred nearly 10 months after the crash.

Figure 2. Pre-crash trajectory of the Ford F150.

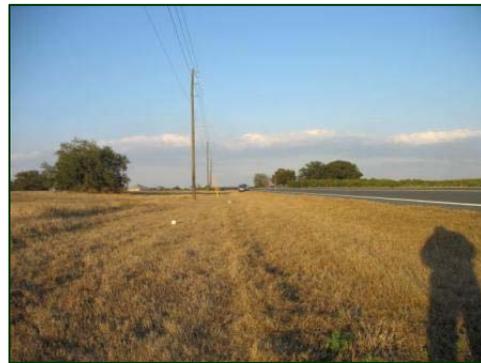
Figure 3. Off-road terrain adjacent to the west road edge.

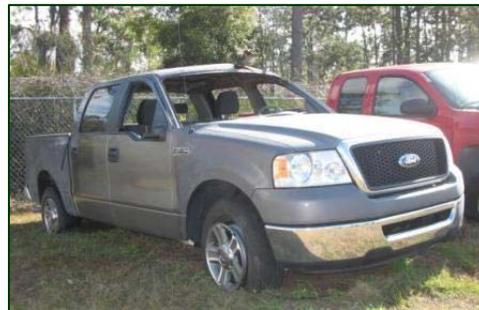
Figure 5. Condition of the F150 at the time of the SCI inspection.

The SCI team obtained permission to inspect the vehicle and the inspection was conducted on January 27, 2007. The vehicle was in the above condition at the time of the inspection and was exposed to the elements. Based on the condition of the vehicle, it was apparent that the F150 was uncovered for an extended period of time prior to the inspection.

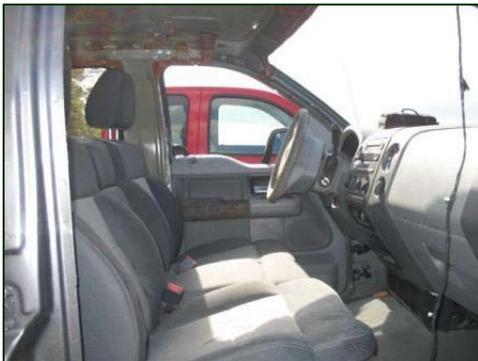
As previously noted, at the time of the SCI inspection, the interior trim above the beltline had been removed from the vehicle. The headliner had been removed and was lying loose in the vehicle. The door panels were intact and undamaged with mold present on all four armrests. The right front seat was unbolted from the floor and was lying loose in its position. The front outboard safety belt systems had been removed and found lying on the front floor of the F150. There was no discernable occupant contact damage present within the vehicle or on the removed and available components. A blood-like stain was noted to the headliner. **Figures 9 and 10** are views of the interior at the time of the SCI inspection.

Figure 9. Left interior view of the Ford F150 at the time of the SCI inspection.

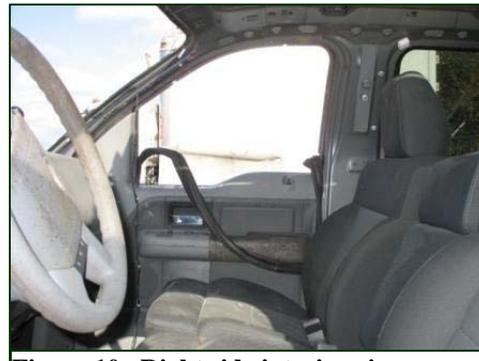
Figure 10. Right side interior view.

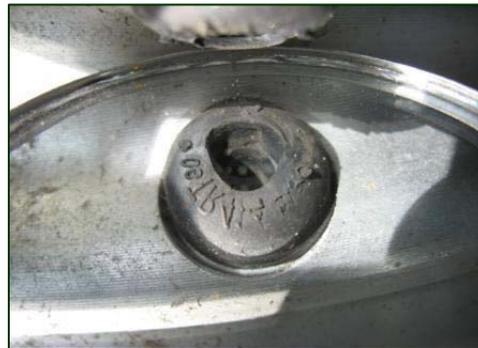
Valve Stem – The rubber snap-in valve stem was in place in the wheel rim and exhibited a laterally oriented crack at the base of the stem, immediately above the wheel on the inboard aspect of the stem (with respect to the wheel). A second laterally oriented crack of approximately 4 mm in length was located on the flare of the stem above the previously mentioned crack (**Figure 15**). A mirror was positioned on the inside aspect of the wheel rim to obtain the identification numbers from the stem. The identification appeared to be 08TR4 with the remainder of the characters abraded from probable interaction of the tire bead (**Figure 16**).

Figure 16. Identification numbers on the inside aspect of the left rear valve stem.

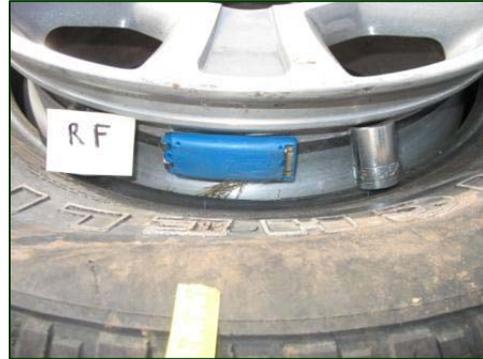
Aluminum Wheel Rim – The OEM right front aluminum wheel was not damaged. Dirt was embedded into the spokes of the wheel following the crash, but was removed prior to this SCI inspection. A 71 gm (2.5 oz) wheel balancing weight was attached to the outboard aspect of the wheel rim and a 64 gm (2.25 oz) weight was affixed to the inboard edge of the wheel. **Figure 18** is the TPMS band sensor in the right front wheel.

Figure 18. Right front TPMS band sensor.

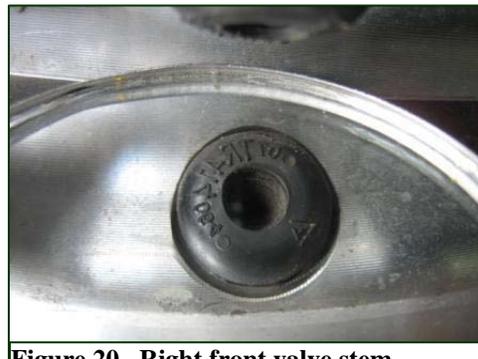
The outboard bead of the tire was compressed and an inspection mirror was placed under the inner base of the stem. The stem was identified by the following alpha numeric characters: 07 TR414 064 (**Figure 20**).

Figure 20. Right front valve stem identification numbers.
