On-Site Ambulance Investigation  
Dynamic Science, Inc. (DSI), Case Number DS09019  
1999 Ford E350 Econoline  
Arizona  
February 2009

1. Report No. DS09019	2. Government Accession No.		3. Recipient Catalog No.	
4. Title and Subtitle On-Site Ambulance Investigation			5. Report Date February 9, 2010

14. Sponsoring Agency Code	
15. Supplemental Notes				
16. Abstract <p>This on-site investigation focused on the crash dynamics and injuries sustained in a crash involving a 1999 Ford E350 Econoline van that was configured as an ambulance. The crash occurred within an intersection. The Ford was being driven by a 24-year-old male. The front right seat was occupied by a 71-year-old male who was the uncle of the patient that was being transported. There was a male Emergency Medical Technician in the rear of the ambulance who was attending to a 31-year-old female. The female was on an ambulance cot prior to the crash. The first other vehicle was a 2006 Dodge Charger that was being driven by a 20-year-old male. The second other vehicle was a 2000 GMC Sierra pickup. The Ford was traveling westbound approaching the intersection on a green light without emergency lights and sirens. The Dodge

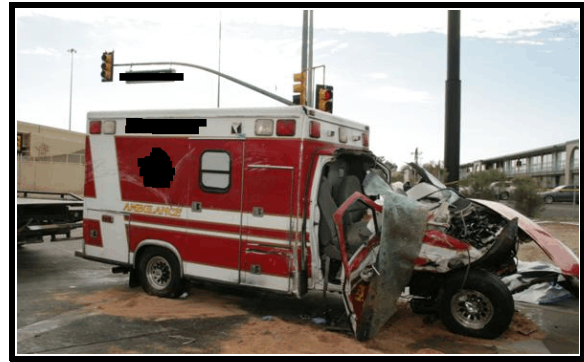
This on-site investigation focused on the crash dynamics and injuries sustained in a crash involving a 1999 Ford E350 Econoline van that was configured as Type III<sup>1</sup> ambulance (**Figure 1**). The crash occurred within an intersection formed by an east/west through roadway and north/south freeway on/off-ramps. The Ford was being driven by a 24-year-old male. The front right seat was occupied by a 71-year-old male who was the uncle of the patient that was being transported. There was a male Emergency Medical Technician (EMT) in the rear of the ambulance who was attending to a 31-year-old female. The female was on an ambulance cot prior to the crash. The first other vehicle was a 2006 Dodge Charger that was being driven by a 20-year-old male. There were three additional passengers in the Dodge. The second other vehicle was a 2000 GMC Sierra pickup that was being driven by an 18-year-old male. The Ford was traveling westbound approaching the intersection on a green light. The Ford was traveling without emergency lights and sirens. The Dodge was traveling southbound on the off-ramp approaching the intersection on a red light. The GMC was heading east and was stopped in the west leg of the intersection. The Dodge reportedly entered the intersection against a red signal. The front of the Dodge struck the right front of the Ford. Both vehicles were redirected counterclockwise toward the southwest corner of the intersection. There was a secondary impact between the two vehicles and the Ford partially overturned onto the Dodge. As the vehicles continued in a southwest direction, the Ford separated from the Dodge and overturned onto its right side. The Dodge continued in a southwest direction and impacted the stopped GMC. All the vehicles came to rest in the intersection.

**Figure 1.** 1999 Ford E350 Econoline Type III Ambulance

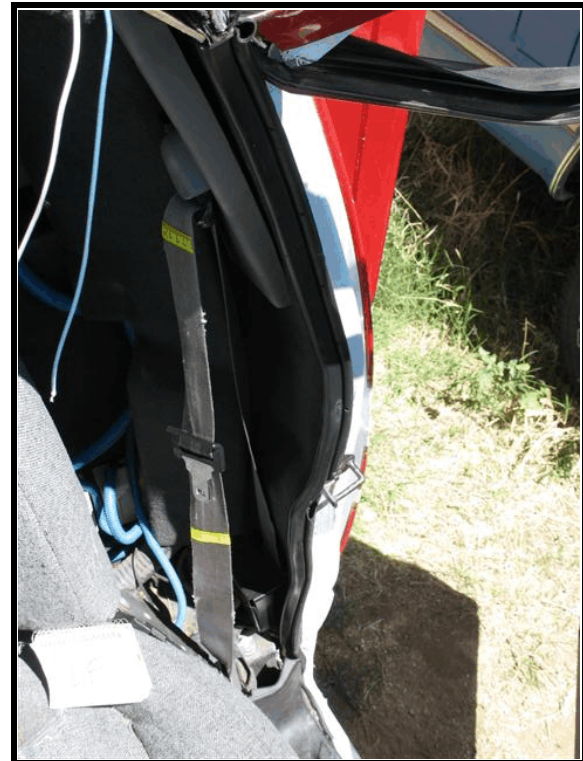
**Figure 10.** Driver's safety belt (subject vehicle)

The Ford was equipped with manual 3-point lap and shoulder belts for the front row seats. The driver's safety belt shoulder anchorage was adjusted to between the mid and full down position; the front right shoulder anchorage was adjusted to the full down position. The driver's safety belt webbing exhibited loading that began 48 cm (18.9 in) from the anchor and measured 41 cm (16.1 in) in length (**Figure 10**). The front right occupant's safety belt had been cut by rescue personnel at a point 171 cm (67.3 in) from the anchor at a point near the shoulder anchorage. Both front seats were equipped with buckle pretensioners that actuated during the impact with the Dodge (**Figure 11**). All the seats in the rear of the ambulance were equipped with manual lap belts. There was evidence of historical usage to the belts at the rear-facing and right-facing seat positions.

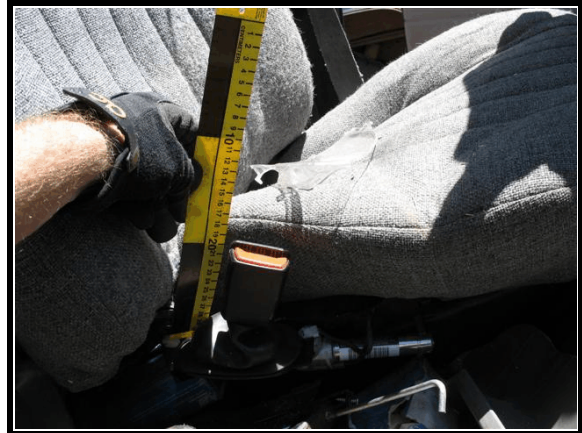
**Figure 11.** Driver's safety belt pretensioner (subject vehicle)

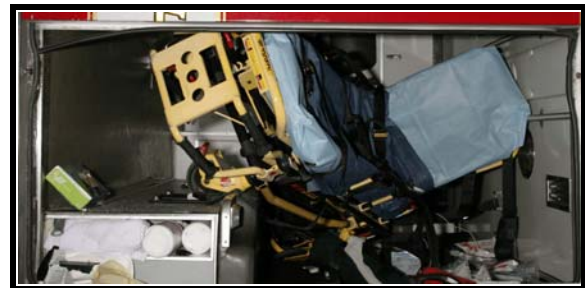
**Figure 21.** Final rest position of ambulance cot (police photo)

The 31-year-old female patient was being transported from her home to the hospital for behavioral reasons. The interviewee indicated that she was suicidal. She was restrained with her head toward the front of the vehicle to a Rugged brand ambulance cot using the leg, torso, and shoulder harnesses. The cot was anchored to the left side floor rail. The forward aspect of the cot was in the semi-reclined position. At impact with the Dodge, the tubular portion of the cot that was anchored to the floor rail fractured and the cot broke away. As the Ford overturned to the right, the cot was displaced to the right and came to rest on the right side of the ambulance (**Figure 21**). The forward aspect was resting against the right interior side surface, the aft aspect was resting against the base of the right side bench seat. The patient loaded the cot harness and sustained liver and spleen lacerations and fractures of right side ribs 9-12. She also sustained eyelid abrasions and a forehead contusion. The patient was extricated through the rear doors with the assistance of the EMT. She was belligerent and combative upon her arrival at the hospital and had a GCS of 9. She was admitted, hospitalized for five days, and then transferred to a psychiatric facility.

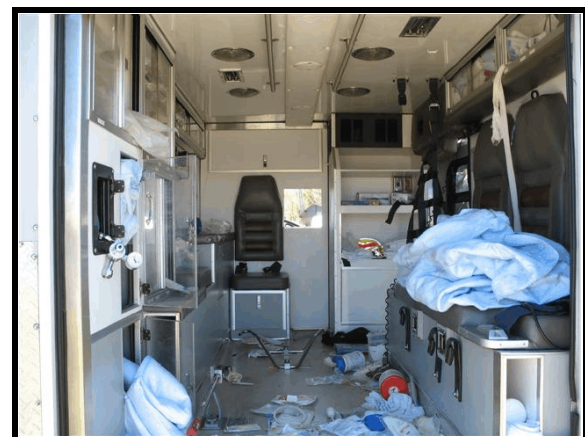
**Figure 22.** Overview of ambulance interior

The 23-year-old male EMT was seated on the left facing right side bench seat (**Figure 22**). He was not wearing the available lap belt. He was beginning his evaluation of the patient. At impact with the Dodge, he was displaced forward and to the right. He sustained bilateral lower leg abrasions from contact with the ambulance cot as it was displaced to the right. He was able to assist the patient and they both exited the vehicle through the rear doors.
