CRASH DATA RESEARCH CENTER

**CALSPAN ON-SITE HEAVY TRUCK REAR IMPACT GUARD CRASH INVESTIGATION
SCI CASE NO.: CA09060**

**VEHICLE: FREIGHTLINER TRACTOR W/ 2005 STOUGHTON TRAILER
LOCATION: NORTH CAROLINA**

CRASH DATE: SEPTEMBER, 2009

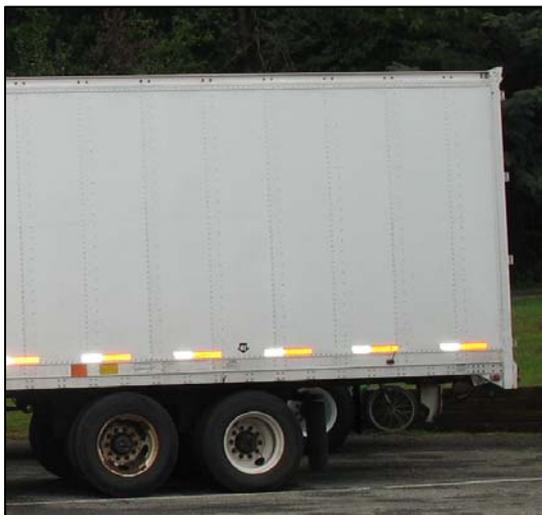
Figure 2: Left view of the aft portion of the Stoughton trailer.

The Stoughton trailer (**Figure 2**) was 16.1 m (53 ft) in length, 259 cm (102 in) in overall width and 4.1 m (13.5 ft) in overall height. The rear overhang measured 333 cm (131 in). The height of the trailer floor measured 114 cm (45 in) above the ground. The van trailer was manufactured with ladder-type steel frame floor construction. The floor framing was overlaid with oak floor boards. The sides, top and front planes of the trailer were aluminum panels. The trailer was configured with dual-axles, an air ride suspension and an adjustable slider frame. The width between the longitudinal slider frame rails measured 122 cm (48 in).

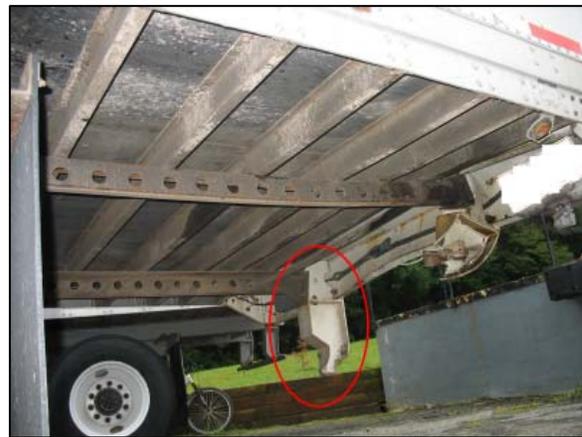
Figure 3: Left view of the trailer depicting the slider frame and the attachment of the rear impact guard.

The rear impact guard was a three-piece bolt-on assembly that attached to the reinforced attachment junction of the slider frame and the back plane of the trailer (**Figure 3**). The rear impact guard was constructed from two vertical I-beam supports attached to a horizontal box-beam bumper. The vertical supports of the guard were constructed of 23 x 13 cm (9 x 5 in) tapered I-beam section that measured 41 cm (16 in) in length. The vertical supports were located on 122 cm (48 in) centers. The 10 x 10 cm (4 x 4 in) steel box-beam bumper measured 239 cm (94 in) in total width and was attached to the lower ends of the tapered I-beams. The guard was attached to the trailer frame by four 16 mm (5/8 in) Grade 5 bolts. Two bolts were oriented vertically through the rear frame and two bolts were oriented horizontally through the back plane.

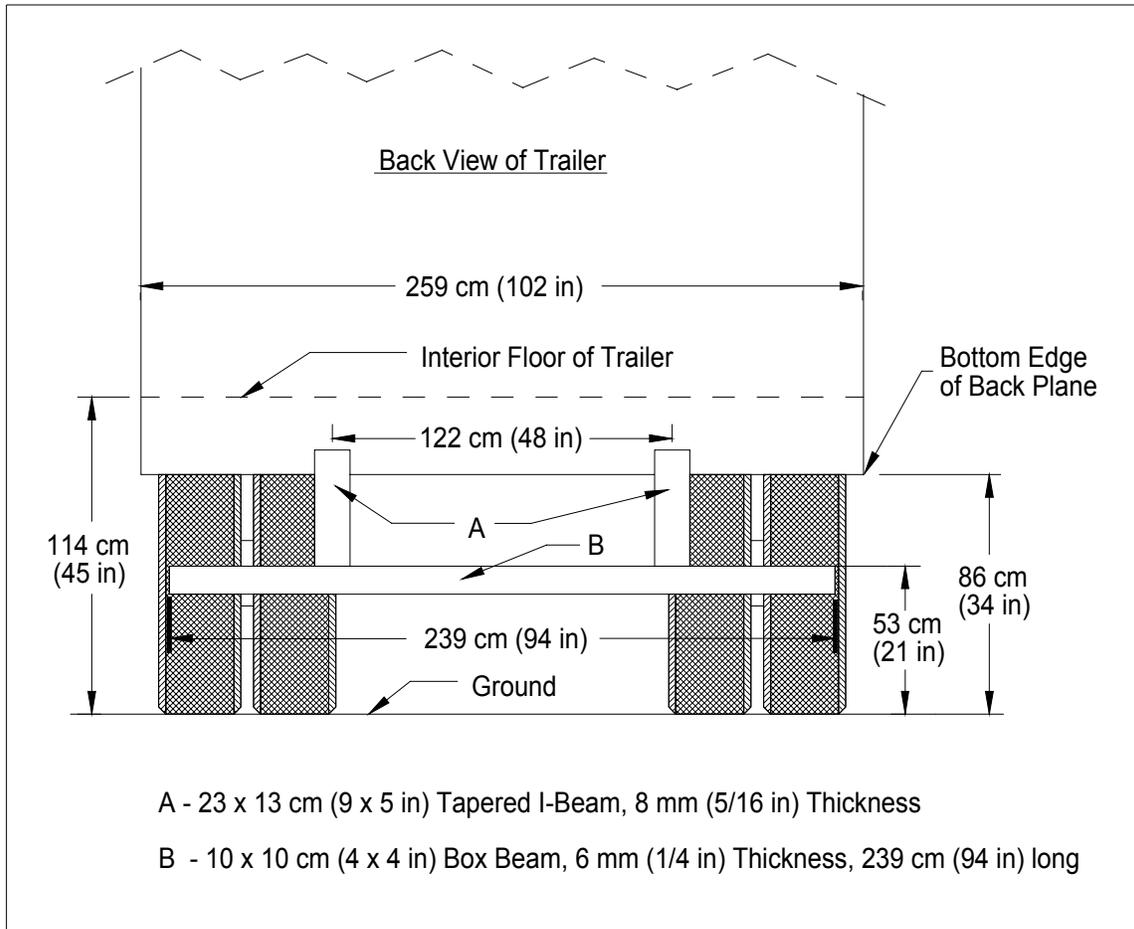
Figure 4: Schematic of the pre-crash arrangement of the rear impact guard.

The bumper separated from the vertical supports due to the force of the crash. It was located with the Ford F-150 and inspected at that location. Refer to the *Exterior Damage* section of this report for further information regarding the post-crash condition of the rear impact guard. The pre-impact height of the bumper was reconstructed from the measurements taken during the vehicle inspections. The bumper height was 53 cm (21 in). This height is referenced to the bumper's top surface. **Figure 4** is an end-view of the trailer depicting the pre-crash arrangement of the rear impact guard.

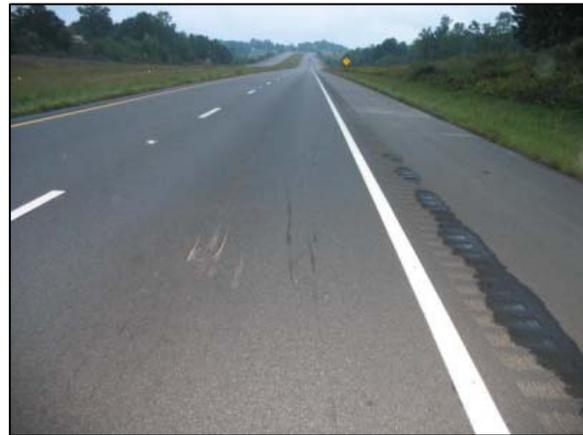
Figure 5: Westbound trajectory view and point of impact at the crash site.

This two-vehicle crash occurred during the daylight hours of September 2009. At the time of the crash, the weather was not a factor. The crash occurred in the outboard westbound lane of a two-lane, divided east/west interstate highway in a rural setting. The road way was straight with a negative two percent grade (-2%) in the area of the crash. The traffic lanes measured 3.7 m (12.1 ft) in width and were separated by broken center lines. The outboard edges of the travel lanes were delineated by solid fog lines. The north shoulder consisted of a 3.5 m (11.5 ft) wide breakdown lane. The speed limit was 105 km/h (65 mph). The impact was evidenced by a series of gouge marks on the inboard westbound lane. The gouge marks measured 3.6 m (11.8 ft) in length. The post-crash trajectory of the vehicles was evidenced by a fluid trail from the point of impact leading to the final rest position of the vehicles on the north breakdown lane. **Figure 5** is a trajectory view of the vehicles at the point of impact.

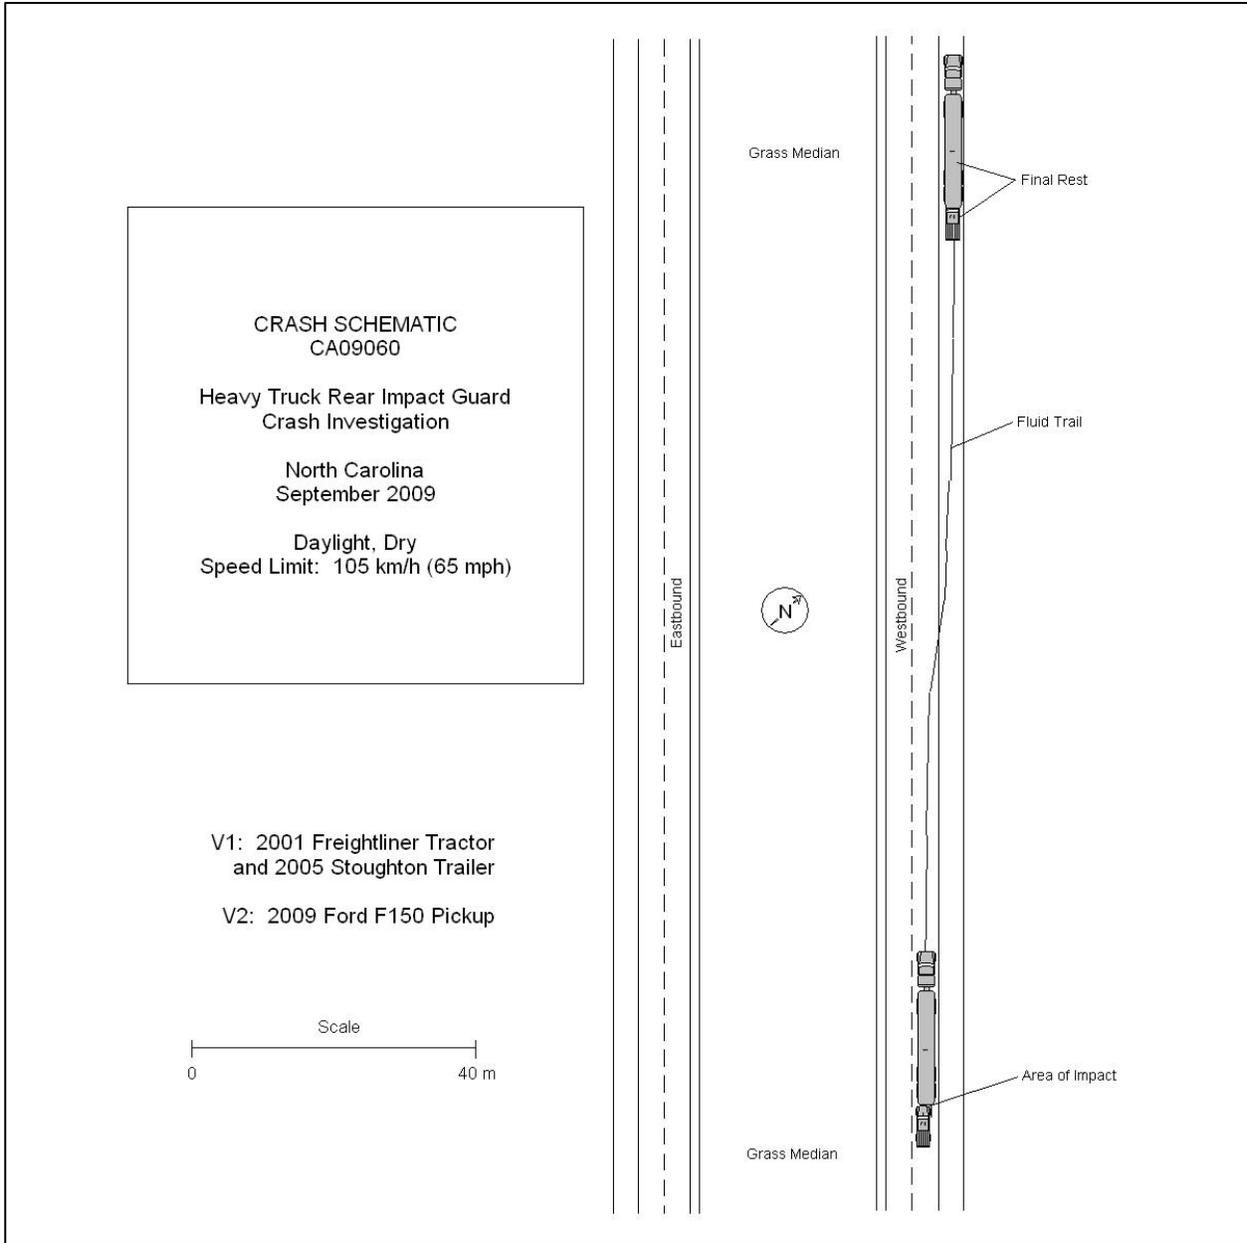
Figure 19: Crash Schematic.

The tractor trailer was westbound driven by a 57-year-old male. A 49-year-old female was a passenger in the sleeper berth of the tractor. The tractor trailer was operating at a reduced speed due to a driver reported air pressure problem. The driver reported to the investigating officer that his speed was approximately 64 km/h (40 mph). The vehicle was in the outboard lane of the interstate and the vehicle’s emergency flashers were “On”. The 2009 Ford F-150 was westbound driven by a 39-year-old unrestrained male and occupied by a 24-year-old unrestrained female front right passenger. Witnesses to the crash reported that the speed of the Ford was above the posted 105 km/h (65 mph) speed limit. The EDR data imaged at the time of the vehicle inspection indicated the speed of the Ford was 133 km/h (82.7 mph) one second prior to the impact. The EDR data also indicated that the driver steered left and applied the brakes during the last second prior to the impact in an attempt to avoid the crash. A schematic of the crash is included at the end of this report as **Figure 19**.
