CALSPAN ON-SITE AMBULANCE CRASH INVESTIGATION

SCI CASE NO: CA09076

VEHICLE: 1998 FORD E350 TYPE III AMBULANCE

CRASH DATE: OCTOBER, 2009

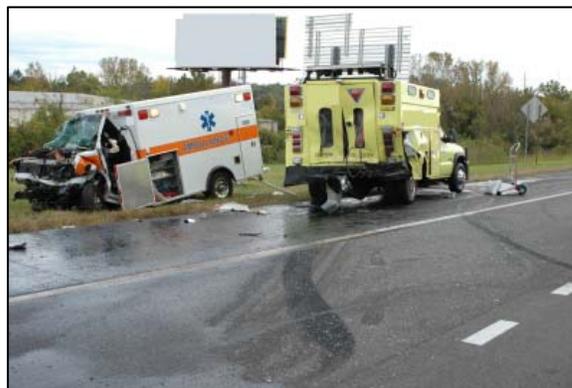
Figure 1: On-scene image of the vehicles at final rest. Image obtained from investigating police.

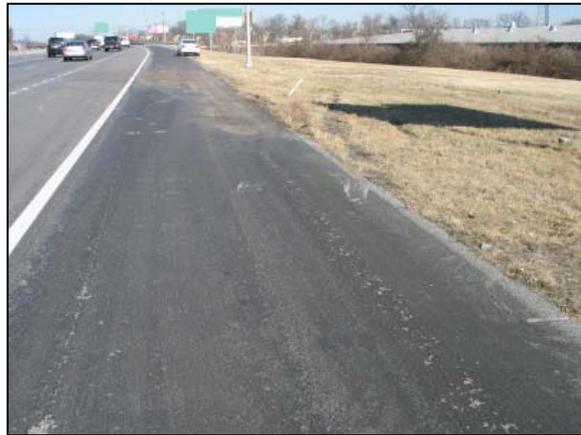
Figure 2: Northward view of the point of impact.

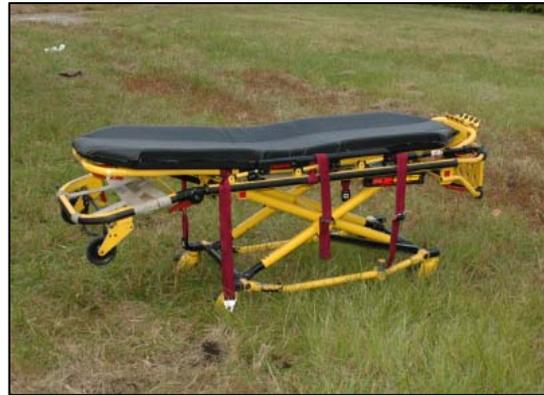
The cot used to transport the patient in this crash was a Stryker MX-PRO. It was not damaged during the crash event. **Figure 19** is a police image of the cot. The cot was not damaged during the crash. It was moved out of the patient compartment by the first responders prior to the arrival of the police investigator. At the conclusion of the on-scene police investigation, the cot was removed from the crash site by the ambulance company. The cot was placed back in service the day following the crash and was not inspected for this SCI investigation.

Figure 19: Police supplied image of the Stryker cot.

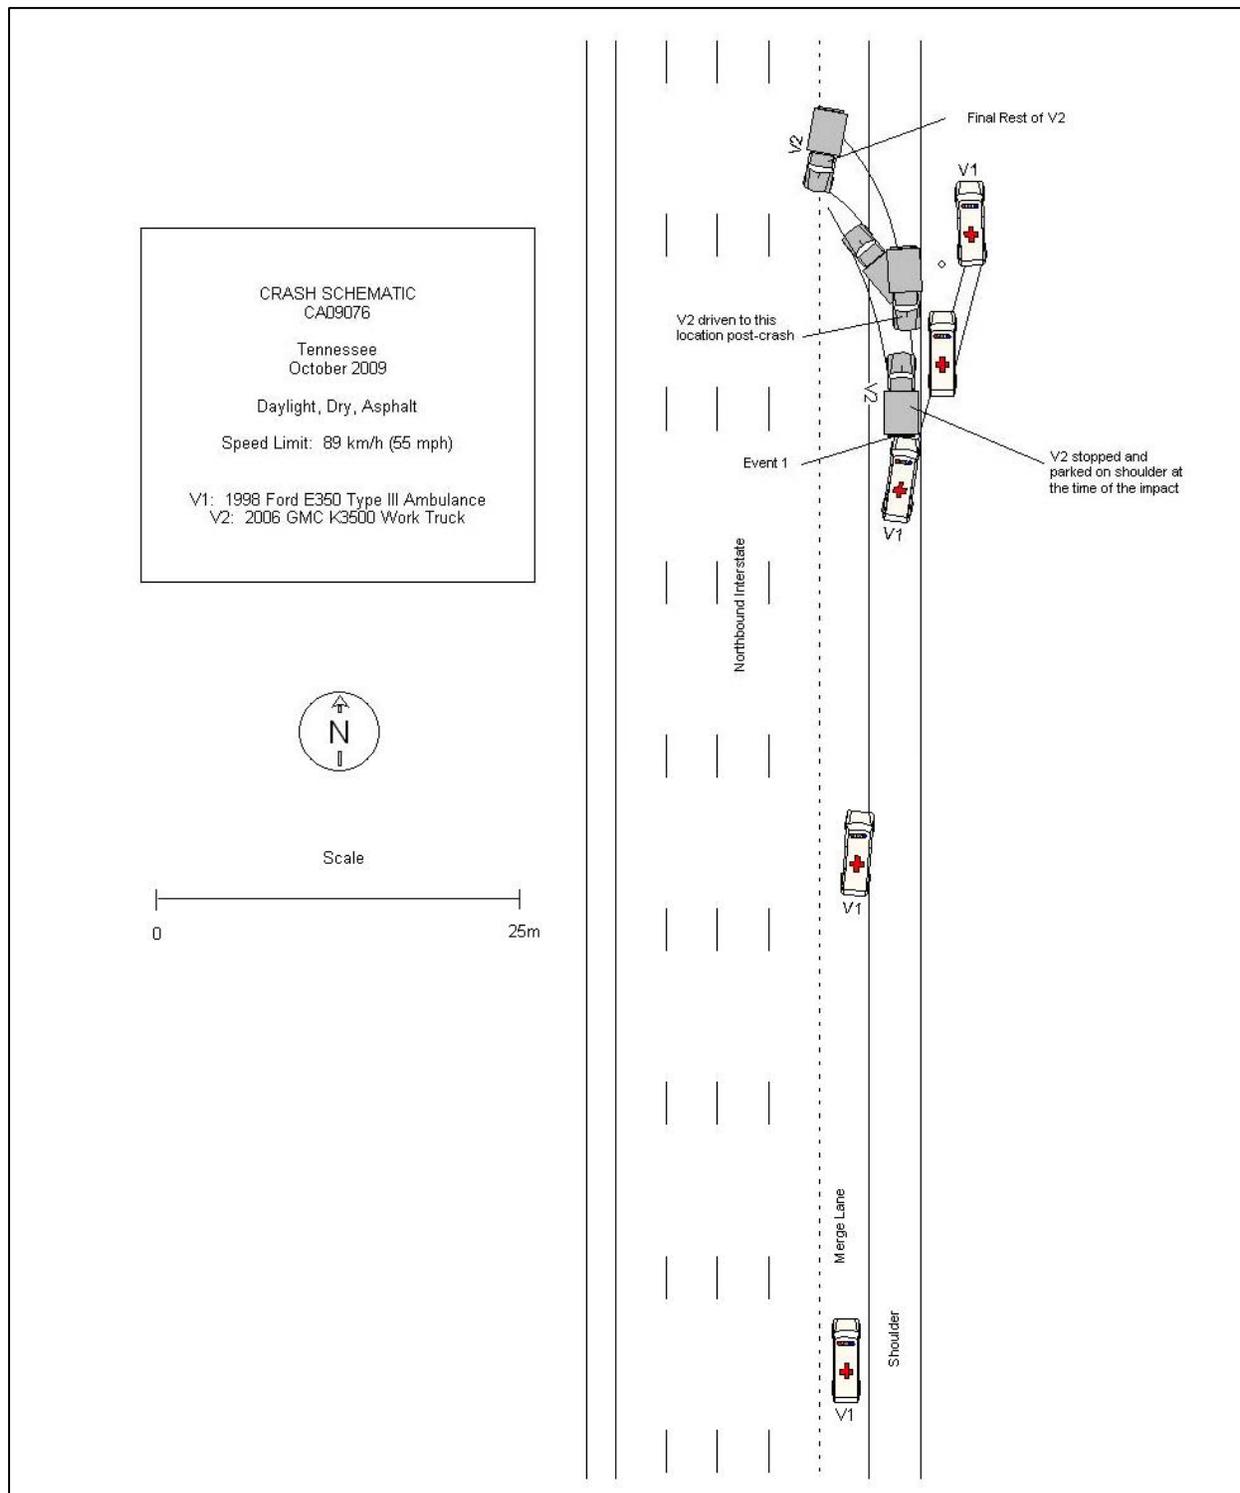
Figure 20: Crash Schematic.

The ambulance drifted to the right, onto the shoulder, to impact with the back plane of the GMC. There was no evidence of pre-crash braking or evasive steering by the ambulance driver. The 60-year-old driver of the GMC work truck indicated that he had just stopped, placed the transmission into park, and released his safety belt when the crash occurred. **Figure 20**, attached to the end of this report, is a schematic of the crash.
