**OFFICE OF DEFECTS INVESTIGATION  
CALSPAN ON-SITE POTENTIAL UNINTENDED ACCELERATION  
CRASH INVESTIGATION**

**SCI CASE NO.: CA10014**

**VEHICLE: 2007 TOYOTA CAMRY**

**CRASH DATE: MARCH, 2010**

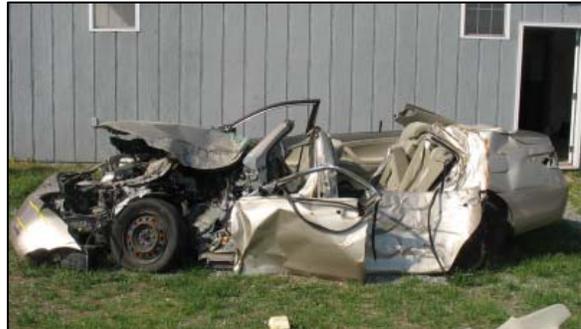
This on-site investigation focused on the alleged Unintended Acceleration (UA) of a 2007 Toyota Camry, **Figure 1**, which was involved in a roadside departure/fixed object crash. The Toyota was driven by a 37-year-old female and was occupied by two 11-year-old female second-row passengers. None of the vehicle's occupants were restrained by the manual safety belt systems. The driver was operating the vehicle northbound on a straight segment of 2-

**Figure 1: Left side view of the Toyota Camry.**

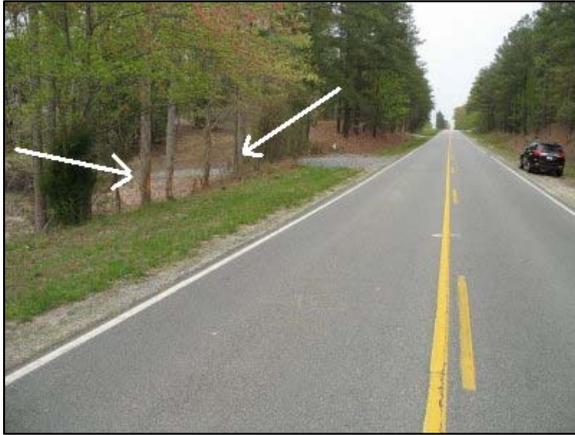
**Figure 5: Northbound trajectory view of the Toyota.**

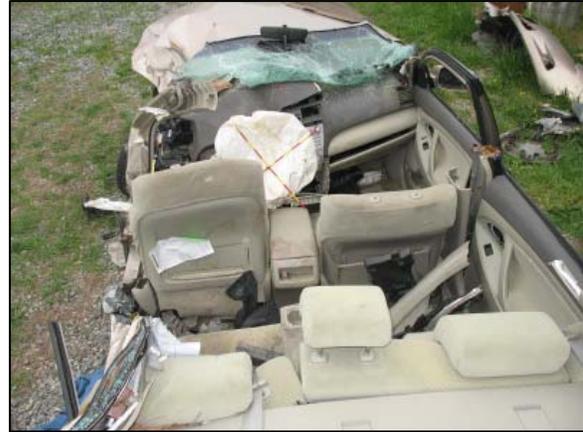
The interior of the Toyota sustained moderate damage as a result of the crash. **Figure 12** is a left lateral view across the front row depicting the intrusion into the driver's interior. **Figure 13** is an overhead view of the interior. The instrument panel, toe pan and associated components intruded into the driver's position. The roof and left C-pillar intruded into occupant space of the second row left passenger. The measured intrusions are listed in the table below:

**Figure 13: Overhead view of the interior.**

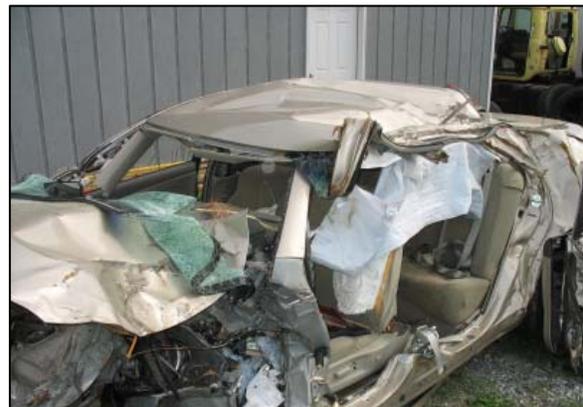
The CAC driver air bag, the knee bolster air bag, the driver seat-mounted side impact air bag and the left IC air bag deployed as a result of the multiple impact crash. **Figure 16** is an oblique view of the Toyota with the roof repositioned. The driver air bag deployed from an H-configuration module that was located in the center hub of the steering wheel. The deployed driver air bag measured 61cm (24.0 in) in diameter in its deflated state. The air bag was tethered by two internal straps sewn to the face of the bag. It was vented by two ports located in the 11 and 1 o'clock sectors on the back side of

**Figure 16: Oblique view of the Toyota with the roof repositioned.**

During the crash, the left A-pillar deformed rearward. This in-turn deformed the left roof side rail and caused a rearward displacement of the most forward attachment point of the IC. The A-pillar and attachment point displacement allowed a pocket to form at the left front window and reduced the tension across the length of the IC. The reduced tension allowed a partial ejection through the left rear window opening. During the crash, the left forearm of the unrestrained second row left passenger was partially ejected and injured. **Figure 18 and 16** (above) depict the pocketing and reduced tension in the IC.

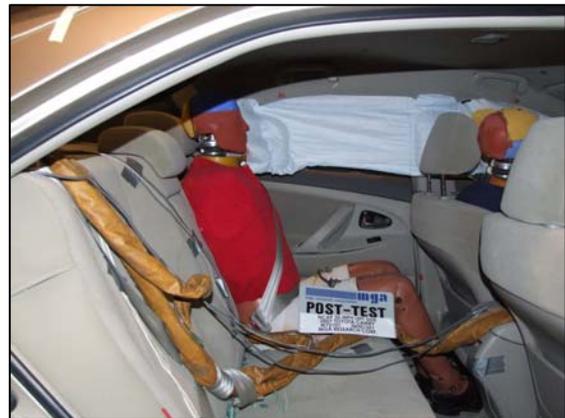
**Figure 17: Right interior post-crash test view of a 2007 Toyota Camry, NHTSA test #5674.**

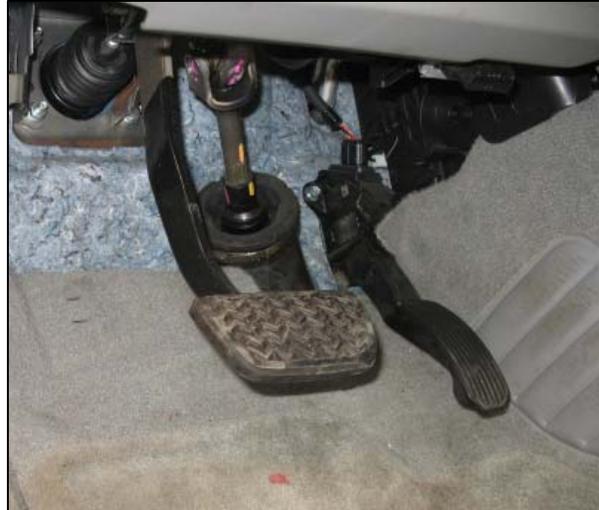
It was noted that the accelerator pedal was in contact with the floor mat. However, the pedal was in the closed position. It was not jammed or captured by the after-market floor mat. The deformation of the toe pan caused the pedal assembly (as a whole) to rotate downward (clockwise) and contact the floor. The pedal assembly was in a near-vertical position. The intrusion prevented fore/aft movement of the pedal. There was minor lateral pedal movement. **Figure 20** is a close-up view of the accelerator at its contact with floor. **Figure 21** is a view of the arrangement of the foot controls in an exemplar 2007 Toyota Camry. The accelerator pedal measured 8 cm (3 in) above the floor in its undamaged condition. The toe pan intrusion and subsequent rotation of the pedal in the case vehicle reduced its clearance above the floor.

**Figure 21: View of the foot controls in an exemplar undamaged 2007 Toyota Camry. Note the angle of the accelerator pedal, as compared to Figure 19.**

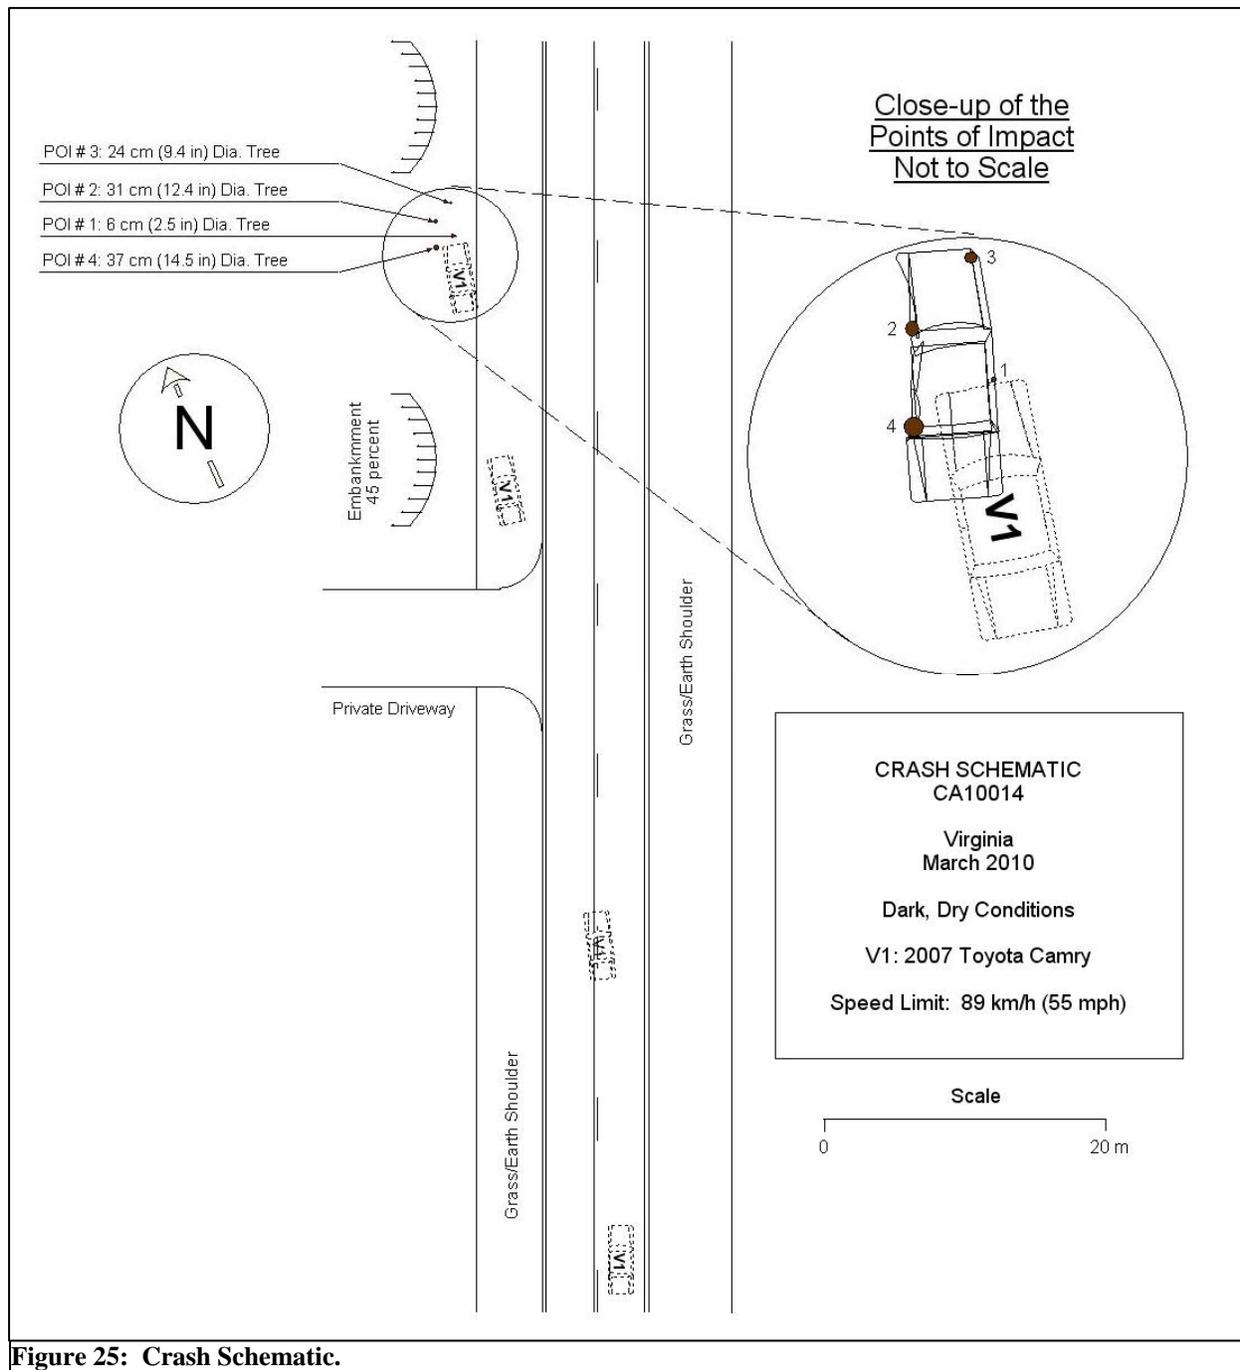
**Figure 25: Crash Schematic.**
