On-Site Potential Unintended Acceleration Investigation  
Dynamic Science, Inc. Case Number DS10024  
Office of Defects Investigation  
2008 TOYOTA CAMRY  
Utah  
November 2010

1. Report No. DS10024		2. Government Accession No.		3. Recipient Catalog No.	
4. Title and Subtitle  On Site Potential Unintended Acceleration Investigation				5. Report Date July 8, 2011

**Dynamic Science, Inc.  
Crash Investigation  
Case Number: DS10024**

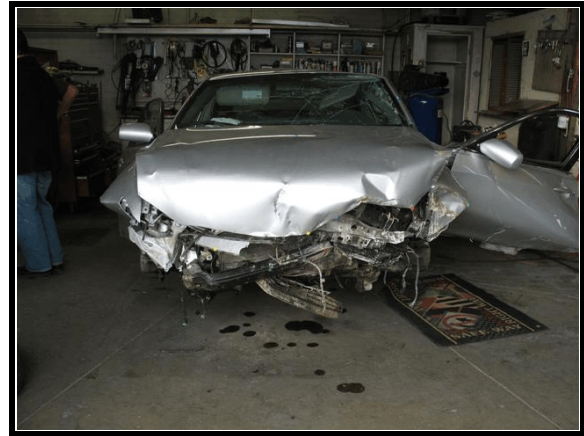
The investigation focused on the alleged unintended acceleration and the crash dynamics surrounding the single vehicle crash of a 2008 Toyota Camry (**Figure 1**). The crash occurred at 1800 hours in November 2010. The crash site was an off-ramp of an interstate highway. The off-ramp intersects a north/south roadway that was bordered on one side by a rock-covered embankment. The Toyota was being driven by a restrained 66-year-old male. The driver was a diabetic but there were no reports of any medically related episodes in this crash. There were three additional occupants in the vehicle. A restrained 61-year-old female was seated in the front right seat position. An unrestrained 38-year-old female was seated in the second row left seat and an unrestrained 34-year-old male was seated in the second row right seat.

**Figure 1.** 2008 Toyota Camry

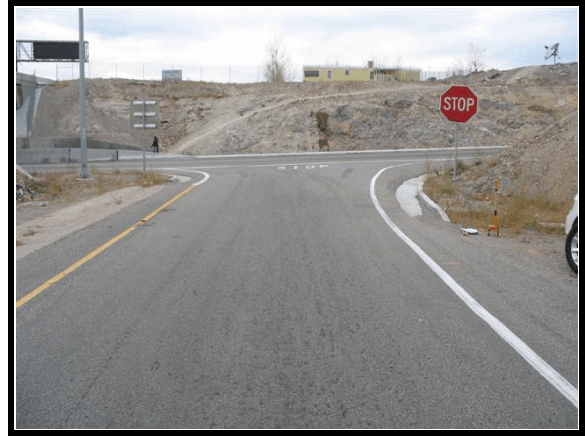
The westbound single-lane off-ramp was 4.3 m (14.1 ft) wide, straight as it approached the intersection, and was bordered on both sides by a combination of asphalt shoulders, gravel shoulders, and rock embankments (**Figure 2**). Nearer the intersection, the roadway was bordered by raised concrete curbs. A 305.0 cm (120.0 in) high stop sign was located on the north side of the roadway, 13.1 m (43.0 ft) east of a white painted stop line. The roadway had an ascending grade of 1.9 percent at the stop line. At 15.2 m (50.0 ft) east the stop line the grade was negative 1.3 percent, at 30.4 m (100.0 ft) it was negative 1.4 percent, and at 60.9 m (200.0 ft) it was negative 4 percent. The distance from the off-ramp exit area of the intersection to the north/south street was approximately 213.3 m (700.0 ft) (**Figure 3**).

**Figure 2.** Westbound approach to end of exit ramp

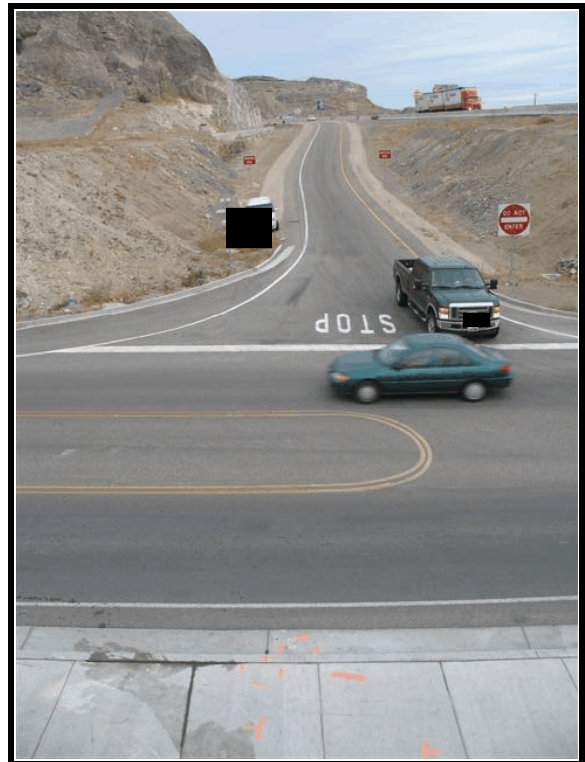
**Figure 3.** Look back view looking east toward exit ramp

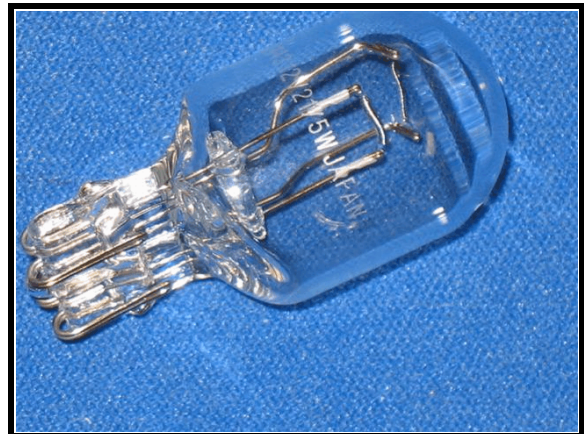
During the mechanical inspection, the police investigators removed and photographed the vehicle tail light lamps (**Figure 21**). The vehicle was equipped with two-filament lamps. The smaller of the two filaments is for the tail lights and the larger (lower) filament is for brake lights, turn signals or a combination of both. If the filaments are incandescent or hot at impact it will stretch out, uncoil, or break. The result deformation is called “hot shock”. There were no indications of hot shock when the photographed lamps were compared to an exemplar lamp (**Figure 22**).

**Figure 22.** Exemplar tail light lamp
