CALSPAN ON-SITE CHILD RESTRAINT SYSTEM CRASH INVESTIGATION
SCI CASE NO.: CA10033

VEHICLE: 2010 DODGE GRAND CARAVAN

LOCATION: NORTH CAROLINA

CRASH DATE: JUNE 2010

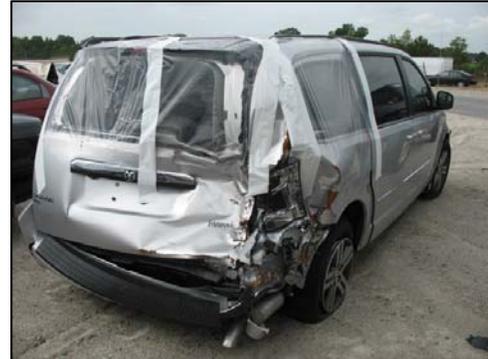
Figure 1: Right rear oblique view of the 2010 Dodge Grand Caravan.

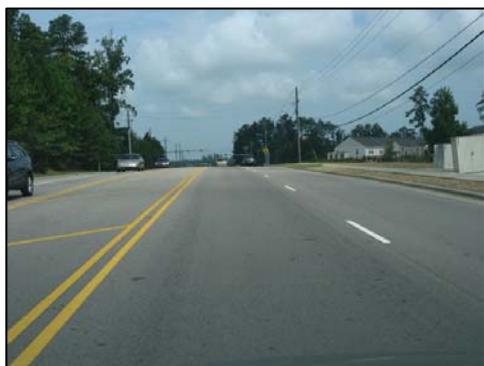
This crash occurred during daylight hours on a four-lane urban roadway. **Figure 2** depicts the approach by all three vehicles to the area of impact. The roadway extended north/south and was

Figure 2: Pre-crash trajectory of all vehicles.

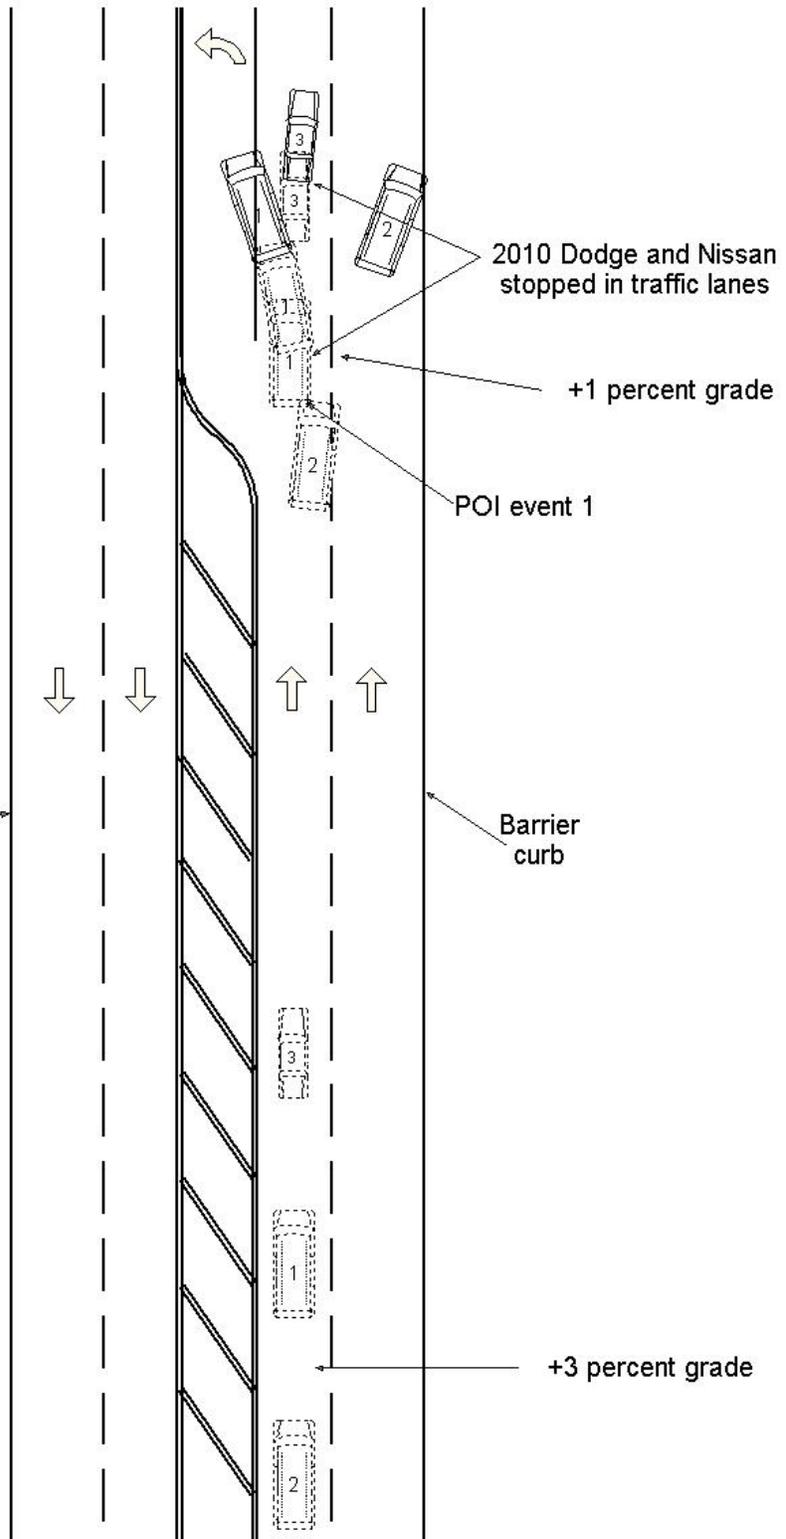
Figure 9: Crash Schematic

The roadway was bordered on both sides by concrete barrier curbs 16 cm (6.3 in) in height. In the pre-crash area for all three vehicles, the grade was +3 percent. This transitioned to a +1 percent grade near the area of impact. The speed limit in the area in which this crash occurred was 72 km/h (45 mph). A Crash Schematic is included as **Figure 9** of this report.
