ON-SITE AIR BAG INVESTIGATION

CASE NUMBER - IN97-017

VEHICLE - 1992 FORD TAURUS GL

CRASH DATE - June, 1997

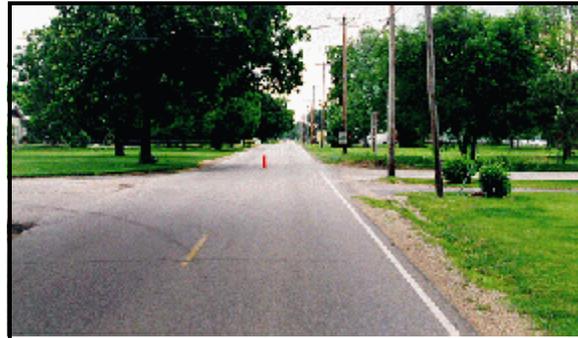
The case vehicle was traveling east in the eastbound lane of a two-lane, undivided, county roadway (**Figure 1**), intending to continue eastbound. Vehicle #2 had been traveling west in the westbound lane on the same, two-lane, undivided county roadway and was turning left intending to travel south on the south leg of the offset, four-leg intersection. Vehicle #3 was stopped heading north-northeast on the south leg of the intersection, waiting to turn right (i.e., a private commercial driveway on the south side of the road). All three vehicle's were traveling on a dry, bituminous roadway that was straight and level at the area of impact. The width of the travel lanes for the case vehicle and vehicle #2 were 3.9 meters (12.9 feet) and 4.1 meters (13.5 feet), respectively. The east and westbound lanes were divided by a dashed yellow line with white fog lines along the roadway edges. The roadway is bordered by gravel shoulders which measure 1 meter (3.3 feet). There were no controls other than a posted regulator SPEED LIMIT sign. The legal limit for the case vehicle was 80 km.p.h. (50 m.p.h.), transitioning to 72 km.p.h. (45 m.p.h.). The legal speed limit for vehicle #2 was 72 km.p.h. (45 m.p.h.). The estimated coefficient of friction for the roadway is 0.75%. The surrounding area is primarily residential with some farm land. The case vehicle's driver made no avoidance maneuvers prior to the crash. The crash occurred in the driveway access portion of the four-leg offset intersection.

Figure 1: Case vehicle's approach path in eastbound lane to offset four-leg intersection showing approx-imate point of impact (red cone); Note: vehicle #2 was approaching from the background in the west-bound lane and vehicle #3 was stopped on the south (toward right) leg (case photo #02)

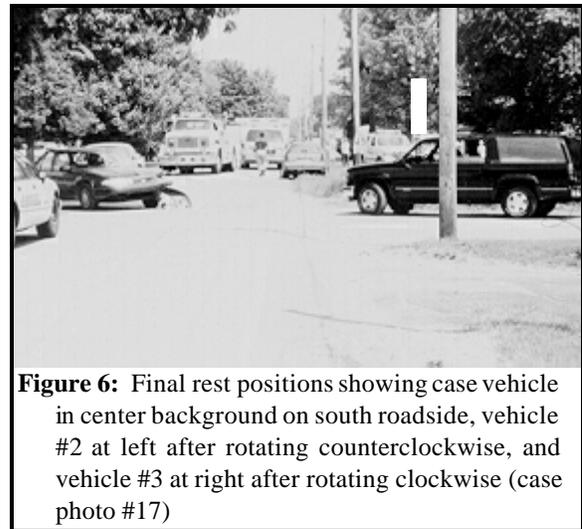
front right of the case vehicle struck a SPEED LIMIT sign on the east roadside of the trafficway. The case vehicle continued eastward (Figure 5) and came to rest heading east on the east shoulder approximately 26 meters (85 feet) farther east of the impacted SPEED LIMIT sign. Vehicle #2 rotated slightly counterclockwise and came to rest heading southwest straddling and diagonally across the centerline of the roadway. Vehicle #3 rotated slightly clockwise post-crash and came to rest heading north-northeast on the south leg of the intersection (Figures 6 through 8).

Figure 6: Final rest positions showing case vehicle in center background on south roadside, vehicle #2 at left after rotating counterclockwise, and vehicle #3 at right after rotating clockwise (case photo #17)

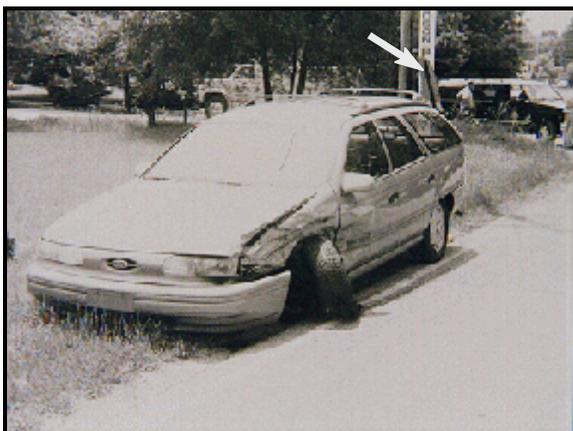
Figure 7: On-scene view of case vehicle at final rest; Note: vehicle #3 (Suburban) in background and struck speed limit sign directly behind case vehicle (case photo #15)

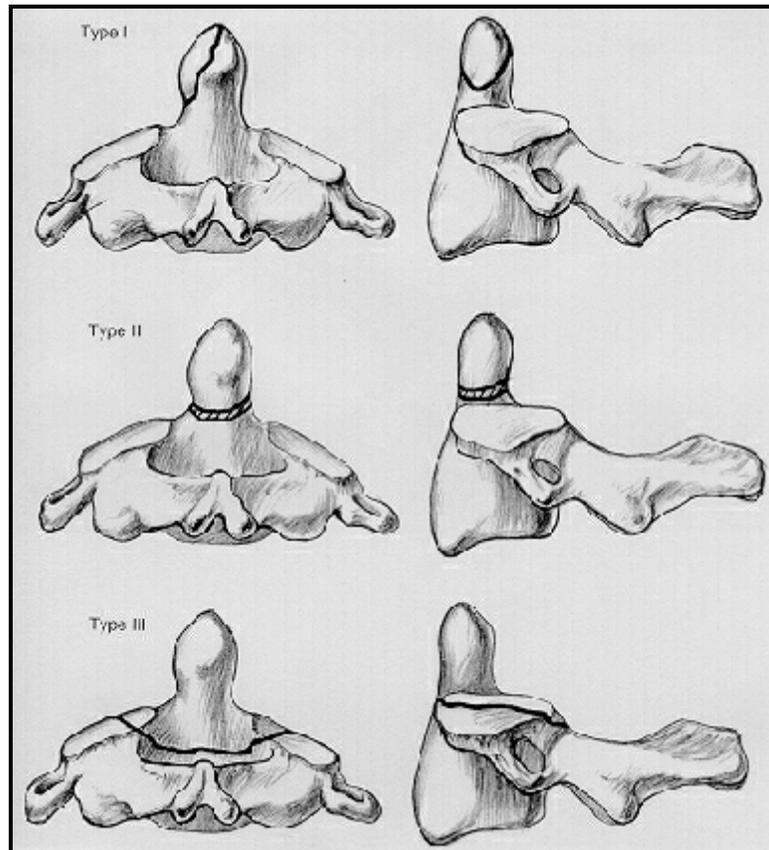
CLASSIFICATION: Odontoid Fractures -- Anderson and D'Alonzo based their classification of odontoid fractures on the location of the fracture (see Figure). **Hangman's Fractures** - Bucholz described hangman's fractures as stable or unstable injuries on the basis of the amount of C₂-C₃ discoligament injury associated with the fracture. Stable hangman's fractures are minimally displaced and the C₂-C₃ disc is intact. In unstable hangman's fractures, the C₂-C₃ disc is disrupted, resulting in C₂-C₃ vertebral body subluxation. A rare third type of hangman's fracture was identified by Levine and Edwards. This injury consists of fracture of the pars interarticularis and dislocation of the C₂-C₃ facet joints.

Figure 22: Anderson and D'Alonzo classification of odontoid fractures.

- Type I: rare, stable avulsion fractures of the tip of the dens
- Type II: unstable transverse fractures in the cortical bone of the waist of the dens
- Type III: unstable fractures in the cancellous bone of the body of C₂
