TRANSPORTATION RESEARCH CENTER

ON-SITE AIR BAG INVESTIGATION

CASE NUMBER - IN97-022
LOCATION - MISSISSIPPI
VEHICLE - 1993 FORD TAURUS GL
CRASH DATE - June, 1997

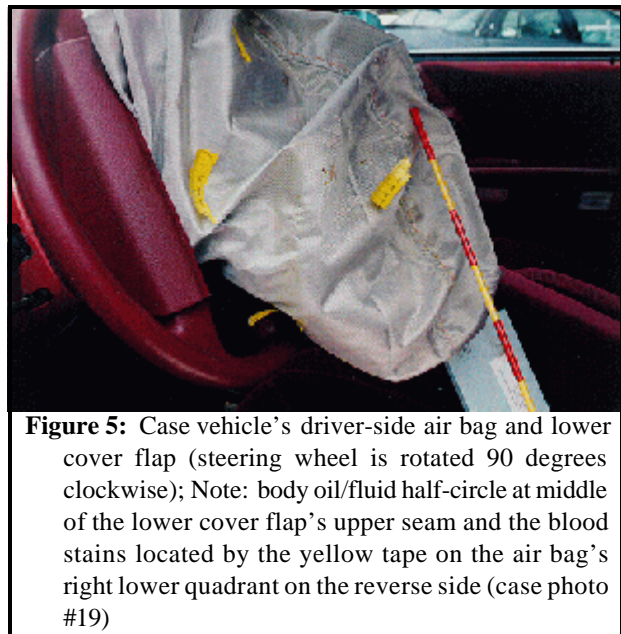
vertically. During the vehicle inspection, the steering wheel was found to be rotated 90 degrees clockwise. The air bag fabric was measured as an oblong shape, 63 centimeters (24.8 inches) high and 52 centimeters (20.5 inches) wide. This air bag was tethered by two cloth straps 6 centimeters (2.4 inches) wide and vented by two exhaust ports 2 centimeters (0.8 inches) in diameter. The exhaust ports were located at the 11 and 1 o'clock positions. The driver air bag module's cover flaps opened along the designated tear seams.

Possible driver contacts were detected on both cover flaps: a "dot" scratch was noted near the center of the upper flap (see **Figure 5** above) and a half-circle of body oil/fluid was detected at the center of the horizontal tear seam of the lower flap (see **Figure 6**). Buttons on the driver's blouse are suspected of causing the top mark and body contact causing the lower mark. As the driver air bag deployed, the close proximity of the driver's body to the steering wheel likely directed the air

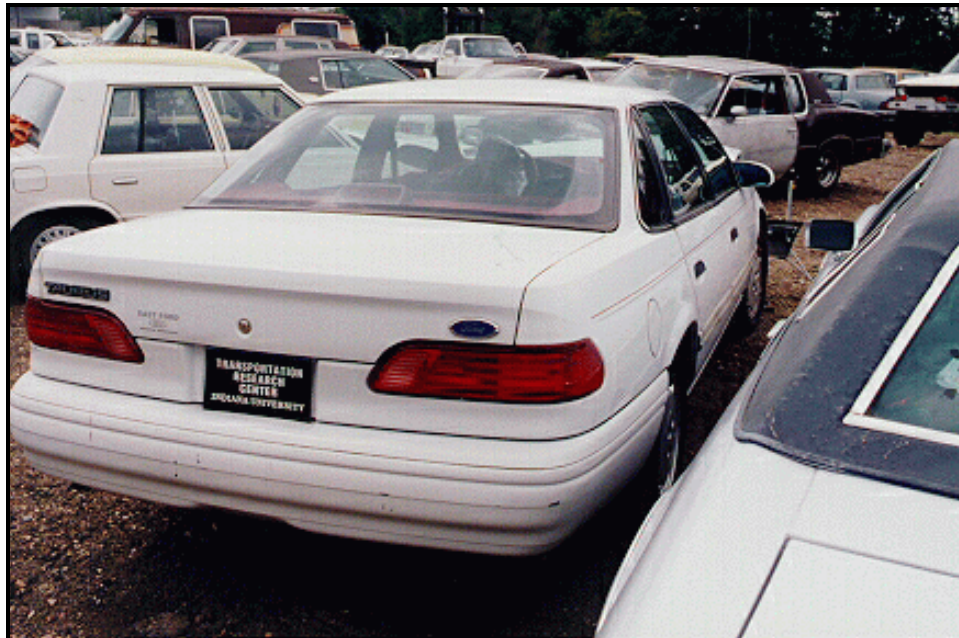
Figure 13: Case vehicle's undamaged back and right side (case photo #12)
