Remote, Redesigned Air Bag Special Study

Dynamic Science, Inc., Case Number (1998-049-804E)

1998 Dodge Durango

Summary

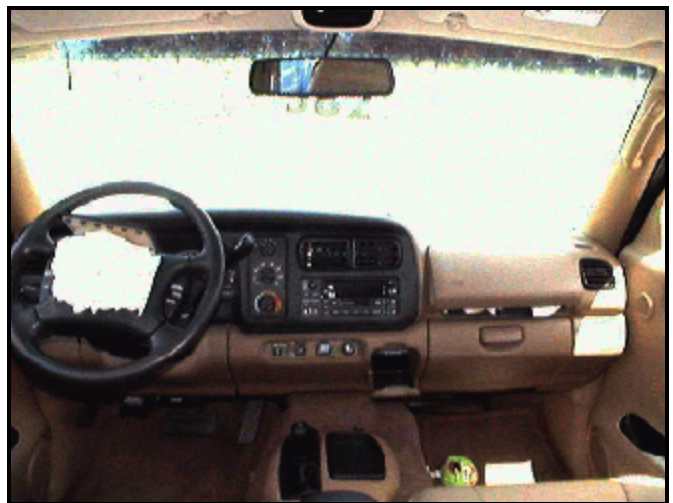
Figure 9. Interior, case vehicle.

The interior of the Dodge Durango sustained minor damage from occupant contact. There were no areas of intrusion into the passenger compartment. There was occupant contact evidence to the front left air bag and front left door panel.
