**VERIDIAN ON-SITE AIR BAG RELATED CHILD PASSENGER
FATALITY INVESTIGATION
VERIDIAN CASE NO. CA98-049
VEHICLE: 1997 FORD EXPLORER
LOCATION: VIRGINIA
CRASH DATE: SEPTEMBER 1998**

Contract No.
DTNH22-94-D-07058

<p>14. <i>Sponsoring Agency Code</i></p>	
<p>15. <i>Supplementary Notes</i> On-site investigation of a front-to-rear crash that resulted in frontal air bag deployment and the death of a 5 year old male front right child passenger.</p>			
<p>16. <i>Abstract</i> This on-site investigation focused on the injury mechanisms and cause of death of a 5 year old male front right passenger of a 1997 Ford Explorer. The Explorer was equipped with frontal air bags for the driver and front right passenger positions that deployed as a result of an off-set, front-to-rear crash with a 1988 Dodge Caravan. The 31 year old female driver of the Ford Explorer was distracted to her right as she approached the slower moving Dodge Caravan. As she redirected her attention forward, the driver detected the Caravan and braked in an attempt to avoid the crash. The front left area of the Explorer impacted the back right area of the Caravan resulting in moderate damage to both vehicles. The unrestrained chi

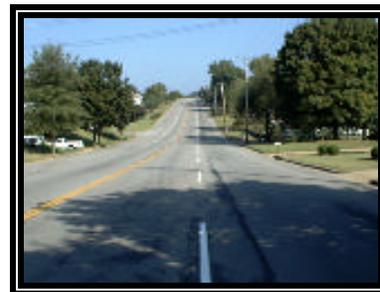
The driver of the 1988 Dodge Caravan was traveling in a northerly direction on the inboard travel lane of the four-lane roadway (**Figure 2**). She was decelerating for a left turn onto an intersecting street. The driver of the Caravan stated that there was no opposing traffic on her approach to the intersection. She further stated that she looked in her rearview mirror as she slowed for the left turn and did not detect the approaching Ford Explorer.

Figure 2. Northbound approach view of the crash scene.

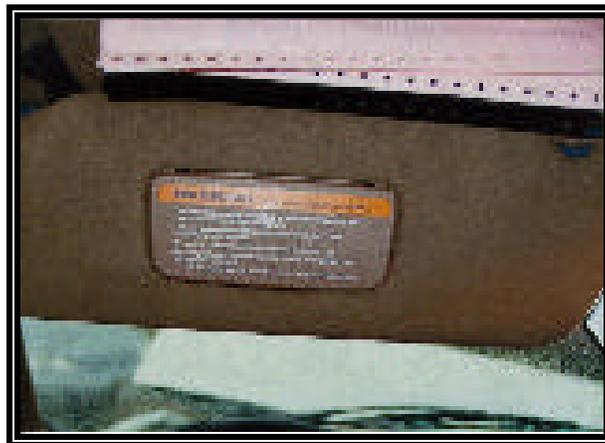
The sunvisors of the Ford Explorer contained warning labels (**Figure 9**) that advised the following:

- For maximum safety protection in all types of crashes, you must always wear your safety belt.
- Do not install rearward-facing child seats in any front passenger seat position.
- Do not sit or lean unnecessarily close to the air bag.
- Do not place any objects over the air bag or between the air bag and yourself.

Figure 9. Sunvisor Air Bag Warning Label

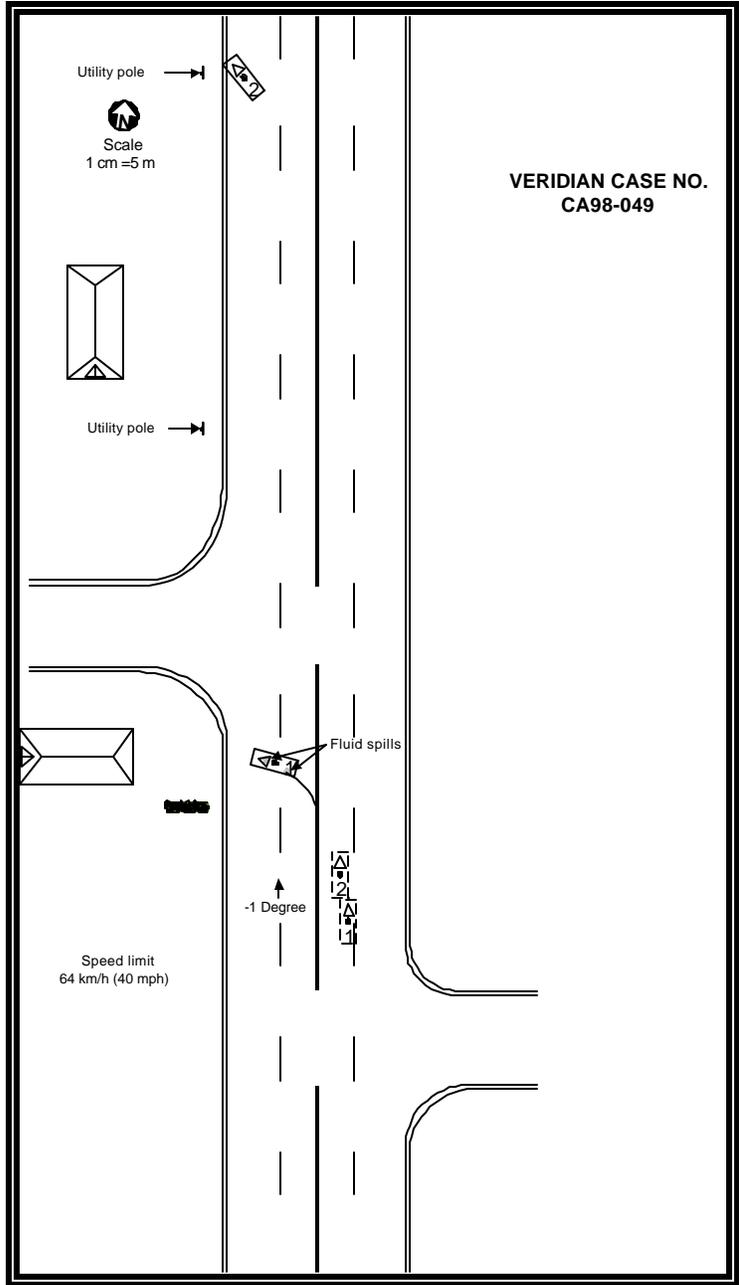
barrier curbs with lawns extending beyond the curblines. At the time of the crash, the asphalt road surface was dry and the weather was clear. The posted speed limit was 64 km/h (40 mph). The crash schematic is included as **Figure 12**.

Figure 12. Scene Schematic.
