Case 422 : Narrative

Case Vehicle (A): 2001 Jeep	Vehicle (B): 2002 Ford
Type: Cherokee Sport, 4x4, 4-door SUV	Type: Mustang, 2-door convertible
Driver: 43-year-old male	Driver: 41-year-old female
CDC: 01-FDEW-2	CDC: 10-LYAW-3

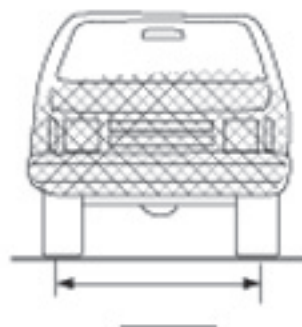
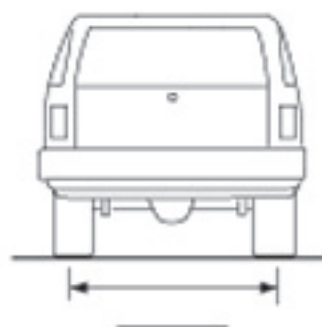
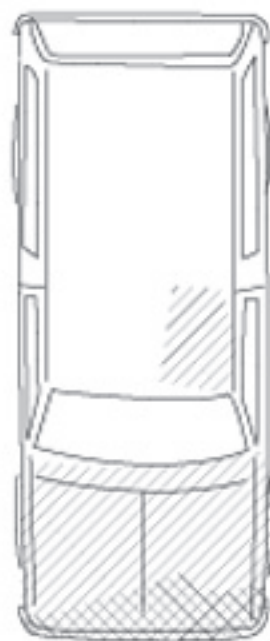
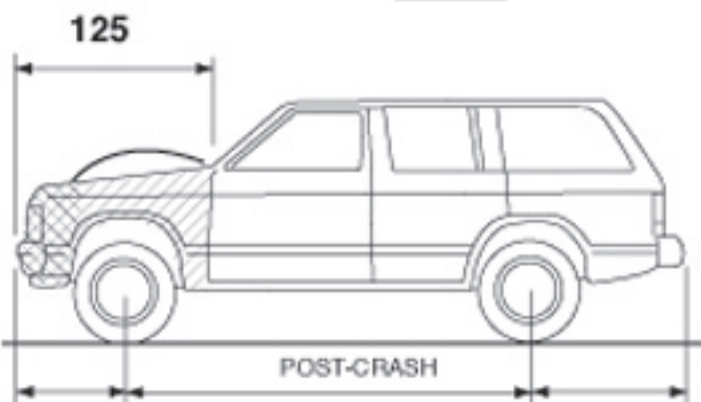
8 Damage to the front of case vehicle (A) was moderate, with 9 direct damage extending across the entire frontal plane. The maximum crush was 42 cm and it occurred near the middle of the front bumper.

Max. crush to center of front bumper

42

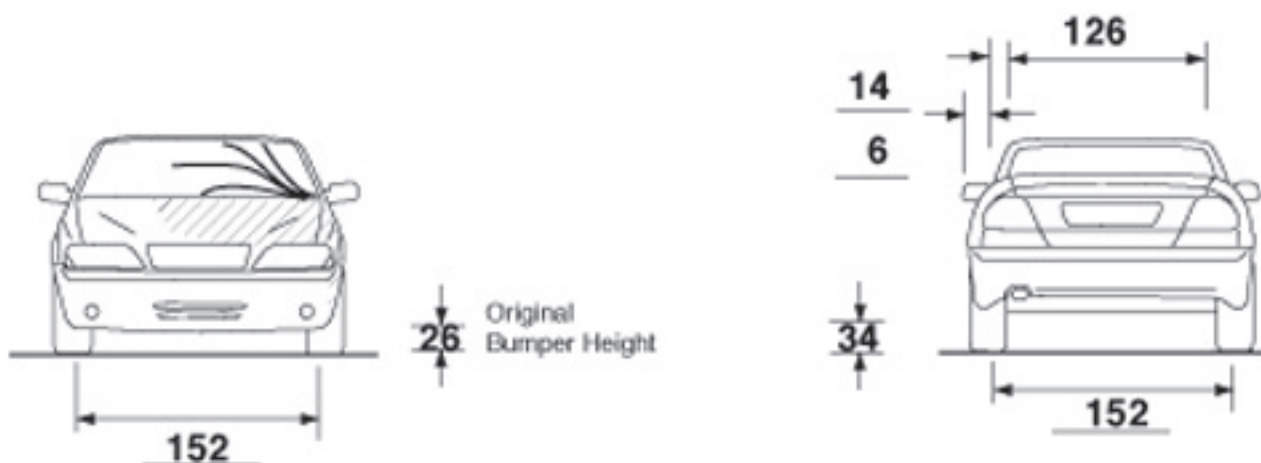
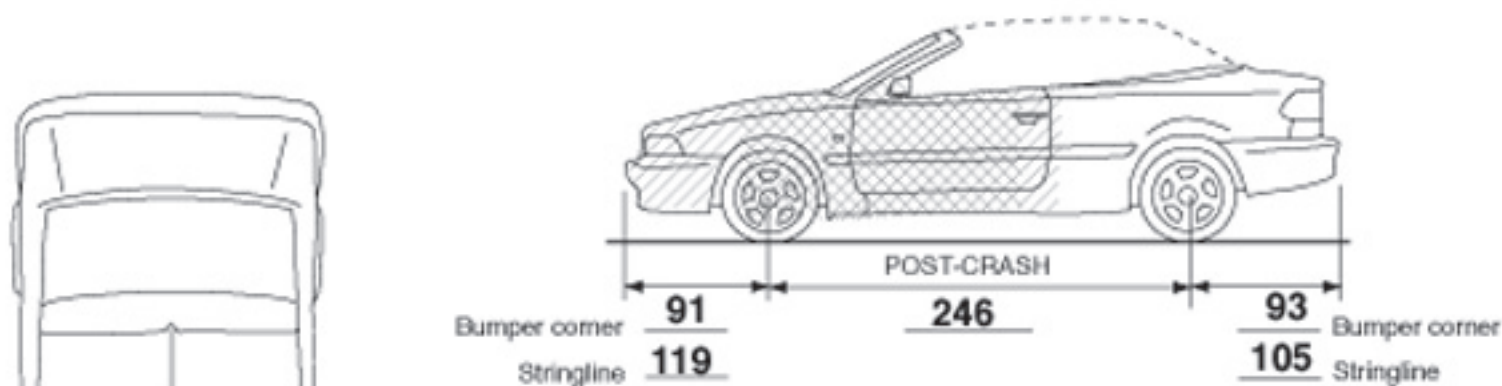
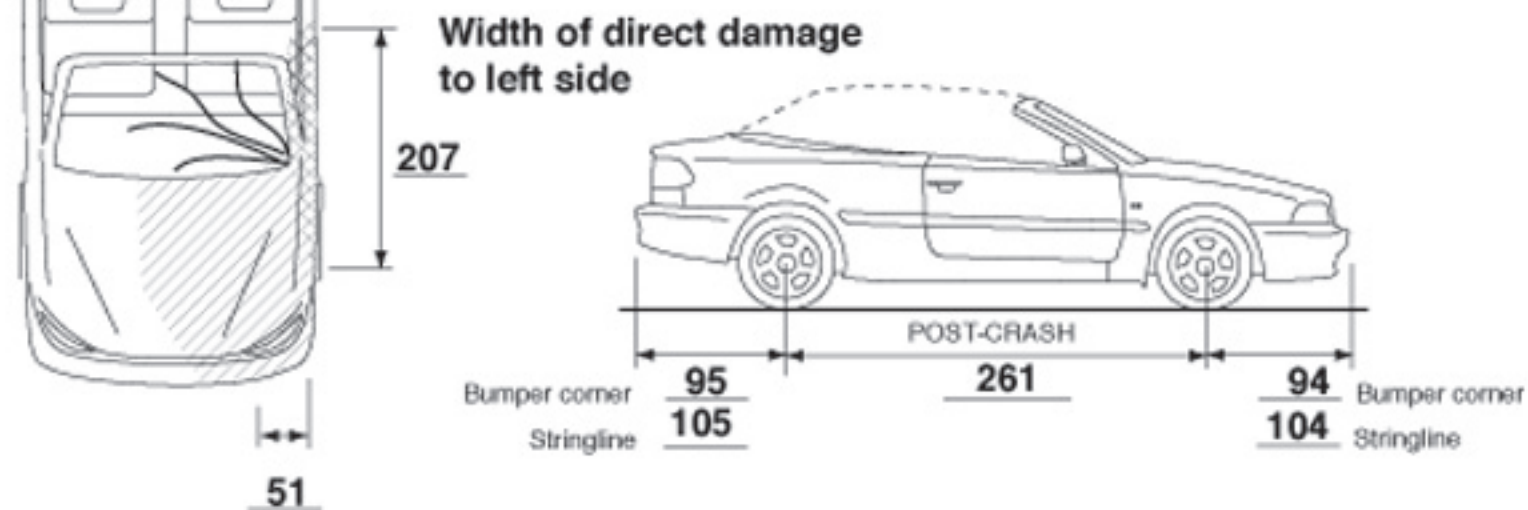
10 Damage to the left side of vehicle (B) was severe. 11 12 Direct damage began at the front of the left-front wheel well and extended 207-cm rearward to the B-pillar. 13 The maximum crush was 51 cm and it occurred near the middle of the driver door. The left wheelbase was reduced by 11 cm 14 and the right wheelbase was increased by 4 cm.

Max. crush to left side at door
