Case 476 : Narrative

Case Vehicle (A): 2003 Lincoln
Type: Town Car Signature, 4-door sedan
Driver: 79-year-old male
CDC: 12-LZES-1, 12-LBWN-2, 12-FZEN-4

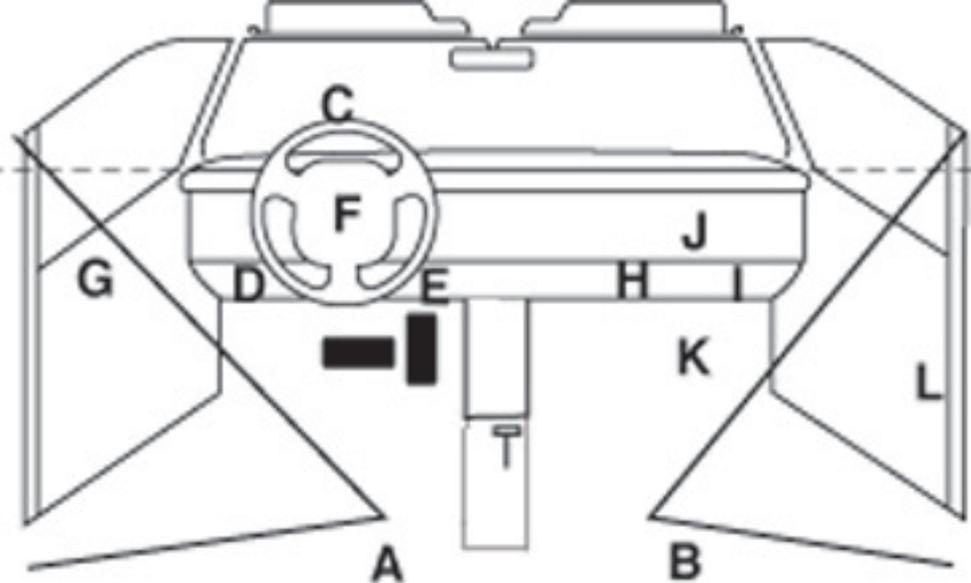
- A = LF seat belt, load marks on D-ring**
- B = RF seat belt, load marks on latch plate**
- C = SW rim, upper half deflected forward 5 cm**
- D = DR knee bolster, L knee, deformed**
- E = DR knee bolster, R knee, scuffed**
- F = SW airbag, blood stain L side**
- G = LF door grab handle, deformed**
- H = glovebox, deformed, RF L knee**
- I = glovebox, deformed, RF R knee**
- J = dash-mounted airbag, blood stain**
- K = RF toepan, blood stain**
- L = RF seatback side airbag, scuff**

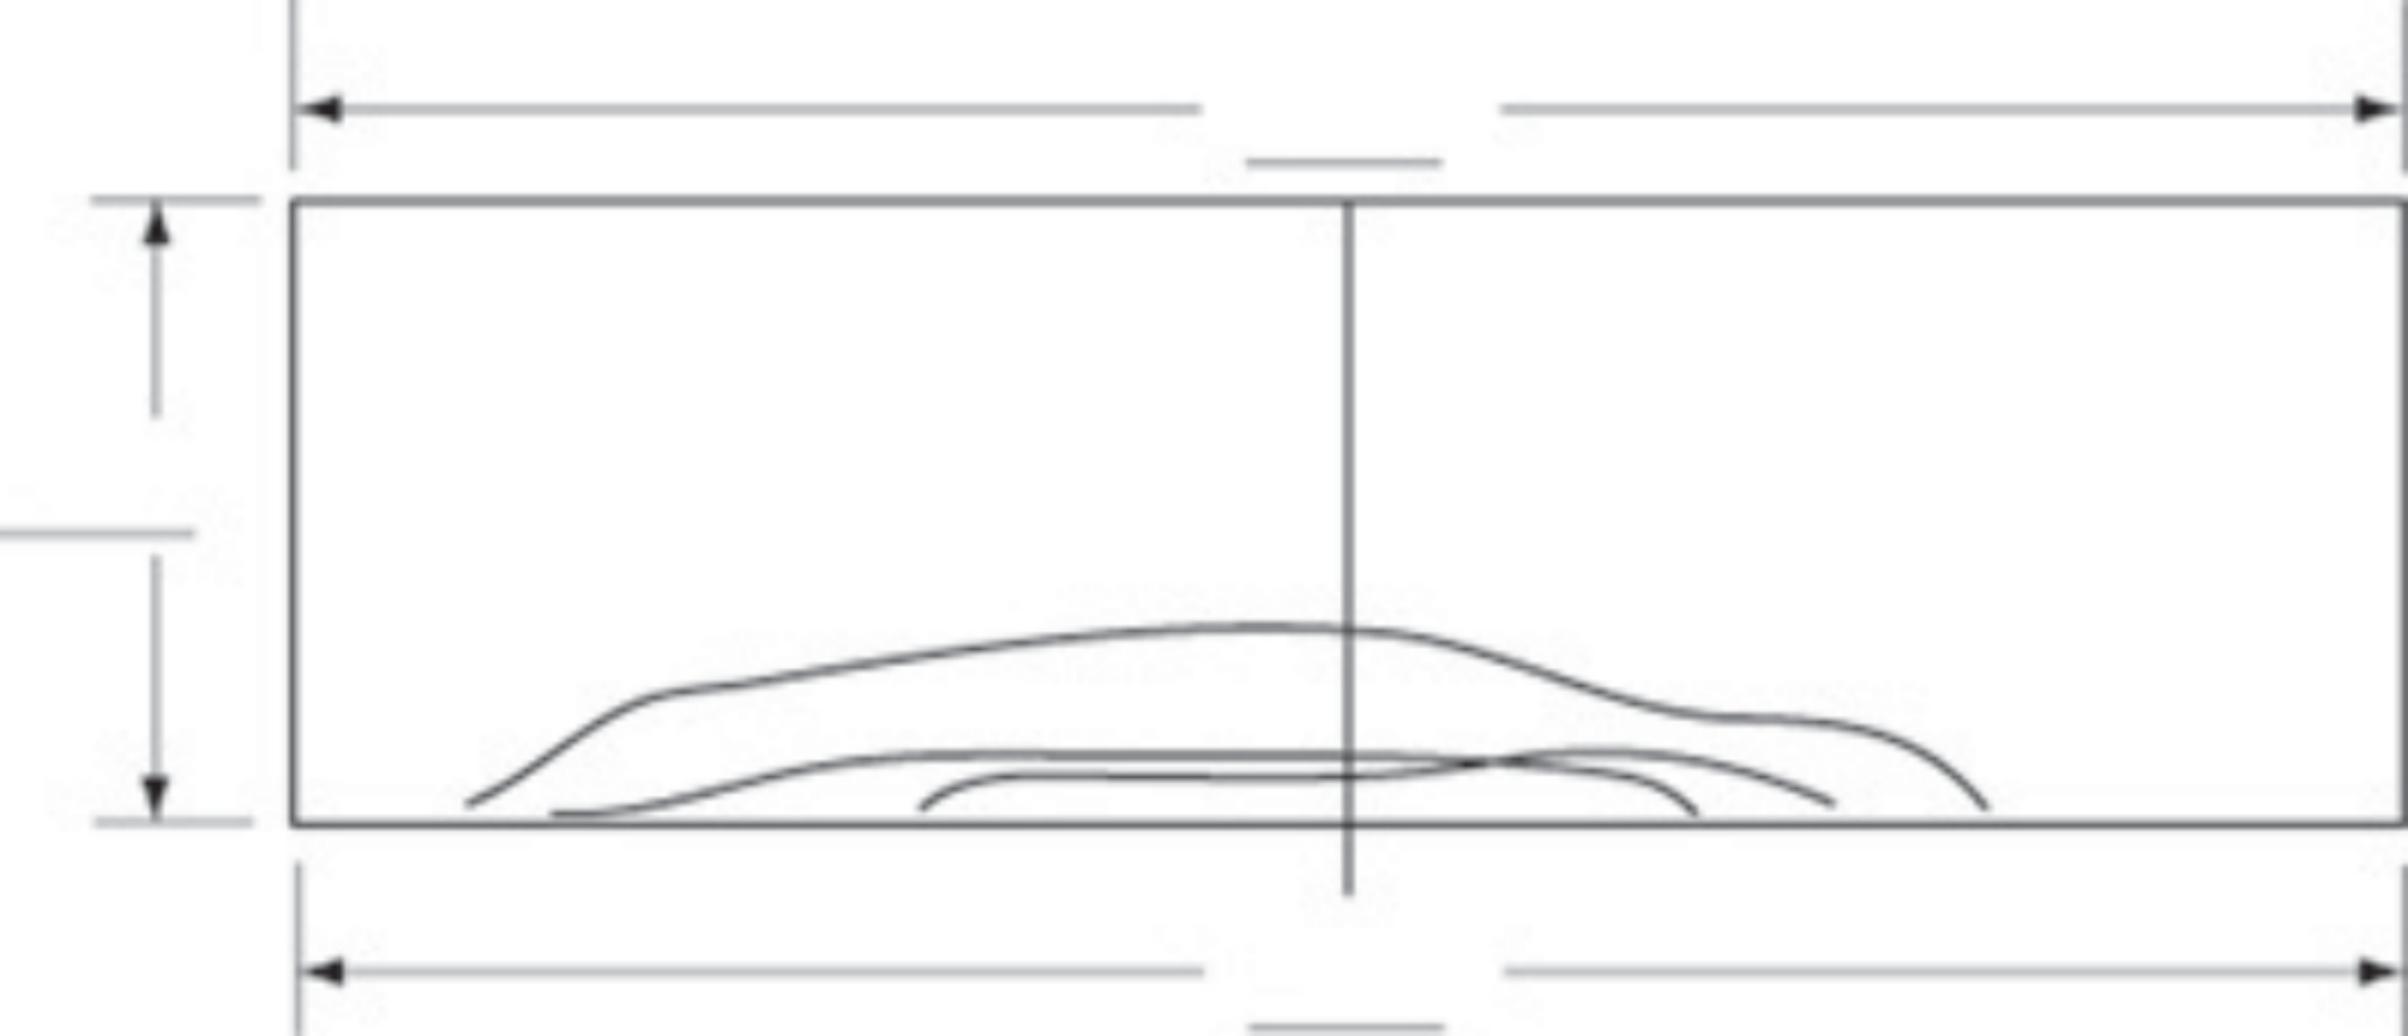
OCCUPANT CONTACT WORKSHEET

Contact	Interior Component Contacted	Occupant No. if Known	Body Region if Known	Supporting Physical Evidence	Confidence Level of Contact Point
A	Driver belt	1	Shoulder	Load marks on D-ring	1
B	RF belt	2	Shoulder	Load marks on latch plate	1
C	Steering rim	1	Face/head	Upper half deflected forward 5-cm	1
D	Knee bolster	1	Left knee	Deformation – left driver side	1
E	Knee bolster	1	Right knee	Scuff – right driver side	1
F	Steering wheel airbag	1	Face	Blood stain on left side	1
G	Left grab handle	1	Unknown	Deformation	2
H	Glove box	2	Left knee	Deformation – left side	1
I	Glove box	2	Right knee	Deformation – right side	1
J	Dash-mounted airbag	2	Face	Blood stain	1
K	Toe pan	2	Foot	Blood stain – right	1
L	RF seatback side airbag	2	Side	Scuff	1
M

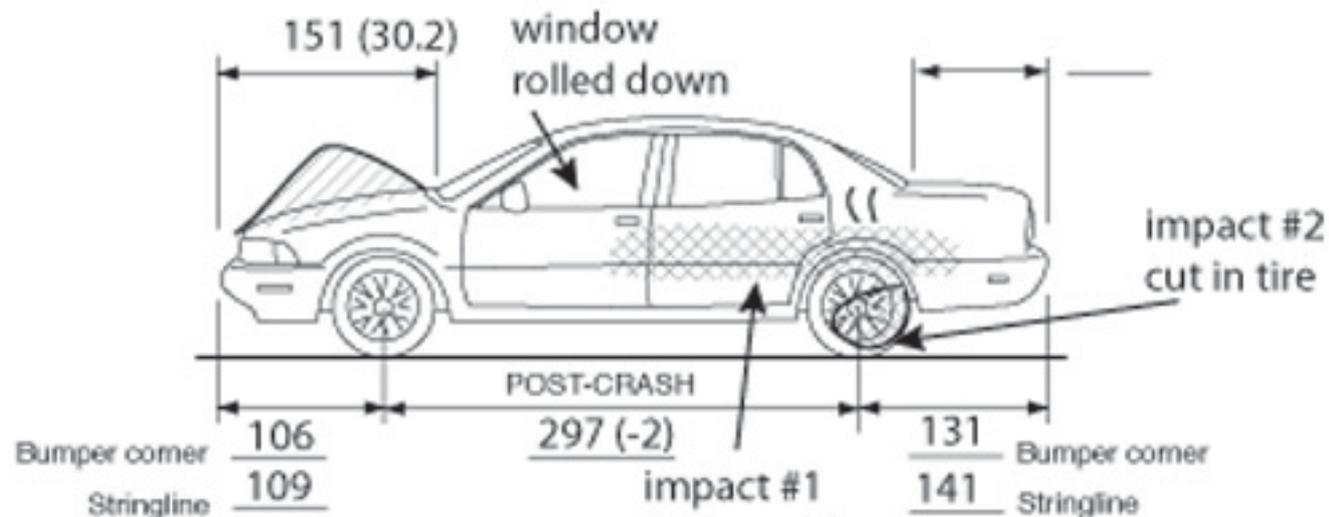
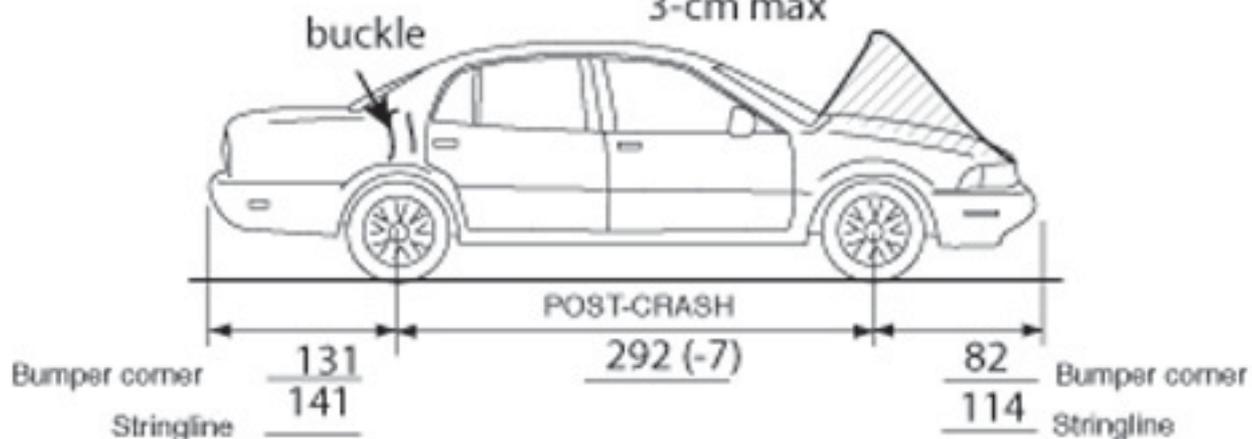
impact #3
35-cm dd
93-cm max
