DOT HS 812 560

Special Crash Investigations

On-Site Alleged Unintended

Vehicle: 2006 Jeep Grand

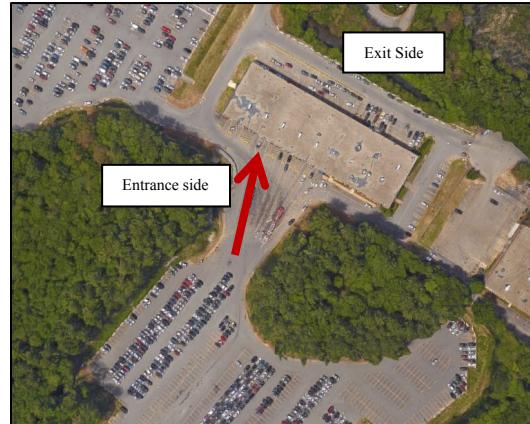
The auction was a live event, scheduled weekly by the business establishment and was attended by numerous private individuals and auto dealers. **Figure 2** is an overhead view of the auction site inclusive of the main building, the parking lot and a staging lot for the auction vehicles. The overall dimensions of the concrete-block building measured approximately 128.0 m x 38.4 m (420.0 ft x 126.0 ft), length by width. The section of the building where the auction was held consisted of eight traffic lanes that were separated by open spaces for pedestrian traffic. During the auction, the for-sale vehicles moved from the staging lot and were paraded through the building via the various traffic lanes. Traffic flowed through the building from the entrance side to the exit denoted by the arrow in the Figure 2.

Figure 2: Overhead image showing the physical layout of the auction facility. The red arrow denotes the directional flow of traffic. Image obtained from an Internet media source.

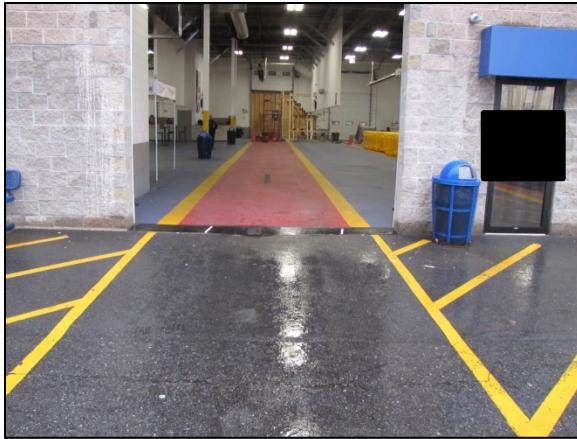
The crash occurred in Lane #6. The interior width of the building (from entrance to exit) measured 38.0 m (124.7 ft). **Figure 3** is a north-facing trajectory view of the Jeep approaching the building entrance. **Figure 4** is a south-facing lookback view.

Figure 3: North-facing trajectory view of the Jeep's approach to the building entrance at Lane #6.

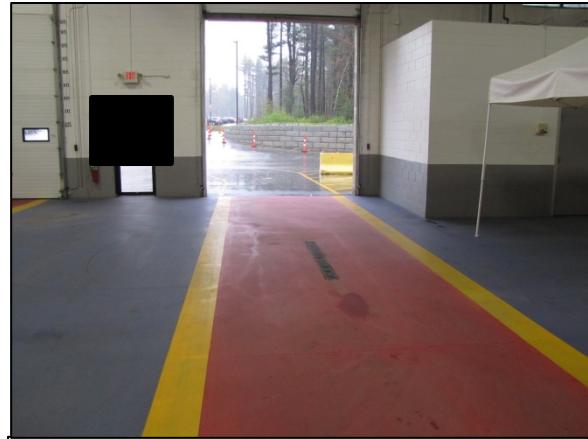
Figure 4: South-facing lookback view from the center of the building along the Jeep's path at Lane #6.

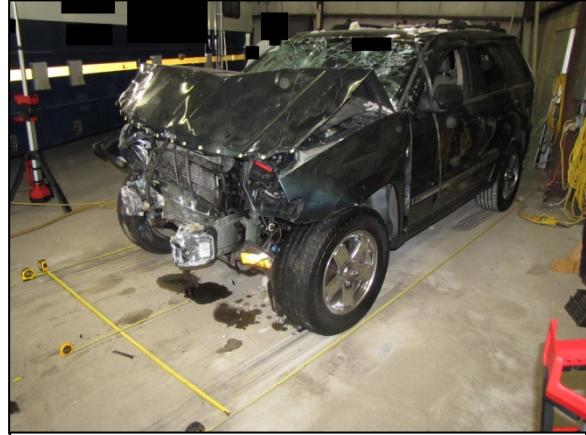
The 2006 Jeep Grand Cherokee (**Figure 10**) was manufactured in August 2006 and was identified by the Vehicle Identification Number

1J4HR58236Cxxxxxx. The digital odometer reading was 245,827 km (152,754 miles). The four-wheel-drive sports utility vehicle (SUV) was built on a 278 cm (109.5 in) wheelbase and equipped with the “Limited” trim package. The Jeep had a GVWR of 2,790 kg (6,150 lb), with front axle and rear axle ratings of 1,339 kg (2,950 lb) and 1,452 kg (3,200 lb), respectively. The powertrain consisted of a 5.7-liter V8 gasoline engine that was linked to a 5-speed automatic transmission. Additional features included electronic throttle control, traction control, electronic stability control, four-wheel antilock brakes and a tire pressure monitoring system. The Jeep’s brakes were a front/rear disc system with emergency braking assist. The vehicle manufacturer’s recommended tire size was P245/65R17 front and rear, with cold tire pressures of 228 kPa (33 PSI). All four tires were Goodyear Fortera of the recommended size. None of the tires were damaged or restricted and all the tread depths measured 4 mm (5/32 in).

Figure 10: Left front oblique view of the Jeep.

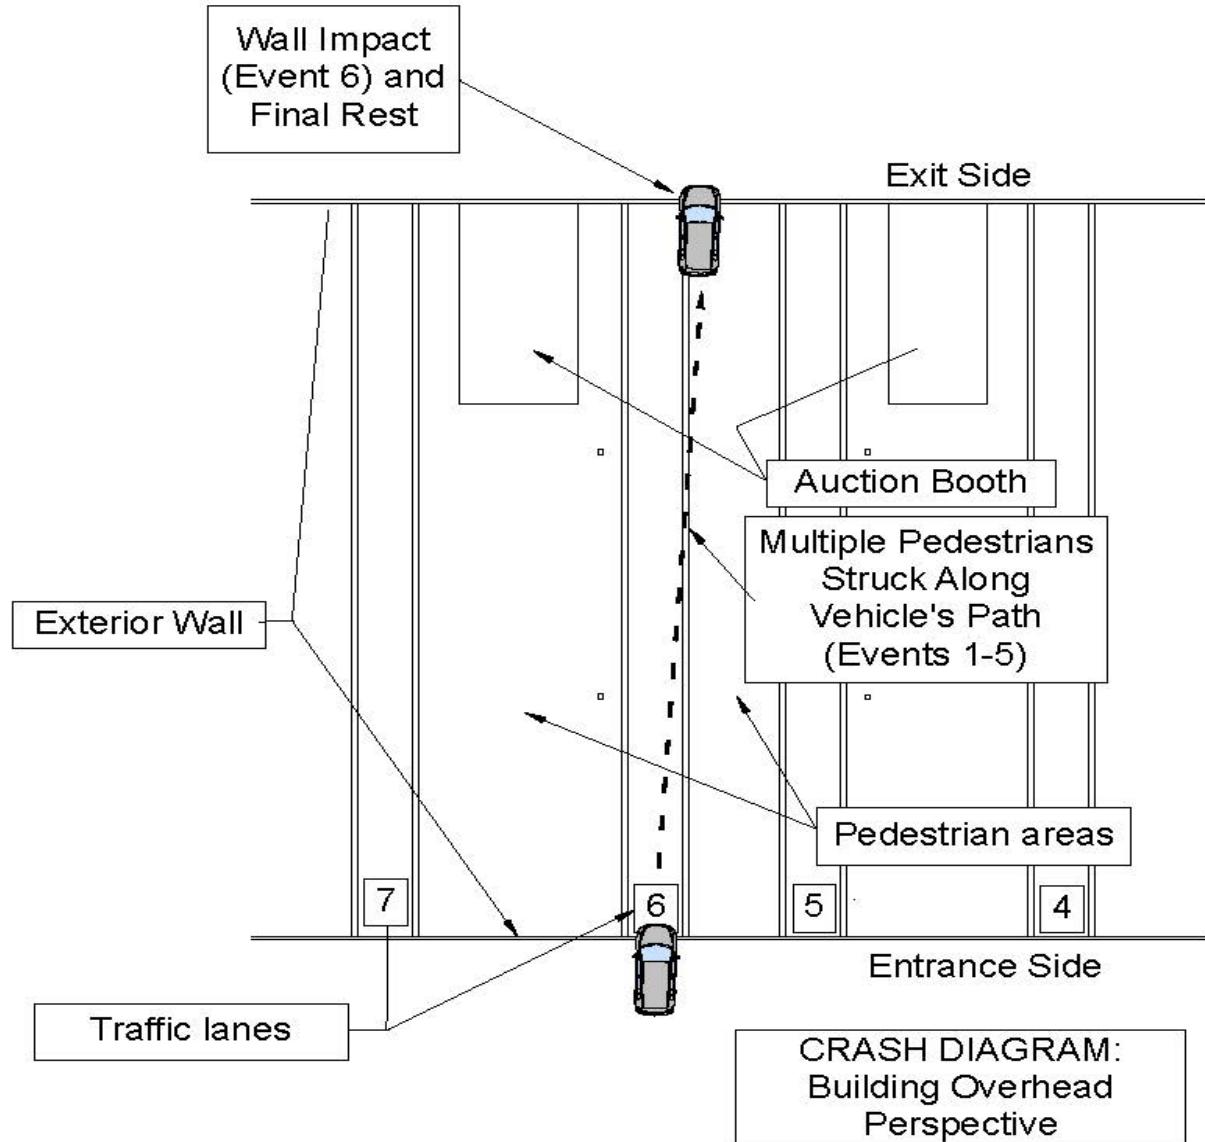
CRASH DIAGRAM

The Jeep accelerated forward out of the driver’s control and into the building. The scan tool remained attached to the vehicle and was pulled from the buyer’s hand. Two short (acceleration) tire marks were identified at the scene during the police investigation and were also observed during the SCI scene inspection. The marks were located at the threshold to the building at the Lane #6 entrance in the pavement transition (**Figure 8**). The tread pattern and track width of the marks were consistent with the tread pattern and track width of the Jeep’s tires. The left front tire mark measured 38 cm (15.0 in) in length and the right tire mark measured 33 cm (13.0 in). Due to its initial orientation, angled slightly to the right with respect to the side plane of the building, the Jeep departed the (red) travel path of Lane #6 and entered the (blue) pedestrian zone as it accelerated forward. The vehicle traveled along a nearly straight path at a reconstructed heading angle approximately 3 degrees to the right of the lane marking. As the Jeep traversed the 38.0 m (124.7 ft) interior width of the structure, 13 pedestrians were injured either due to direct contact with the Jeep, by ground contact, or pedestrian interaction. Five people struck by the front plane of the Jeep (Events 1-5) resulted in fatalities. The front plane of the vehicle then struck and fractured the cement block-construction of the exit wall (Event 6 - **Figure 9**). The Jeep penetrated approximately 3 m (10 ft) through the wall and came to rest. A crash diagram is included at the end of this report on Page 16.
