**Special Crash Investigations:
On-Site Rollover and Child Restraint
System Crash Investigation;
Vehicle: 2009 Honda Odyssey;
Location: Ohio;
Crash Date: November 2022**

Special Crash Investigations
On-Site Rollover and Child Restraint System Crash Investigation
Case Number: CR22019
Vehicle: 2009 Honda Odyssey
Location: Ohio
Crash Date: November 2022

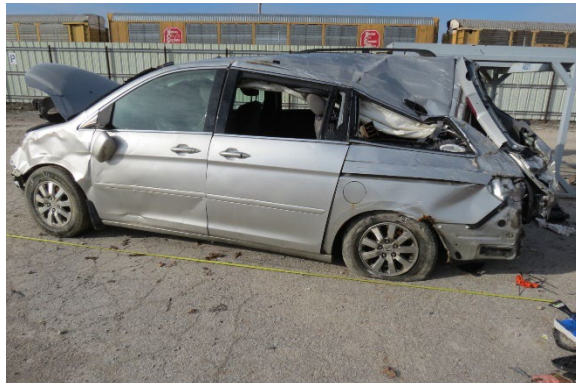
Figure 1. Left-plane view of the 2009 Honda Odyssey

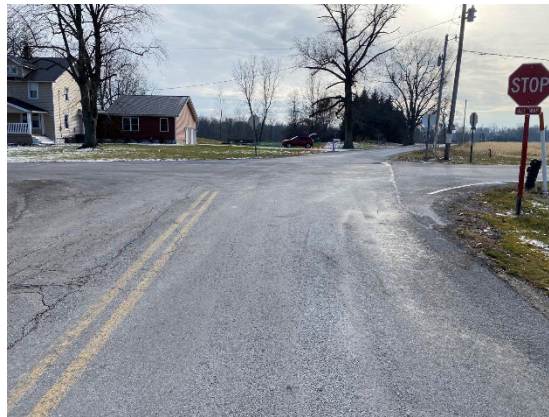
This crash occurred at night on a two-lane rural roadway (Figure 2) south of a four-leg intersection. The intersection was a four-way stop with all stop signs erect and visible. The south leg of the intersection angled to the driver's right. Reported weather included fair skies, a temperature of 0.5 °C (33 °F), 46-percent humidity, and winds from the east-southeast at 5 km/h (3 mph) according to local weather reports. The roadway was level and traversed in a north-south direction. Travel lanes were 3.7 m (12.0 ft) wide. Prior to the intersection, the north and southbound travel lanes were separated by painted solid double yellow lines. Figure 2 shows the south view of the roadway on approach to the crash site. The posted speed limit was 89 km/h (55 mph). A crash diagram is included at the end of this report.

Figure 2. South view of the Honda's pre-crash approach to the crash site

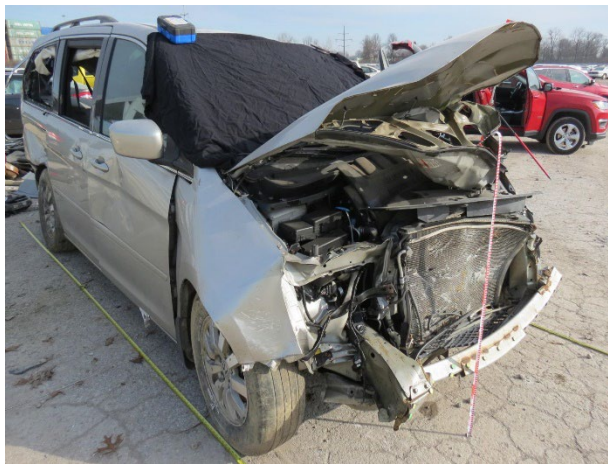
The 2009 Honda Odyssey (Figure 5) was identified by the VIN 5FNRL38499Bxxxxxx. The Honda was built on a front-wheel-drive platform powered by a 3.5-liter, 6-cylinder gasoline engine that was linked to a continuous variable transmission. Its service brakes were power-assisted 4-wheel disc with antilock. The gross vehicle weight rating was 2,695 kg (5,941 lb). The vehicle manufacturer's recommended tire size was P235/65R16. The Honda had four Sumitomo HTR Enhance LX2 tires of the recommended size. The left front, right front, and right rear tires had 3 mm (4/32) of tread and the left rear tire had 5 mm (6/32) of tread. None of the tires were damaged.

Figure 5. Front-right oblique view of the Honda Accord

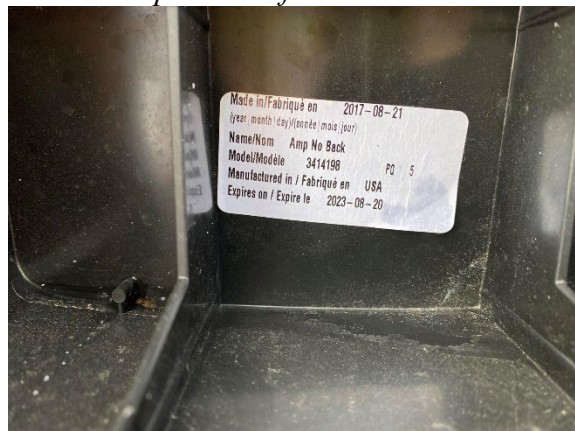
The first child restraint system found was an Evenflo Amp No Back booster seat (Figure 13). It was found in the cargo area during the inspection. The removeable back rest was separated from the base. This CRS was occupied by the 4-year-old female in the second-row-left seating position. The manufacturer label (Figure 14) on the CRS stated that it was produced on August

21, 2017, with an expiration date of August 20, 2023. There was no sign of damage to the CRS at the time of the inspection.

Figure 14. Manufacturer label on CRS

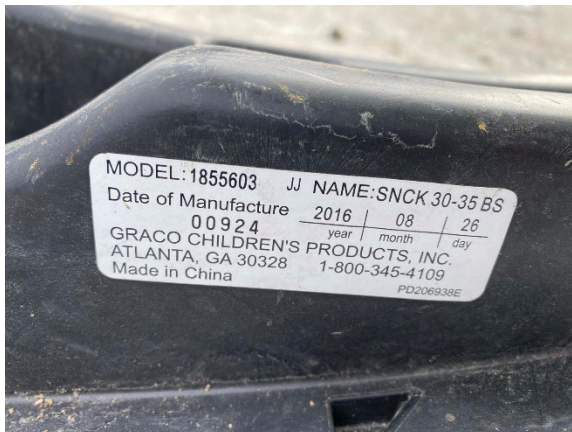
Figure 16. Manufacturer label on CRS base
