## Case 397 : Narrative

Case Vehicle (A): 2002 Ford	Vehicle (B): 2000 Ford
Type: Mustang GT, 2-door coupe	Type: Taurus SE, 4-door sedan
Driver: 44-year-old male	Driver: 19-year-old male
CDC: 12-FREE-6	CDC: 12-FREW-3, 00-TDDO-3

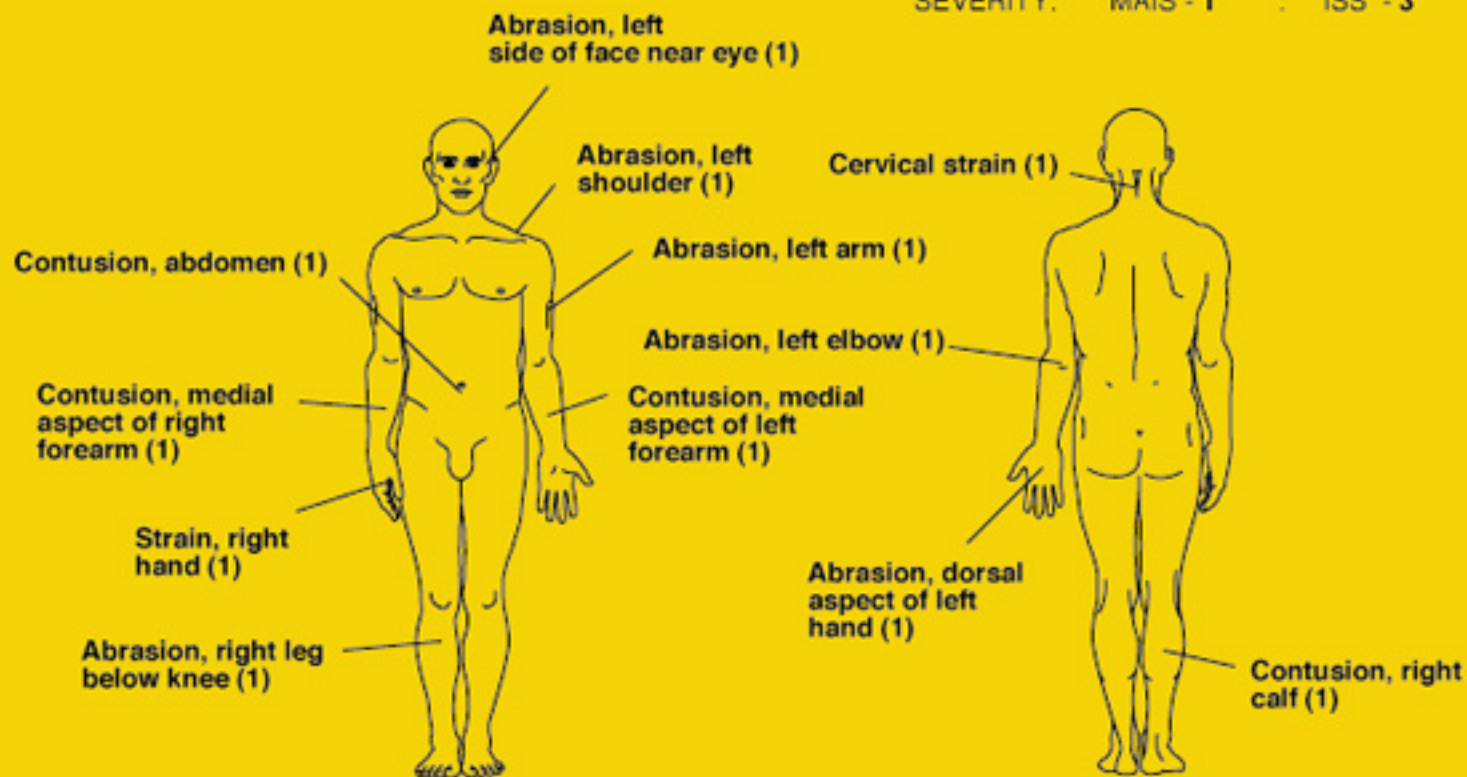
Case No.: 397  
Case Veh. (A): 2002 Ford  
Type: Mustang GT, 2-door coupe  
Driver: 44-year-old male  
Veh. (B): 2000 Ford Taurus SE, 4-door sedan

Light Conditions: Daylight  
Weather: Clear  
Road Surface: Dry  
Road Construction: Asphalt

[1](#) It was daylight and the five-lane east-west asphalt road, with a posted speed limit of 45 mph (72 kph), was dry and in good condition. [2](#) Case vehicle (A) was traveling east at a driver-estimated speed of 45 mph (72 kph) in the left eastbound lane [3](#) and vehicle (B) was traveling west at an unknown speed in the center turn lane. As the two vehicles approached each other at a T-type intersection with a divided two-lane road to the south, the driver of vehicle (B) began a left turn to travel south on the intersecting road and entered the left eastbound lane in front of case vehicle (A). The driver of case vehicle (A) applied the brakes but did not make any other evasive maneuvers, and the right front of case vehicle (A) struck the right front of vehicle (B). [4](#) Case vehicle (A) rotated clockwise approximately 170° and came to rest straddling the eastbound lanes facing southwest. Vehicle (B) rotated clockwise while moving to the south, [5](#) struck a curb with its left-rear wheel, and rolled two quarter turns with the driver side leading before [6](#) coming to rest on its roof at the intersection of the two roads, facing west. Both vehicles were towed due to damage.

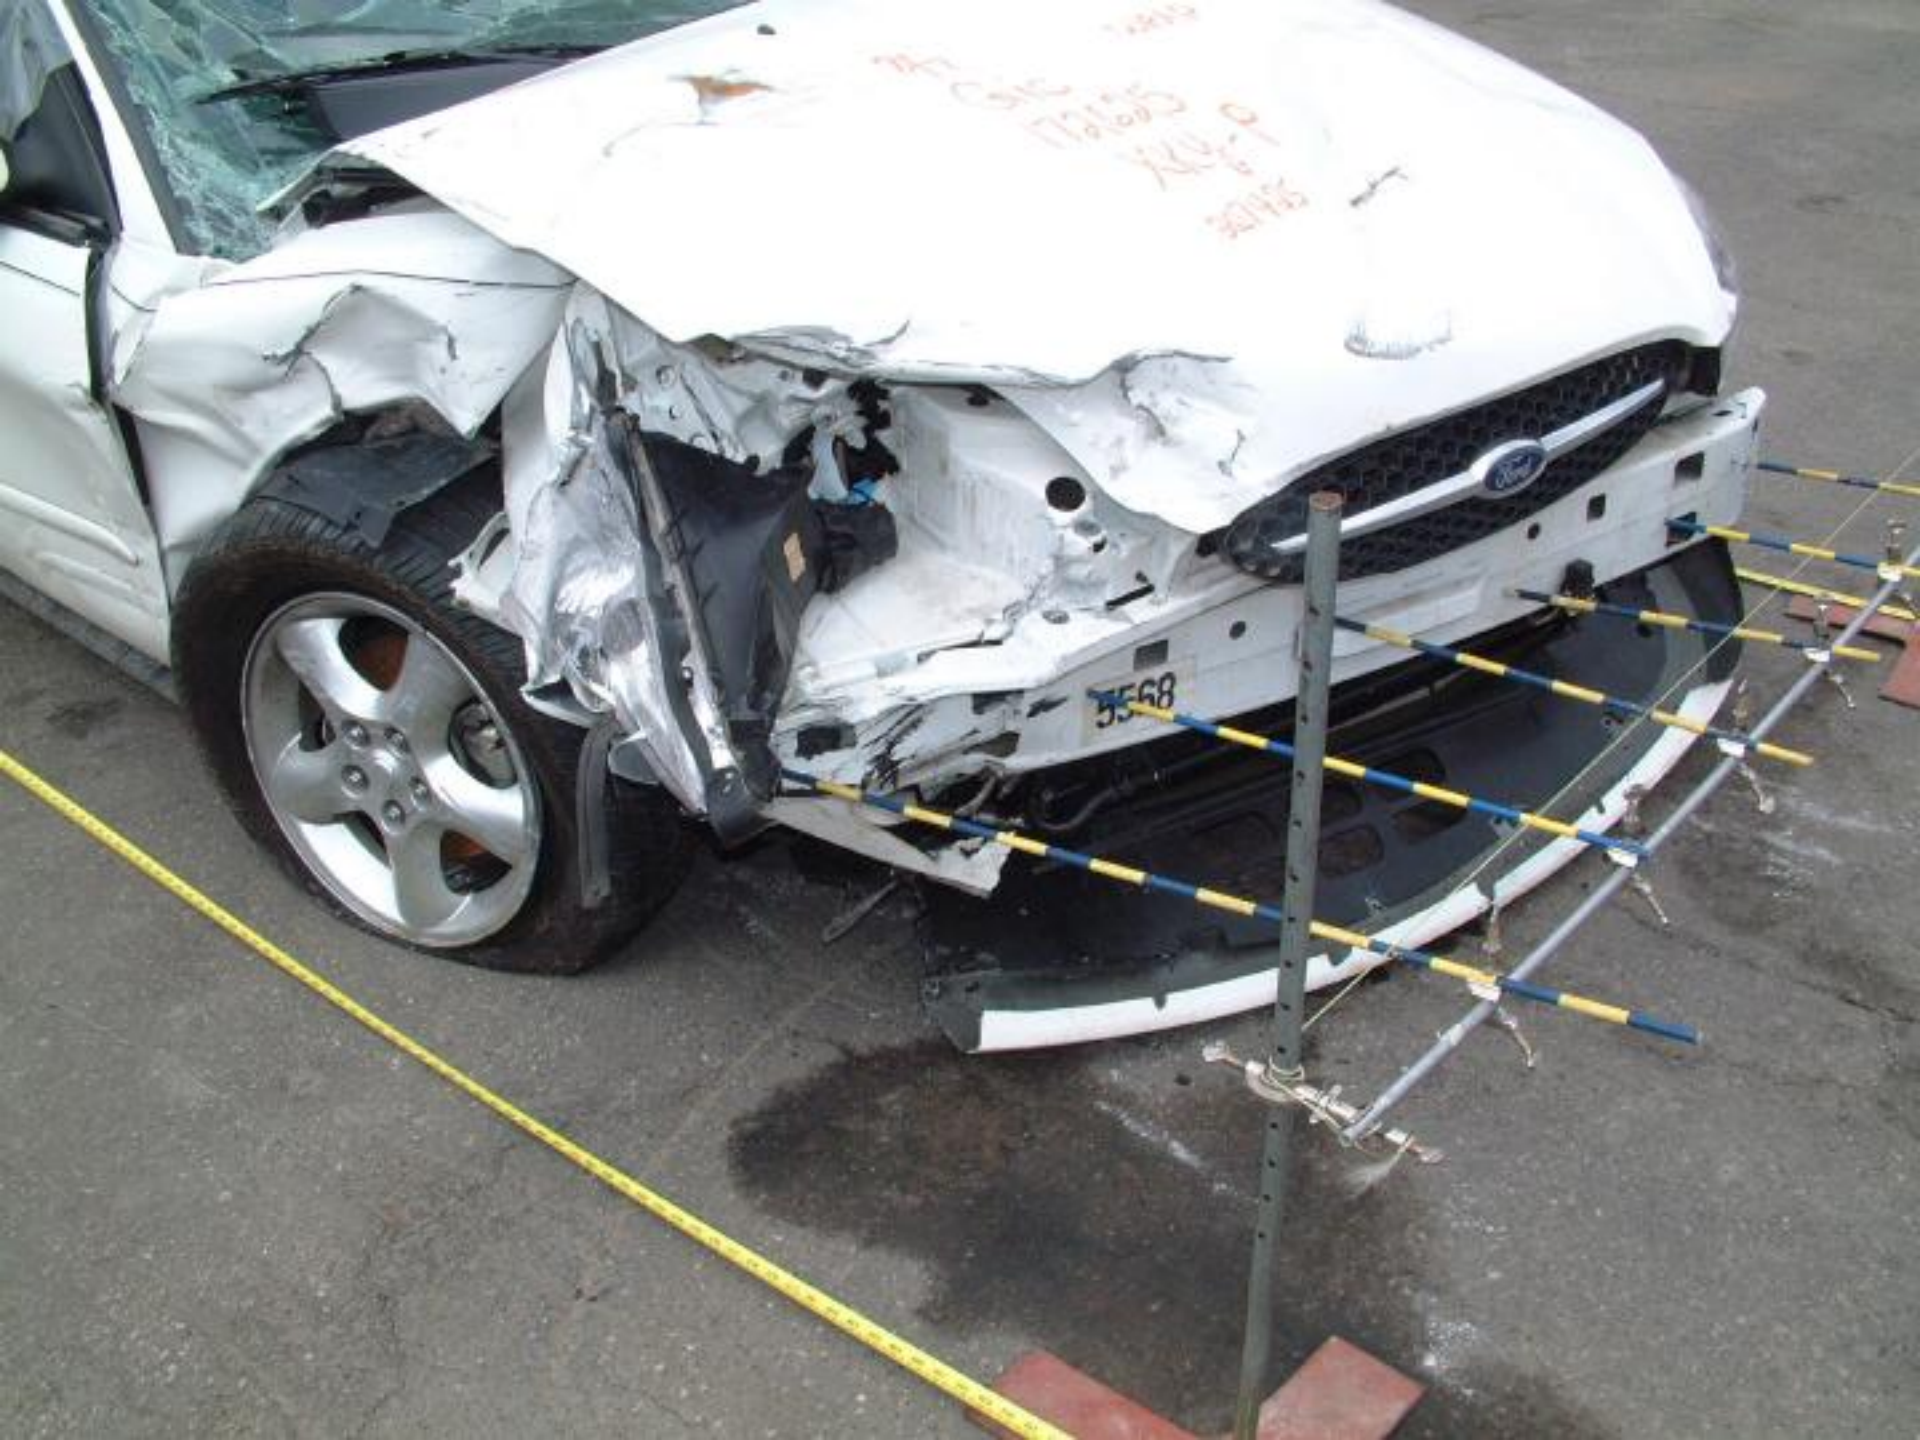
Handwritten text on the hood of the car, including the number '1000' and other illegible markings.
