# STUDIES OF WATER-RETENTIVE CHEMICALS AS ADMIXTURES WITH NONPLASTIC ROAD-BUILDING MATERIALS

BY THE DIVISION OF TESTS, PUBLIC ROADS ADMINISTRATION

Reported by E. A. WILLIS, Associate Highway Engineer, and C. A. CARPENTER, Associate Civil Engineer

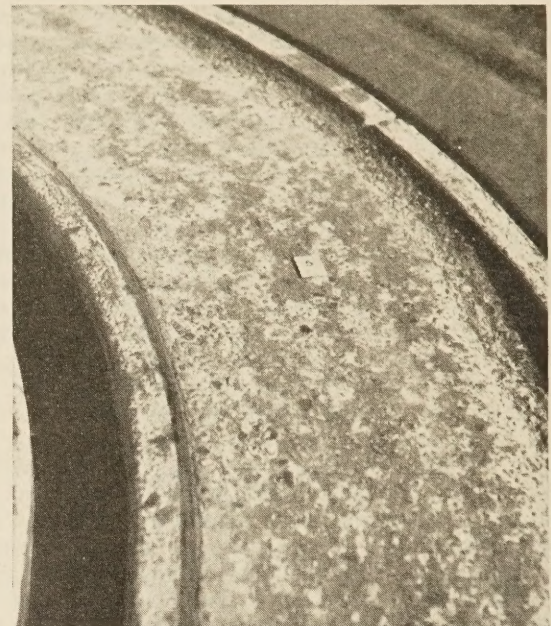
FIGURE 7.—SECTION 5 OF TRACK 2 AT 184,000 WHEEL-TRIPS, JUST BEFORE THE FIRST SPRINKLING. SOME RAVELING HAD DEVELOPED, PARTICULARLY ALONG THE EDGES.

Raveling of the surface under distributed traffic was first noted at about 160,000 wheel-trips in section 5 and progressed gradually to 184,000 wheel-trips, when sprinkling was started. At this time sections 2, 3, and 4 had also started to ravel to some extent along the curb line. The condition of section 5 is illustrated in figure 7.

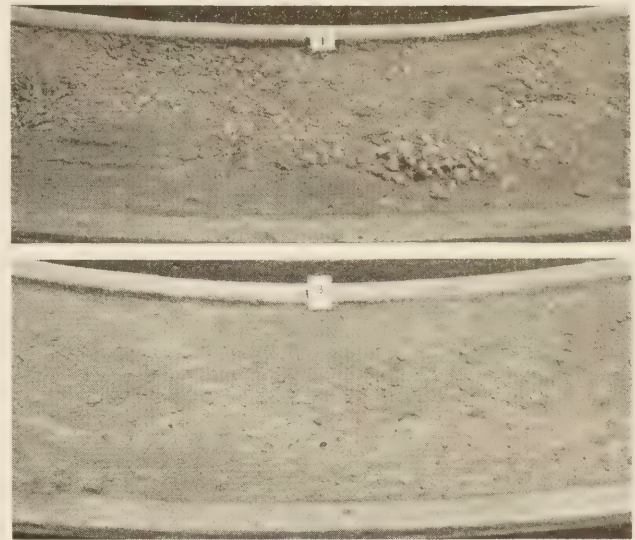
FIGURE 11.—SECTIONS OF TRACK 3 AT 160,000 WHEEL-TRIPS, JUST BEFORE THE FIRST SPRINKLING. UPPER, SECTION 1, WHICH IS ALSO REPRESENTATIVE OF SECTION 2; LOWER, SECTION 3. SECTIONS 4 AND 5 WERE IN SLIGHTLY BETTER CONDITION THAN SECTION 3.

All sections in track 3 were benefited by the application of water to the surface. Although the vertical displacements continued to increase (fig. 10) the surfaces became firm and the aggregates were well bonded under the action of traffic. Figure 12 shows the condition of sections 1 and 3 just prior to the construction of the bituminous surface at 180,500 wheel-trips. Comparison of the sections at this time with their condition as shown in figure 11 clearly illustrates the beneficial effect of the surface water.

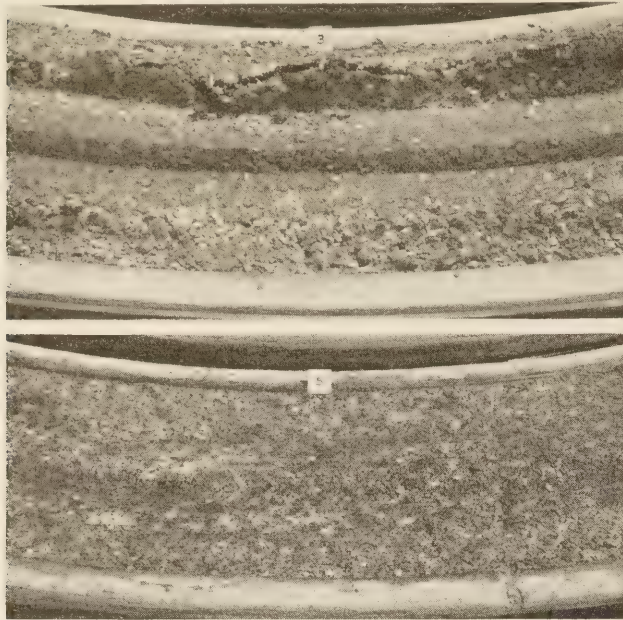
FIGURE 13.—SECTIONS OF TRACK 3 AT THE CONCLUSION OF THE TEST. UPPER, SECTION 3, WHICH IS ALSO REPRESENTATIVE OF SECTION 4; LOWER, SECTION 5, WHICH IS ALSO REPRESENTATIVE OF SECTIONS 1 AND 2.

Sections 1 and 5 exhibited the least amount of movement when tested as base courses. They remained in excellent condition throughout this phase as illustrated in figure 13.

Section 2 moved more than sections 1 and 5 but was still in good condition at the end of the test. Some cracking of the surface treatment between the wheel courses was observed. The condition of these three

sections was similar and is illustrated by the view of section 5, figure 13. Sections 3 and 4 showed sufficient rutting at the end of the test to indicate failure. However, this condition was produced only after unreasonably severe test conditions had been imposed. Section 3 in figure 13 is representative of the condition of both sections 3 and 4 at the conclusion of the test.
