Case 396 : Narrative

Case Vehicle (A): 2001 Ford	Vehicle (B): 1988 Honda
Type: Taurus SE, 4-door sedan	Type: Civic 1500, 4-door sedan
Driver: 51-year-old female	Driver: 19-year-old female
CDC: 12-FDEW-2	CDC: 99-0000-0

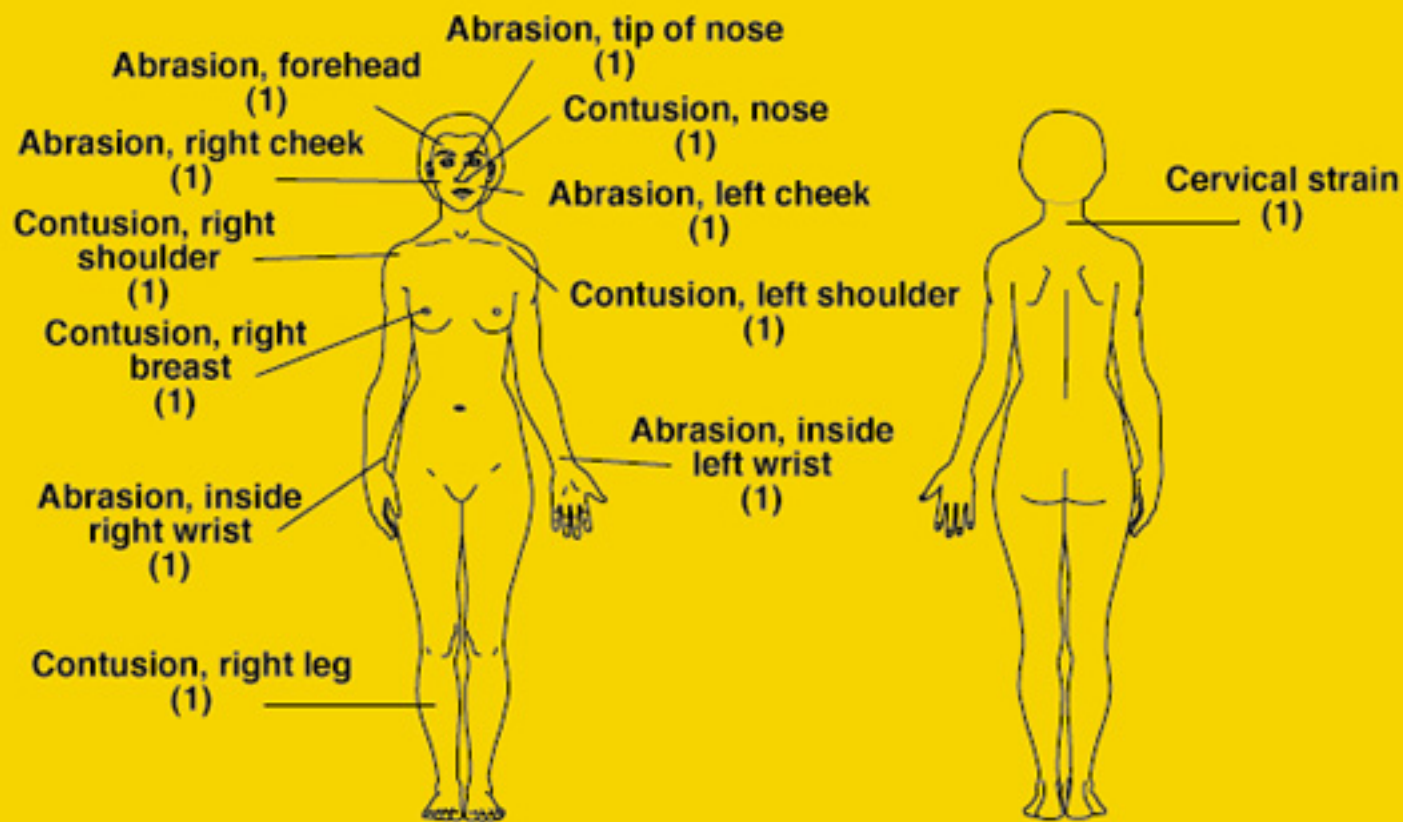
Case No.: 396
Case Veh. (A): 2001 Ford
Type: Taurus SE, 4-door sedan
Driver: 51-year-old female
Vehicle (B): 1988 Honda Civic 1500, 4-door sedan

Weather: Clear
Road Surface: Asphalt
Road Construction: Freshly-laid tar/gravel
Light Condition: Daylight

[1](#) [2](#) [3](#) On a clear day, case vehicle (A) was traveling west at a driver-estimated speed of 35 mph (56 kph) on a two-lane, two-way, asphalt road, in a rural area. The road had just been resurfaced with loose gravel on tar and there were 35 mph (56 kph) temporary speed-limit signs posted along the road. [4](#) [5](#) Vehicle (B) was traveling east in the eastbound lane of the same road at a police-reported speed that exceeded the temporary speed limit. As the two vehicles approached the crest of a hill, the driver of vehicle (B) lost control and entered the westbound lane into the path of case vehicle (A). The driver of case vehicle (A) braked but was not able to avoid a head-on collision with vehicle (B).

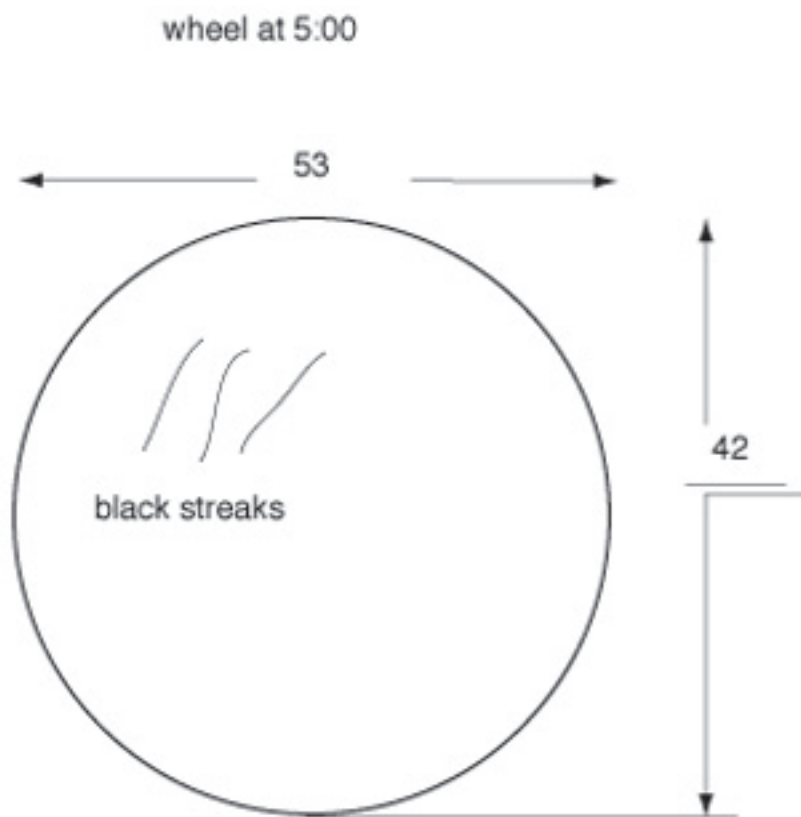
Driver Airbag

AIRBAG NUMBER ON DRIVER SIDE:

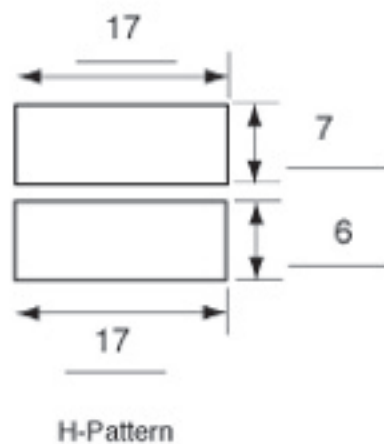
Driver Airbag Doors

Vents: Y N 2
if yes, how many: _____

Tethers: Y N 1
if yes, how many: _____

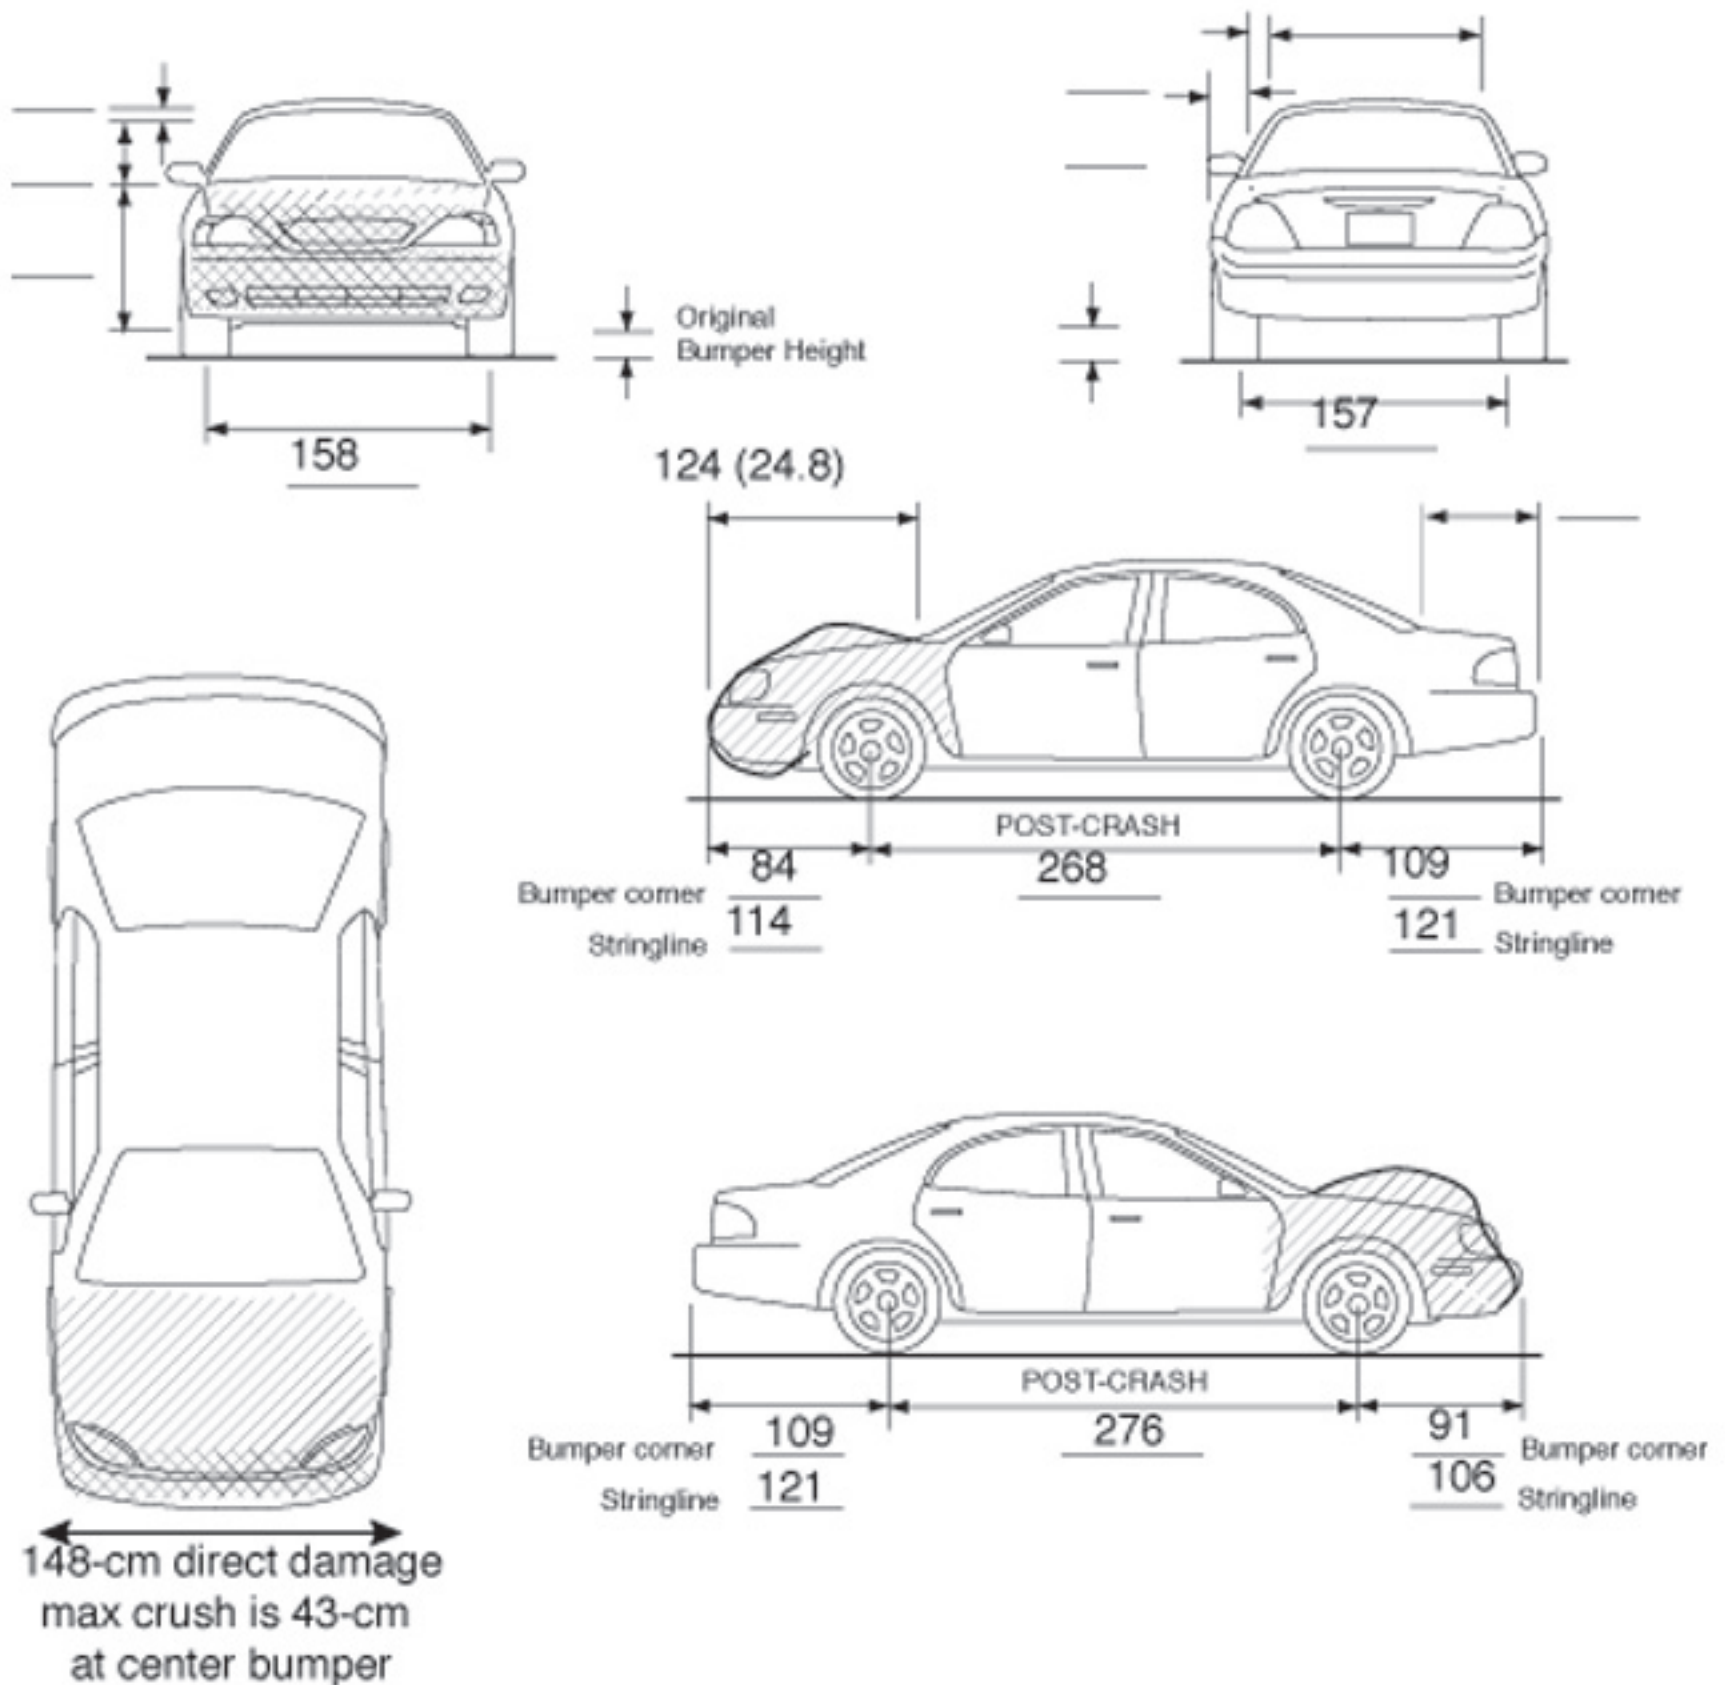
DW-1218

MEASUREMENTS IN CENTIMETERS

[6](#) The direct damage to the front of case vehicle (A) was moderate and extended 148-cm across the entire front of the vehicle. [7](#) The maximum frontal crush was 43 cm and it occurred at the center of the front bumper.
