REPORT NUMBER 207-GTL-05-003

**FMVSS NO. 207  
INDICANT TEST**

**GENERAL MOTORS OF CANADA LTD.  
2005 BUICK LACROSSE, PASSENGER CAR  
NHTSA NO. C50103**

FINAL REPORT

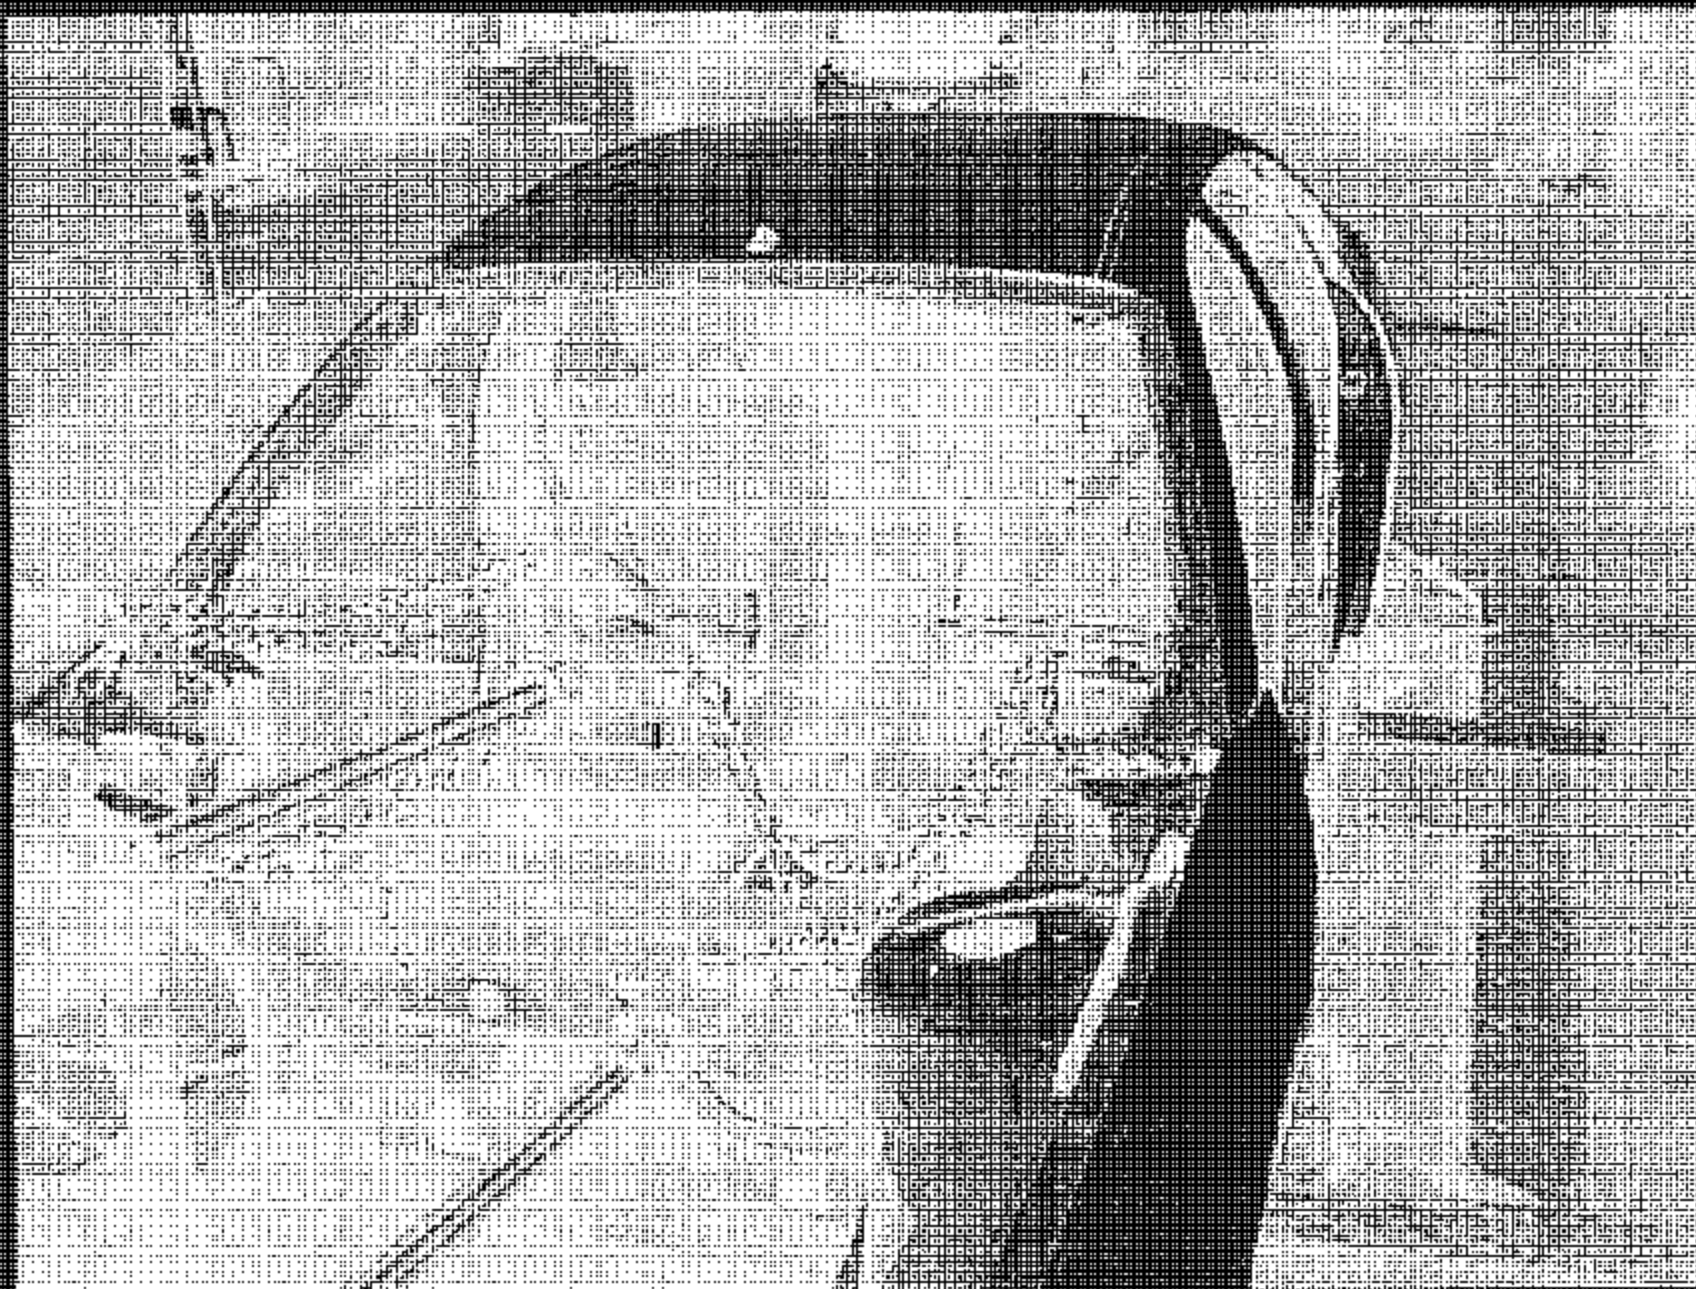
2005 BUICK LACROSSE  
NHTSA NO. C30103  
FMVSS NO. 210

FIGURE 5.8  
¾ LEFT FRONT VIEW OF VEHICLE IN TEST RIG

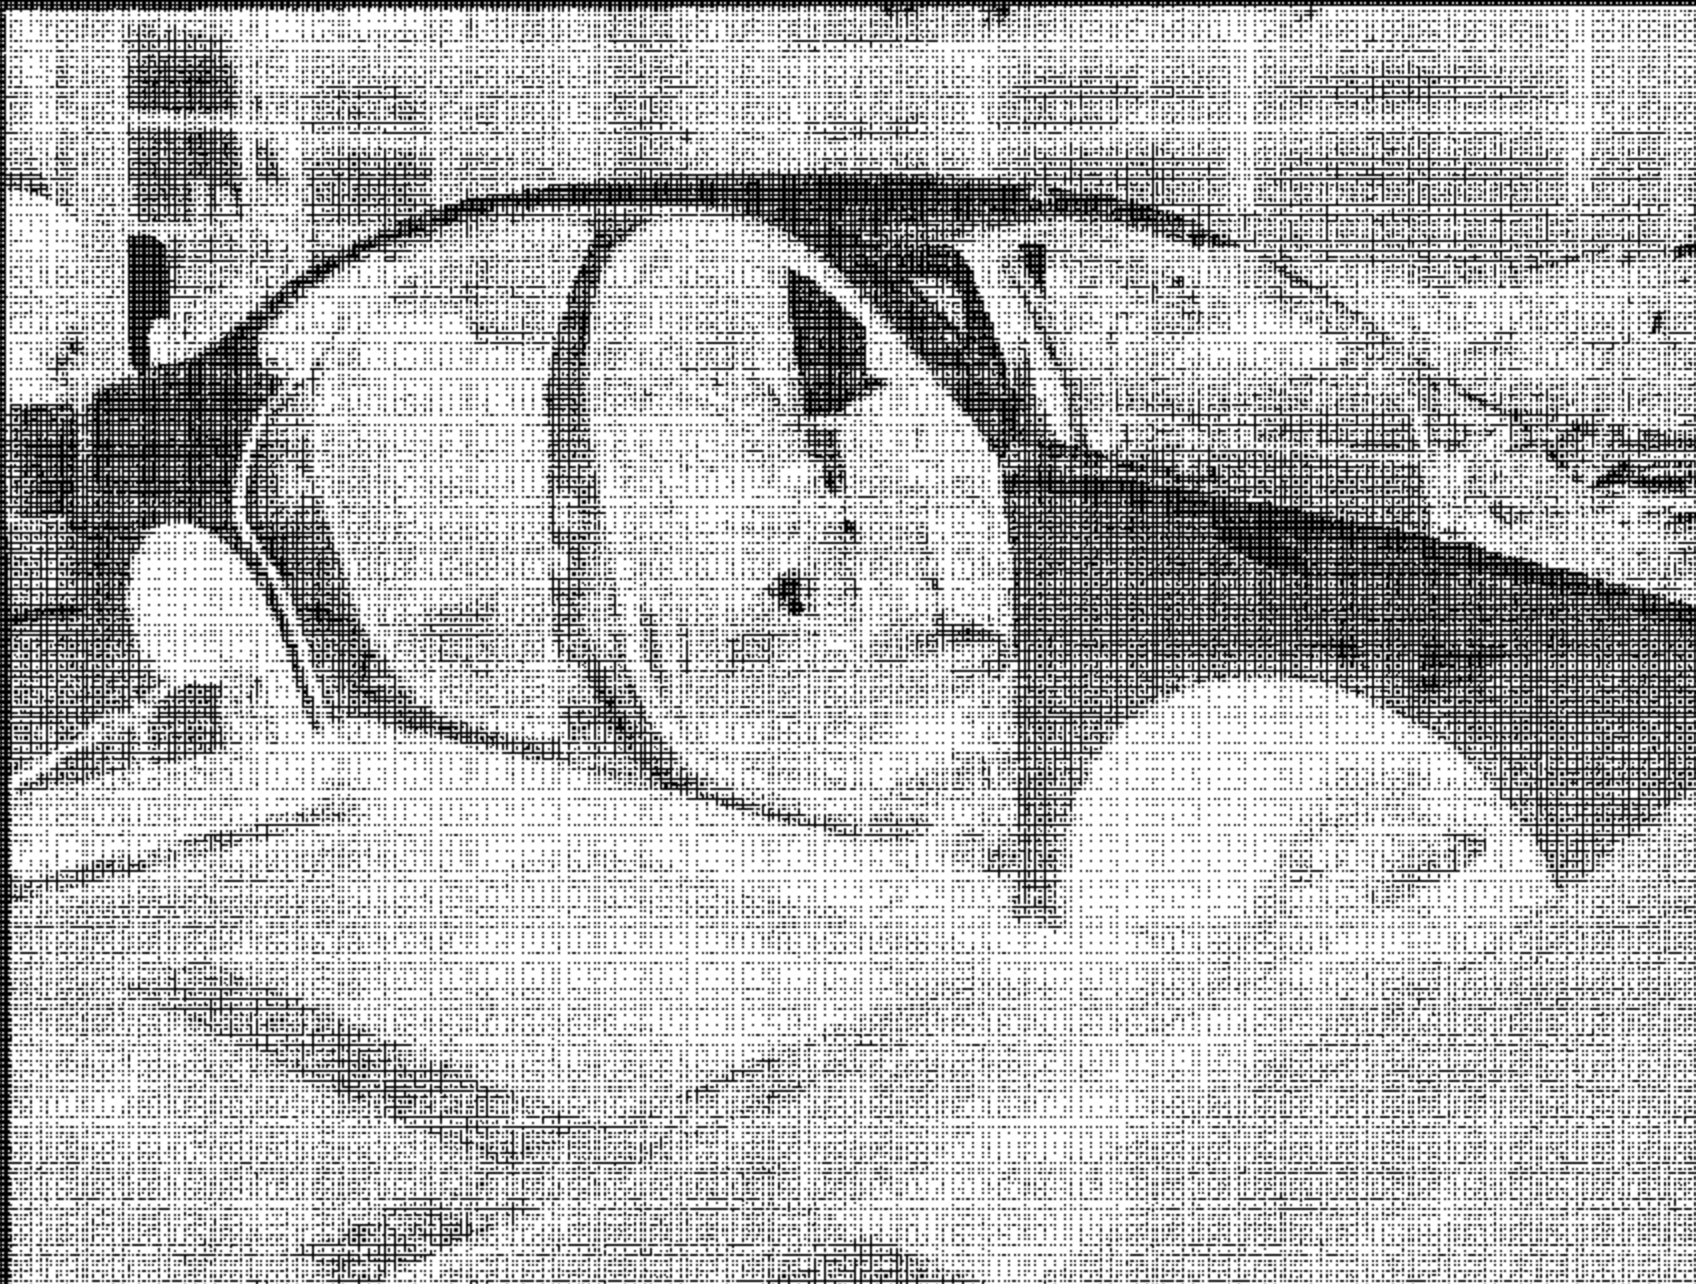
2005 BUICK LACROSSE  
NHTSA NO. C50103  
FMVSS NO. 210

FIGURE 5.7  
3/4 RIGHT FRONT VIEW OF VEHICLE IN TEST RIG

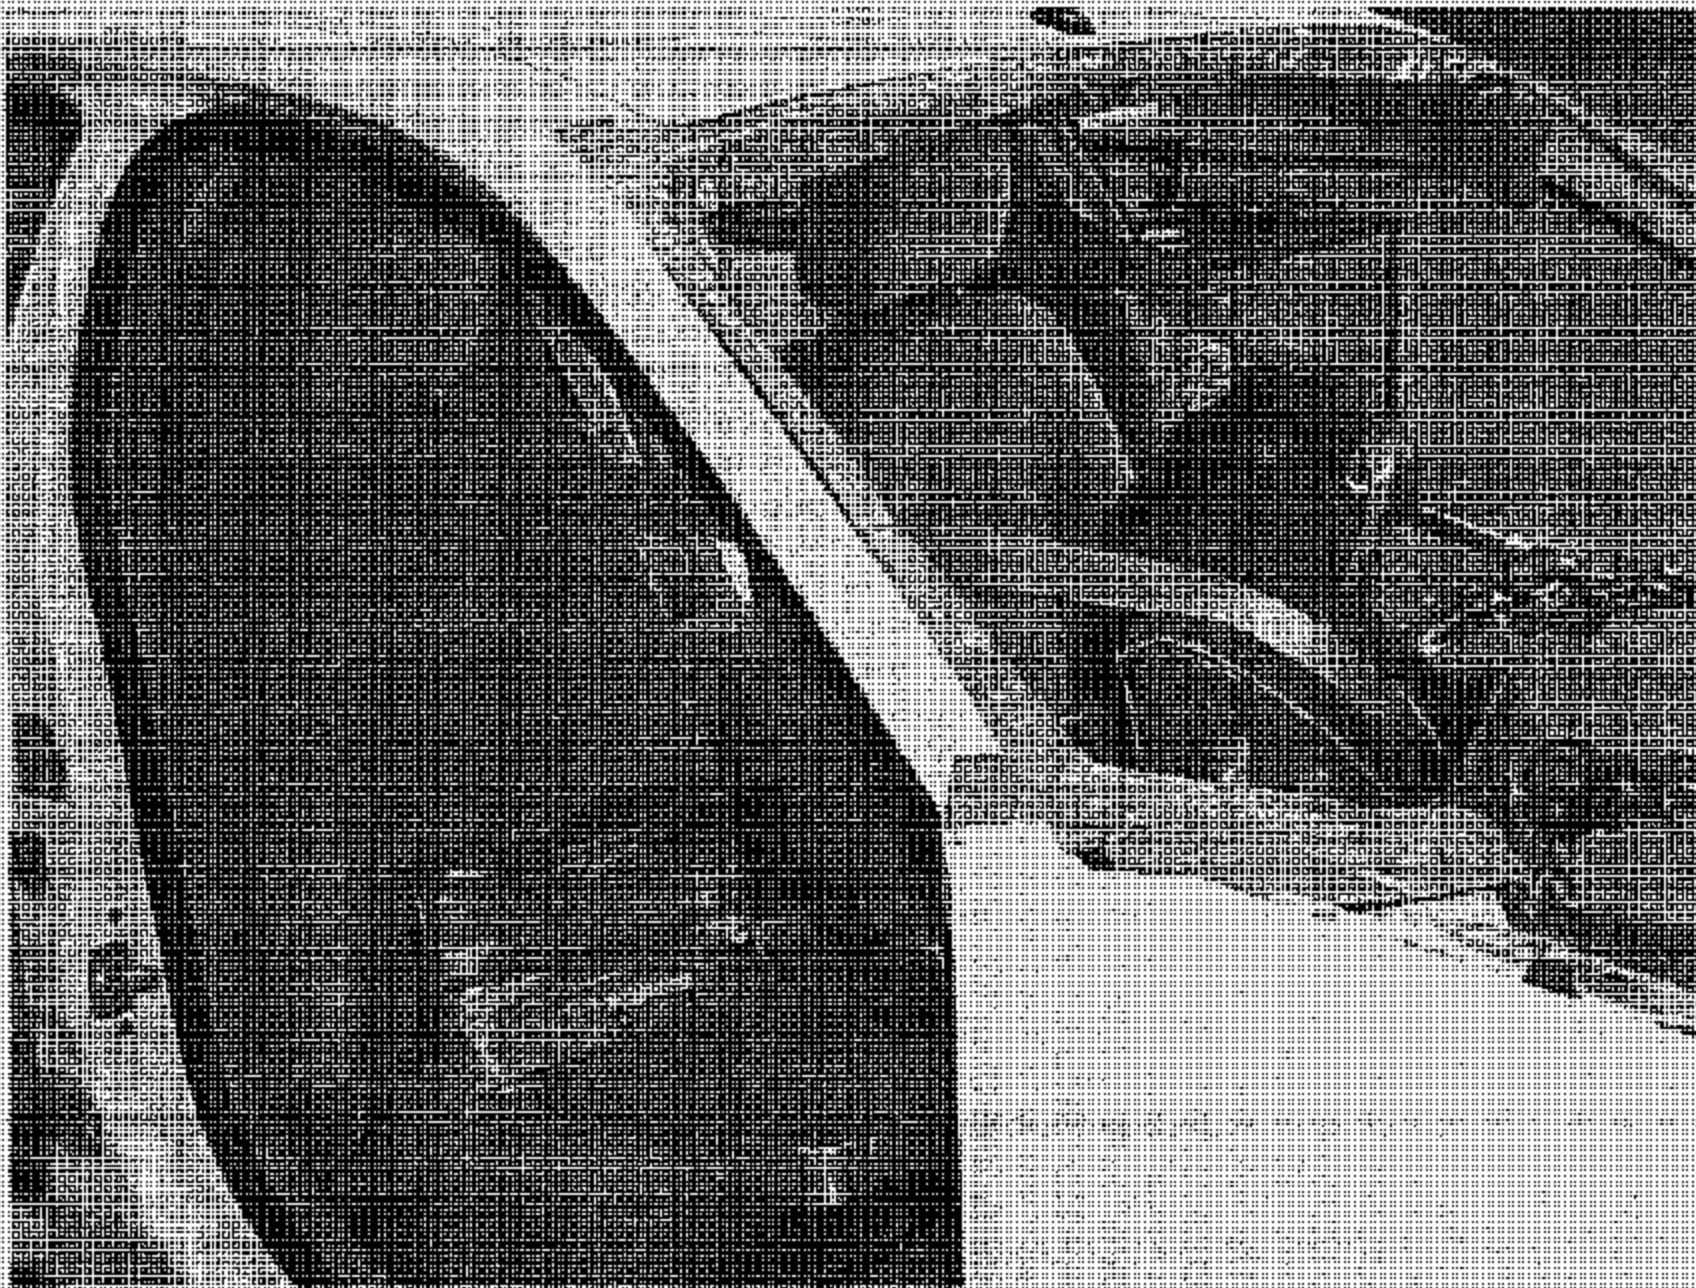
2005 BUICK LACROSSE  
NHTSA NO. C50103  
FMVSS NO. 210

FIGURE 5.19  
PRE-TEST ROW 1,  $\frac{3}{4}$  RIGHT FRONT VIEW

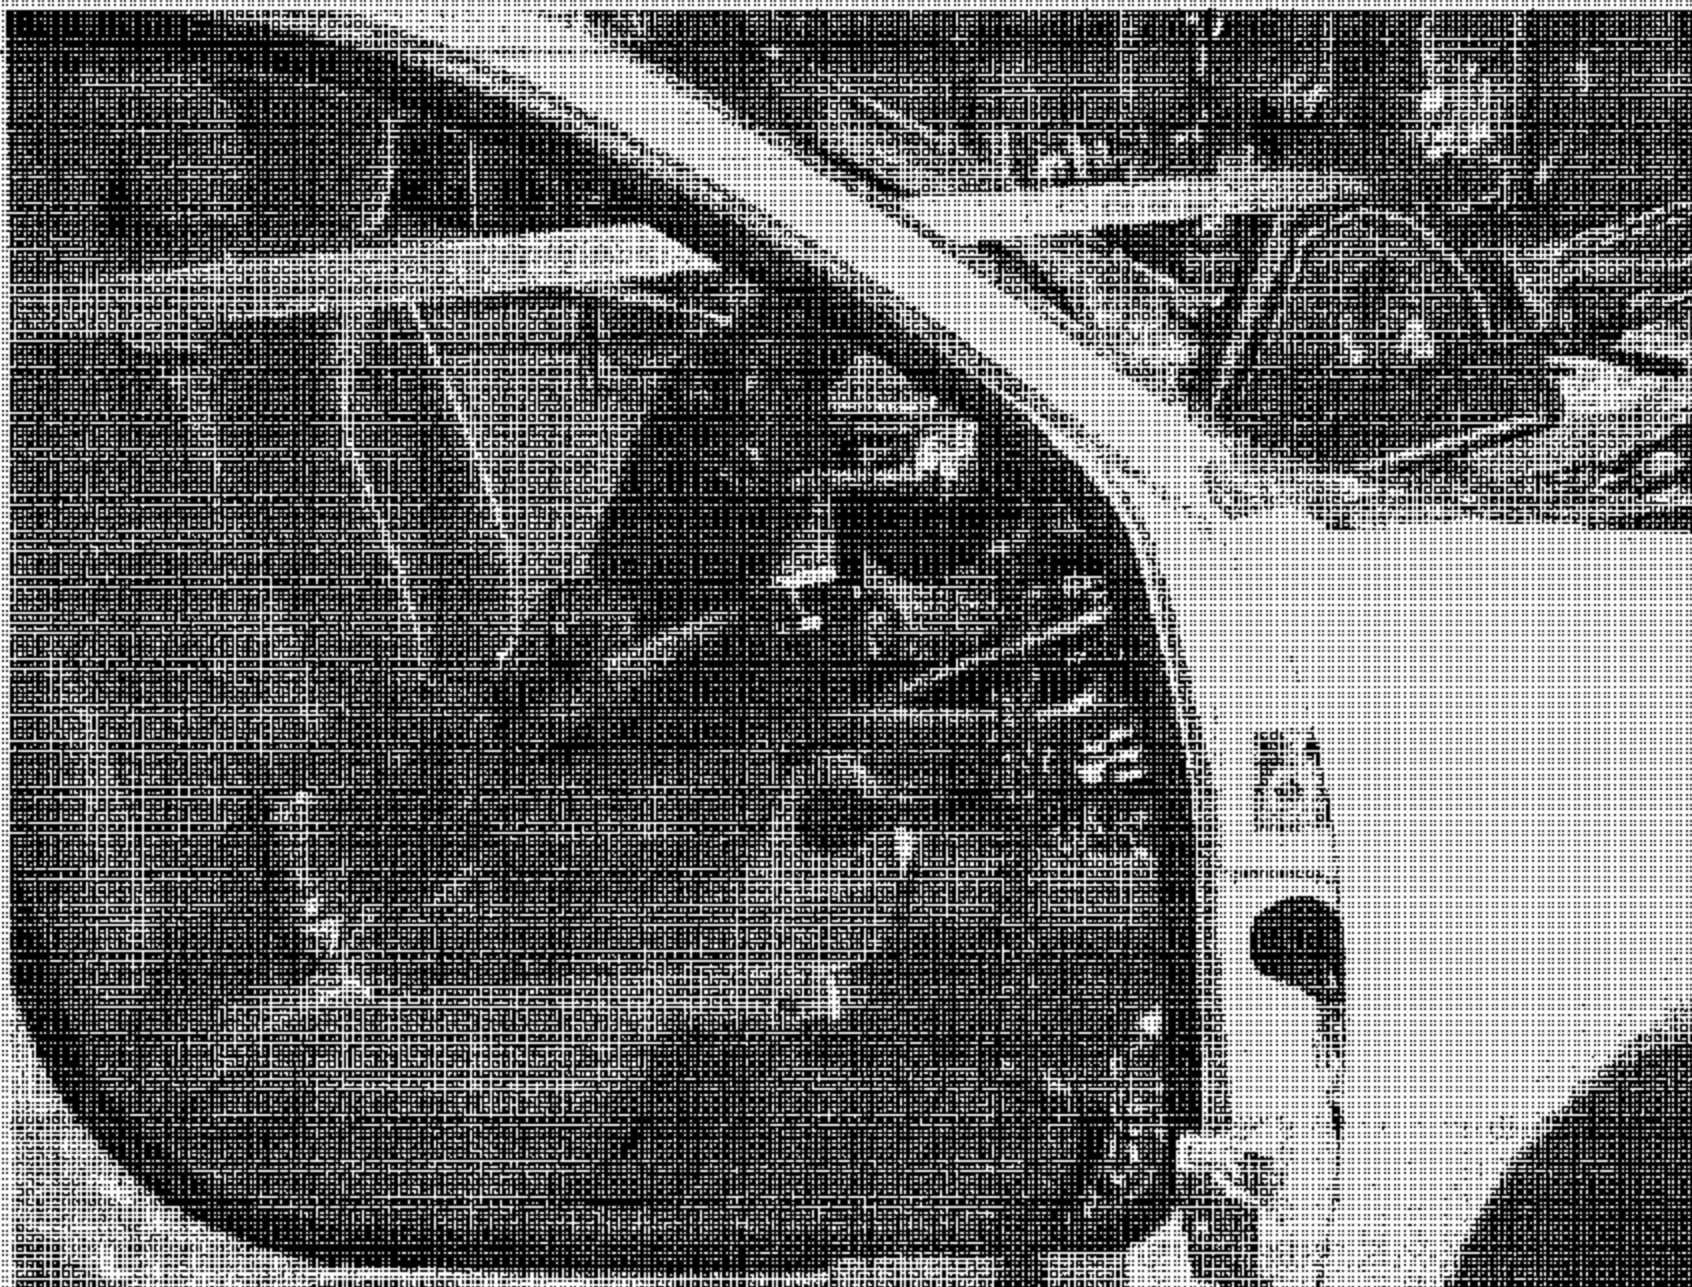
2005 BUICK LACROSSE  
NHTSA NO. C60109  
FMVSS NO. 210

FIGURE 5.24  
FULL LOAD ROW 1, RIGHT SIDE VIEW

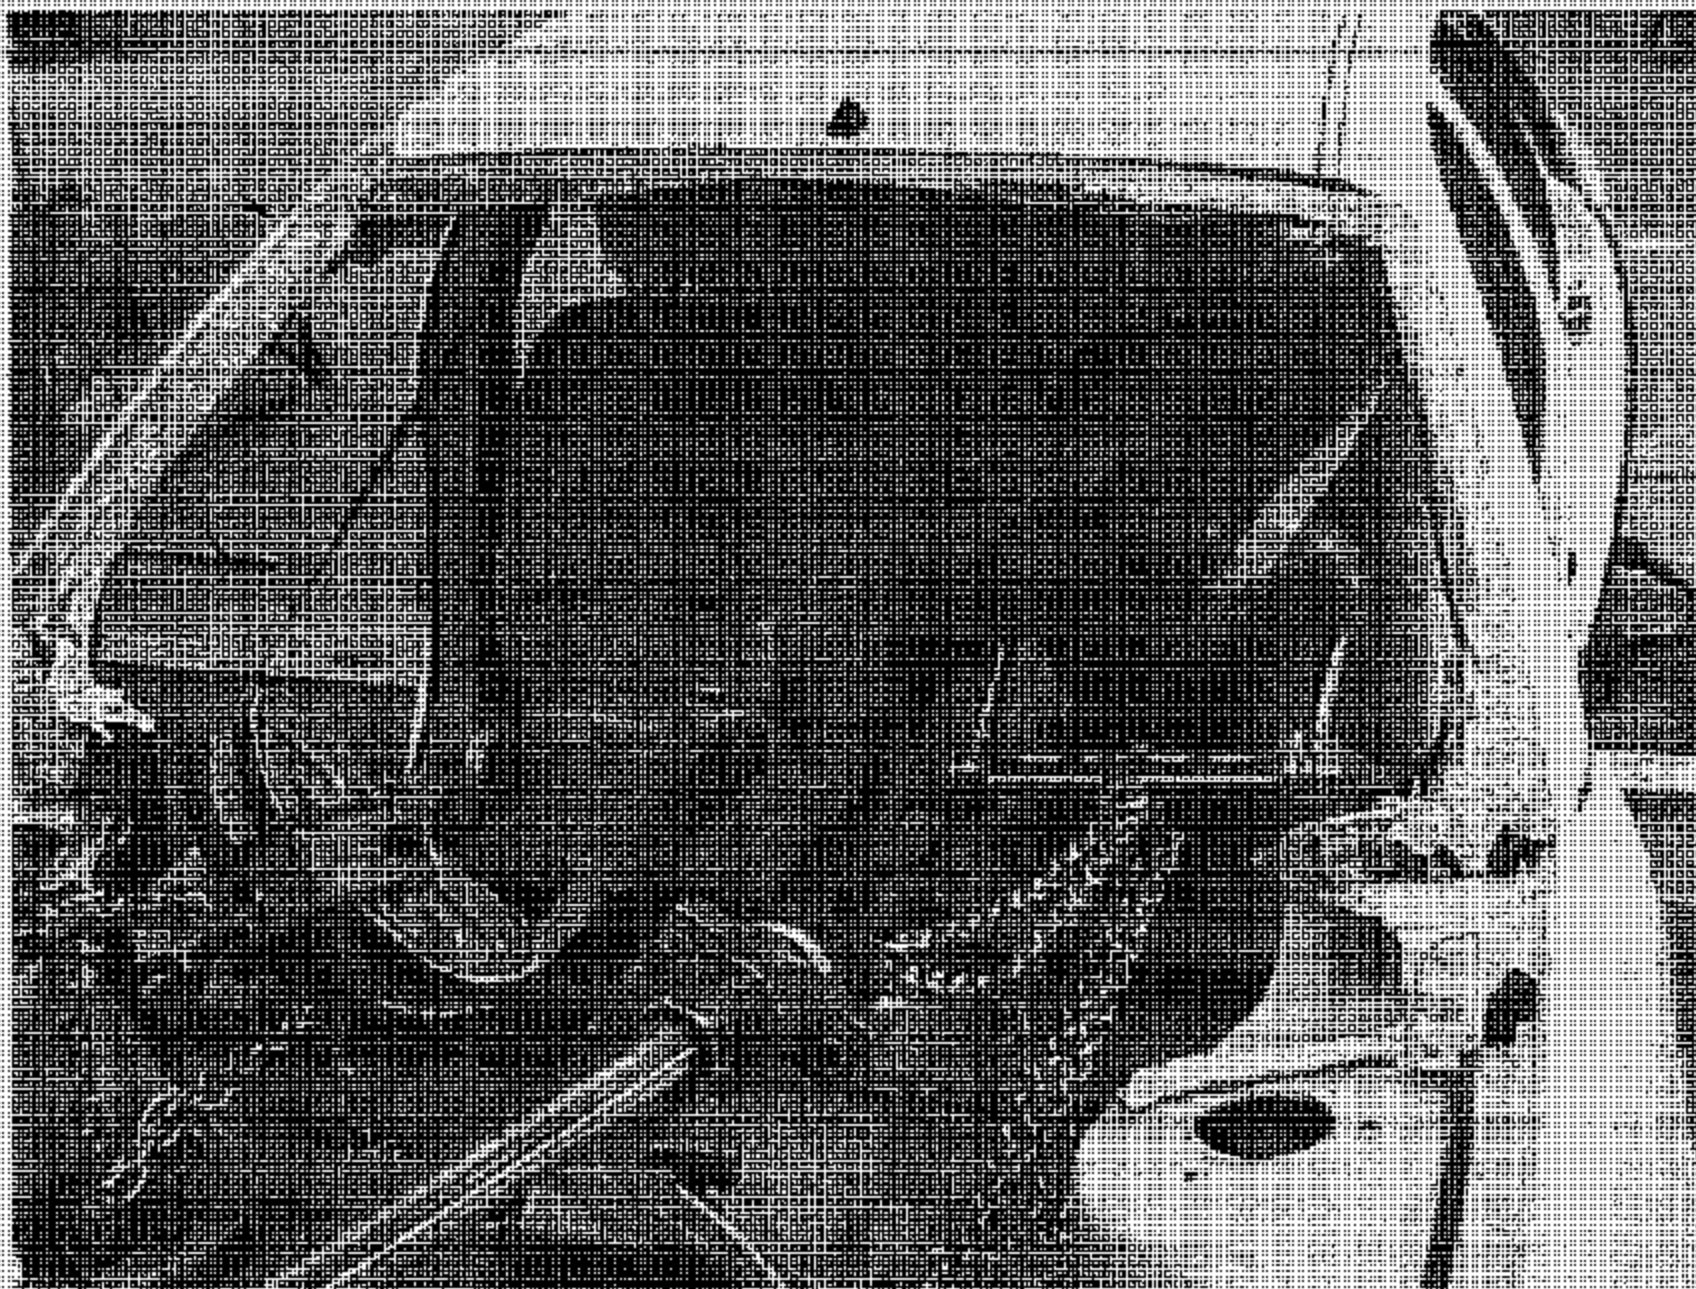
2005 BUICK LACROSSE  
NHTSA NO. C50103  
FMVSS NO. 210

FIGURE 5.26  
POST TEST ROW 1, ¼ LEFT FRONT VIEW

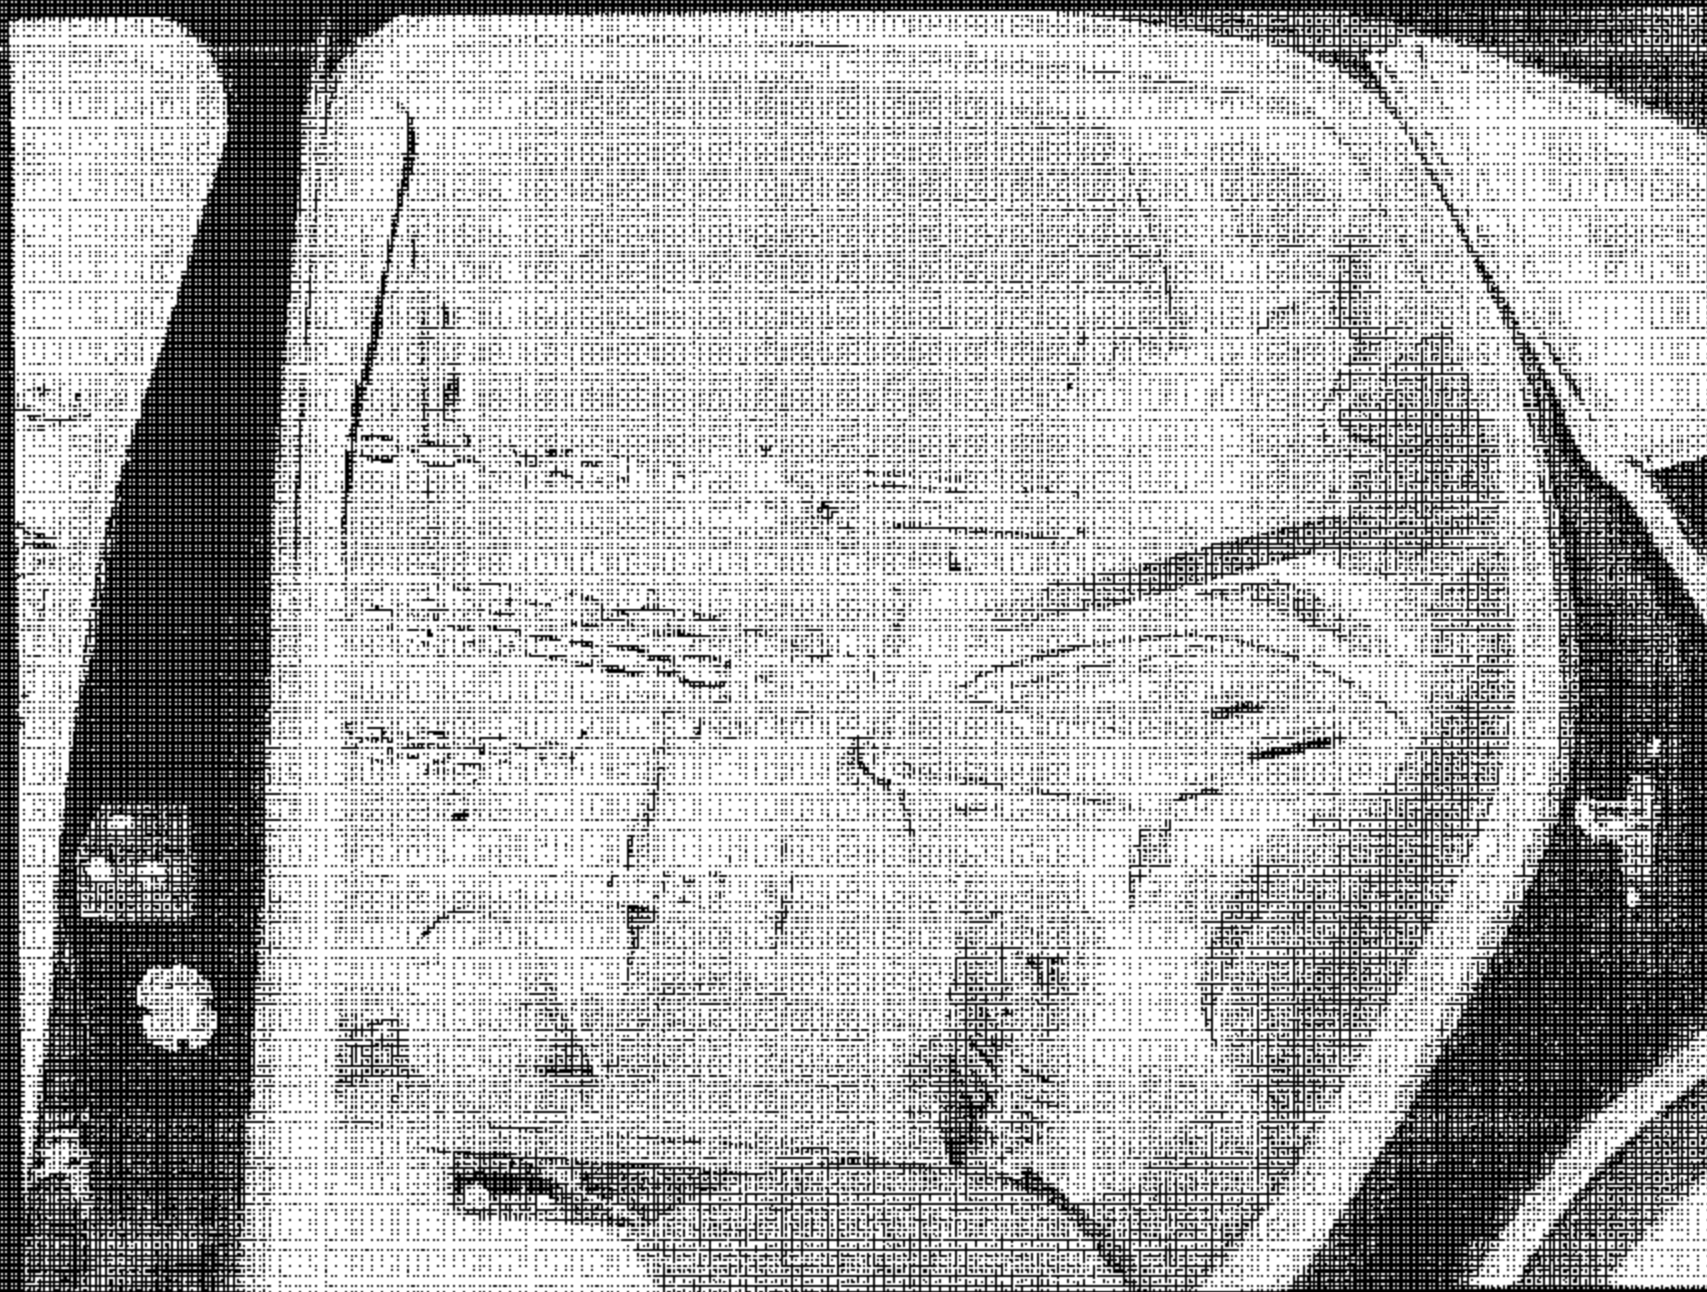
2005 BUICK LACROSSE  
NHTSA NO. C60103  
FMVSS NO. 210

FIGURE 5.29  
PRE-TEST ROW 2, LEFT SIDE VIEW

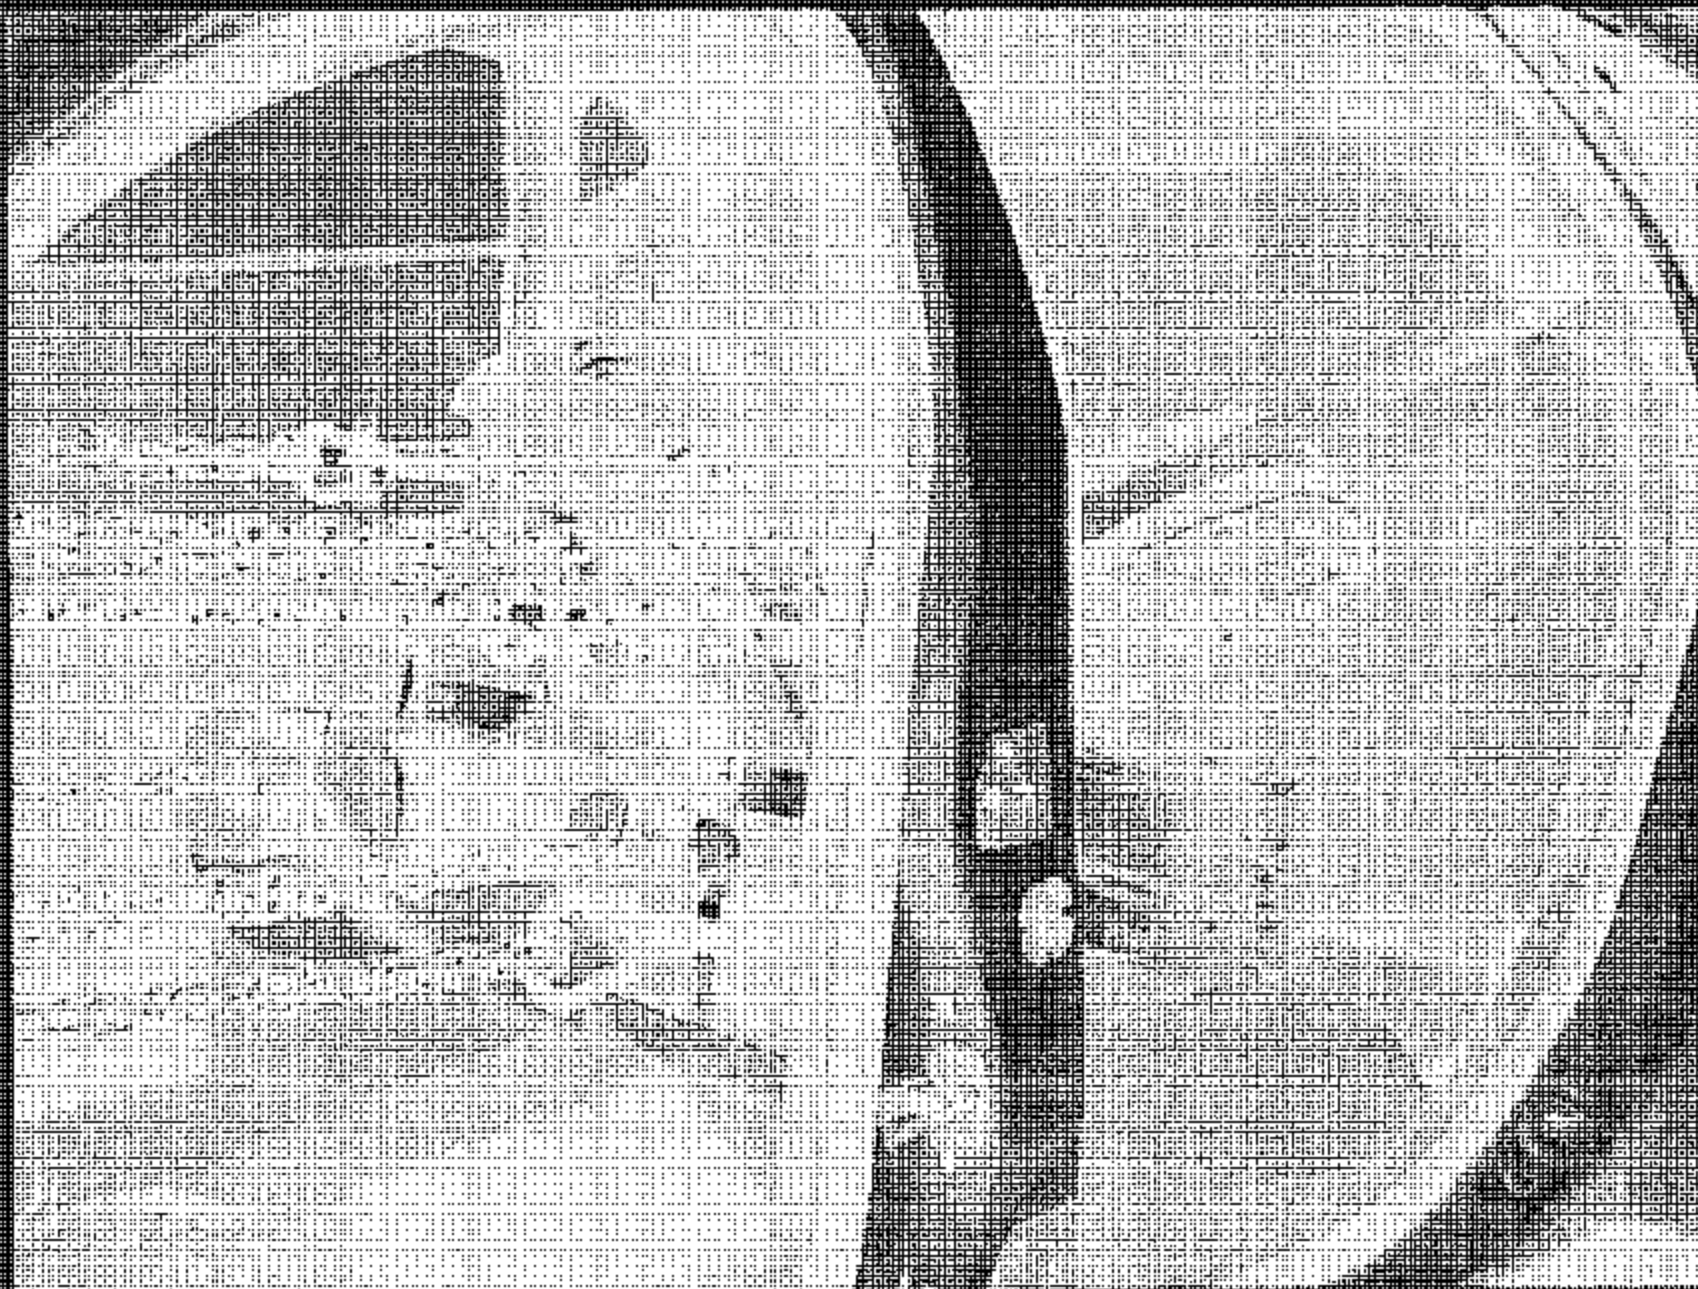
2006 BUICK LACROSSE  
NHTSA NO. C50103  
FMVSS NO. 210

FIGURE 3.30  
PRE-TEST ROW 2, 1/2 LEFT FRONT VIEW

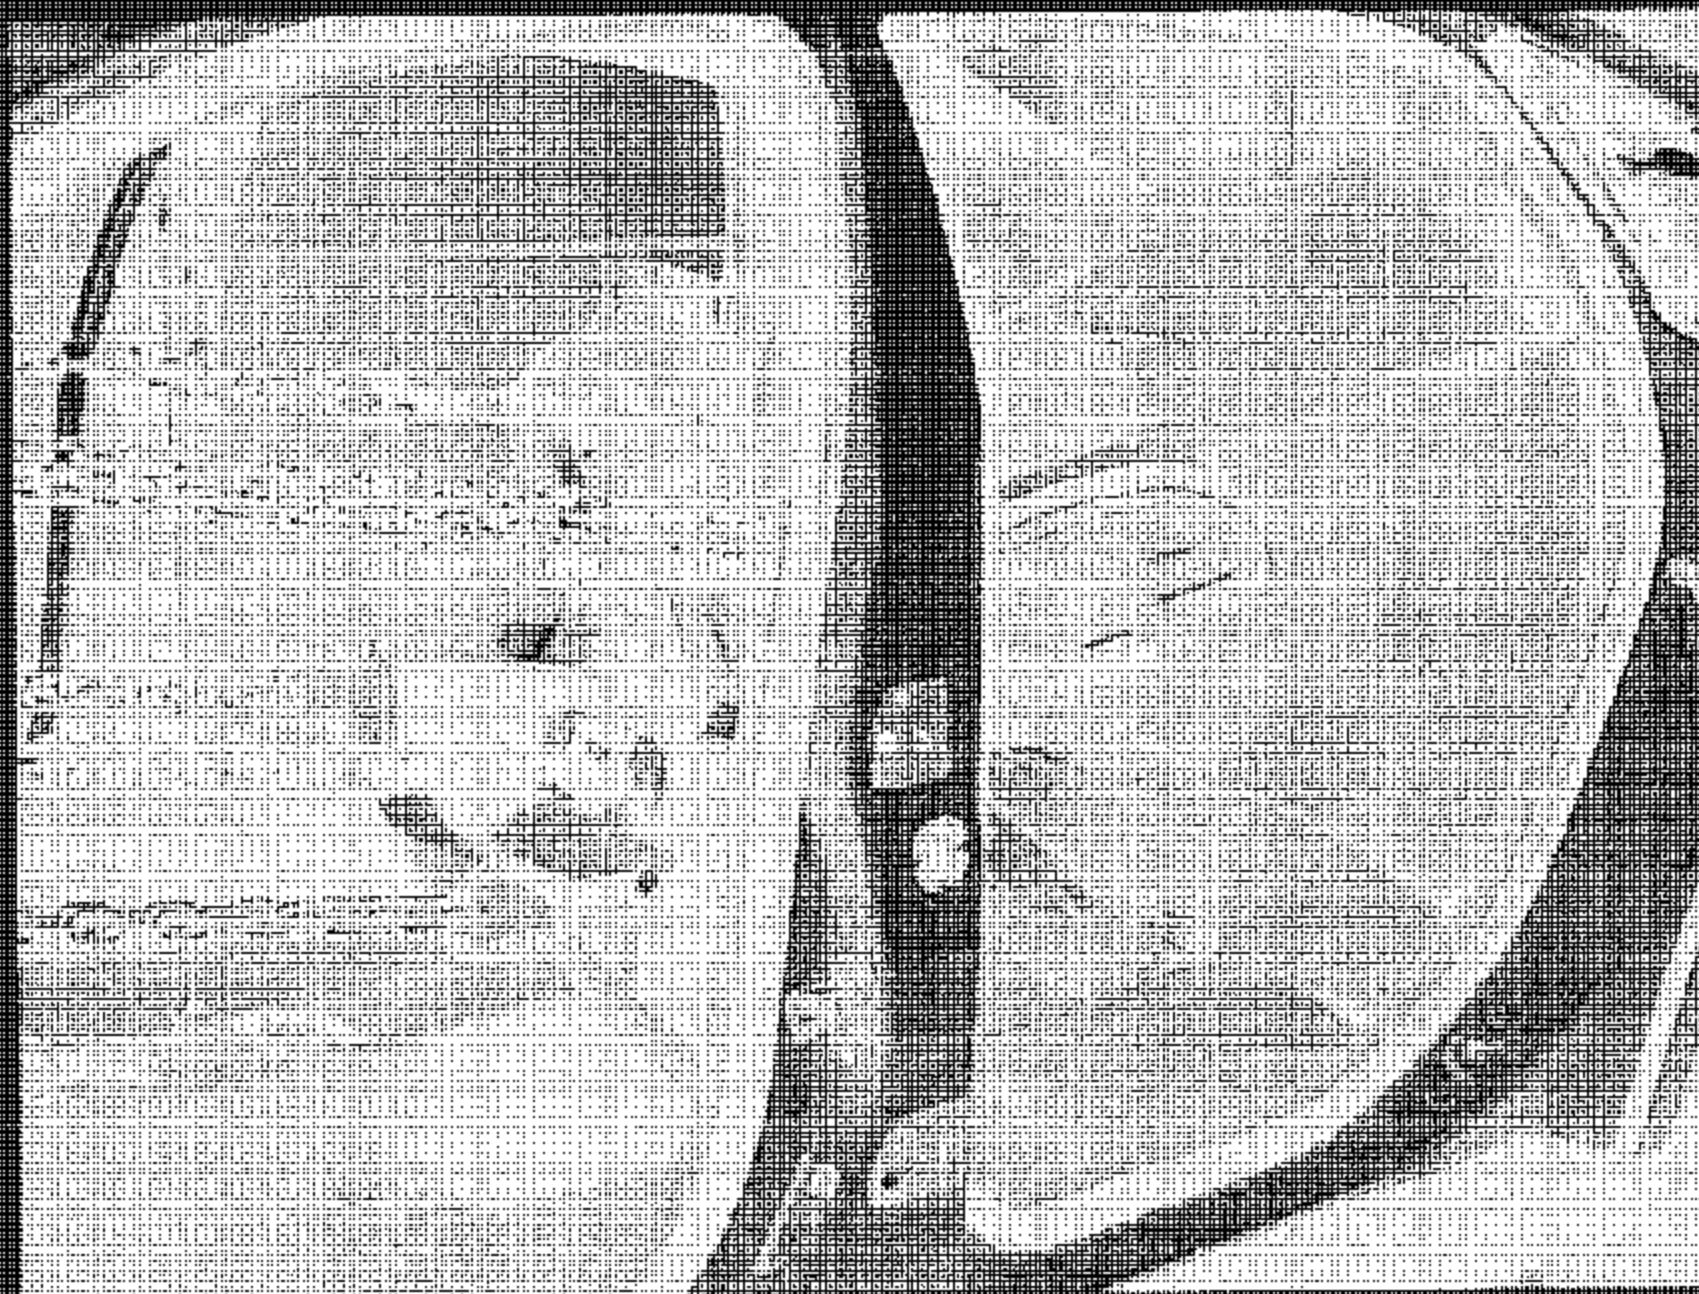
2005 BUICK LACROSSE  
NHTSA NO. C50103  
FMVSS NO. 210

FIGURE 6.24  
FULL LOAD ROW 2, 1/4 LEFT FRONT VIEW

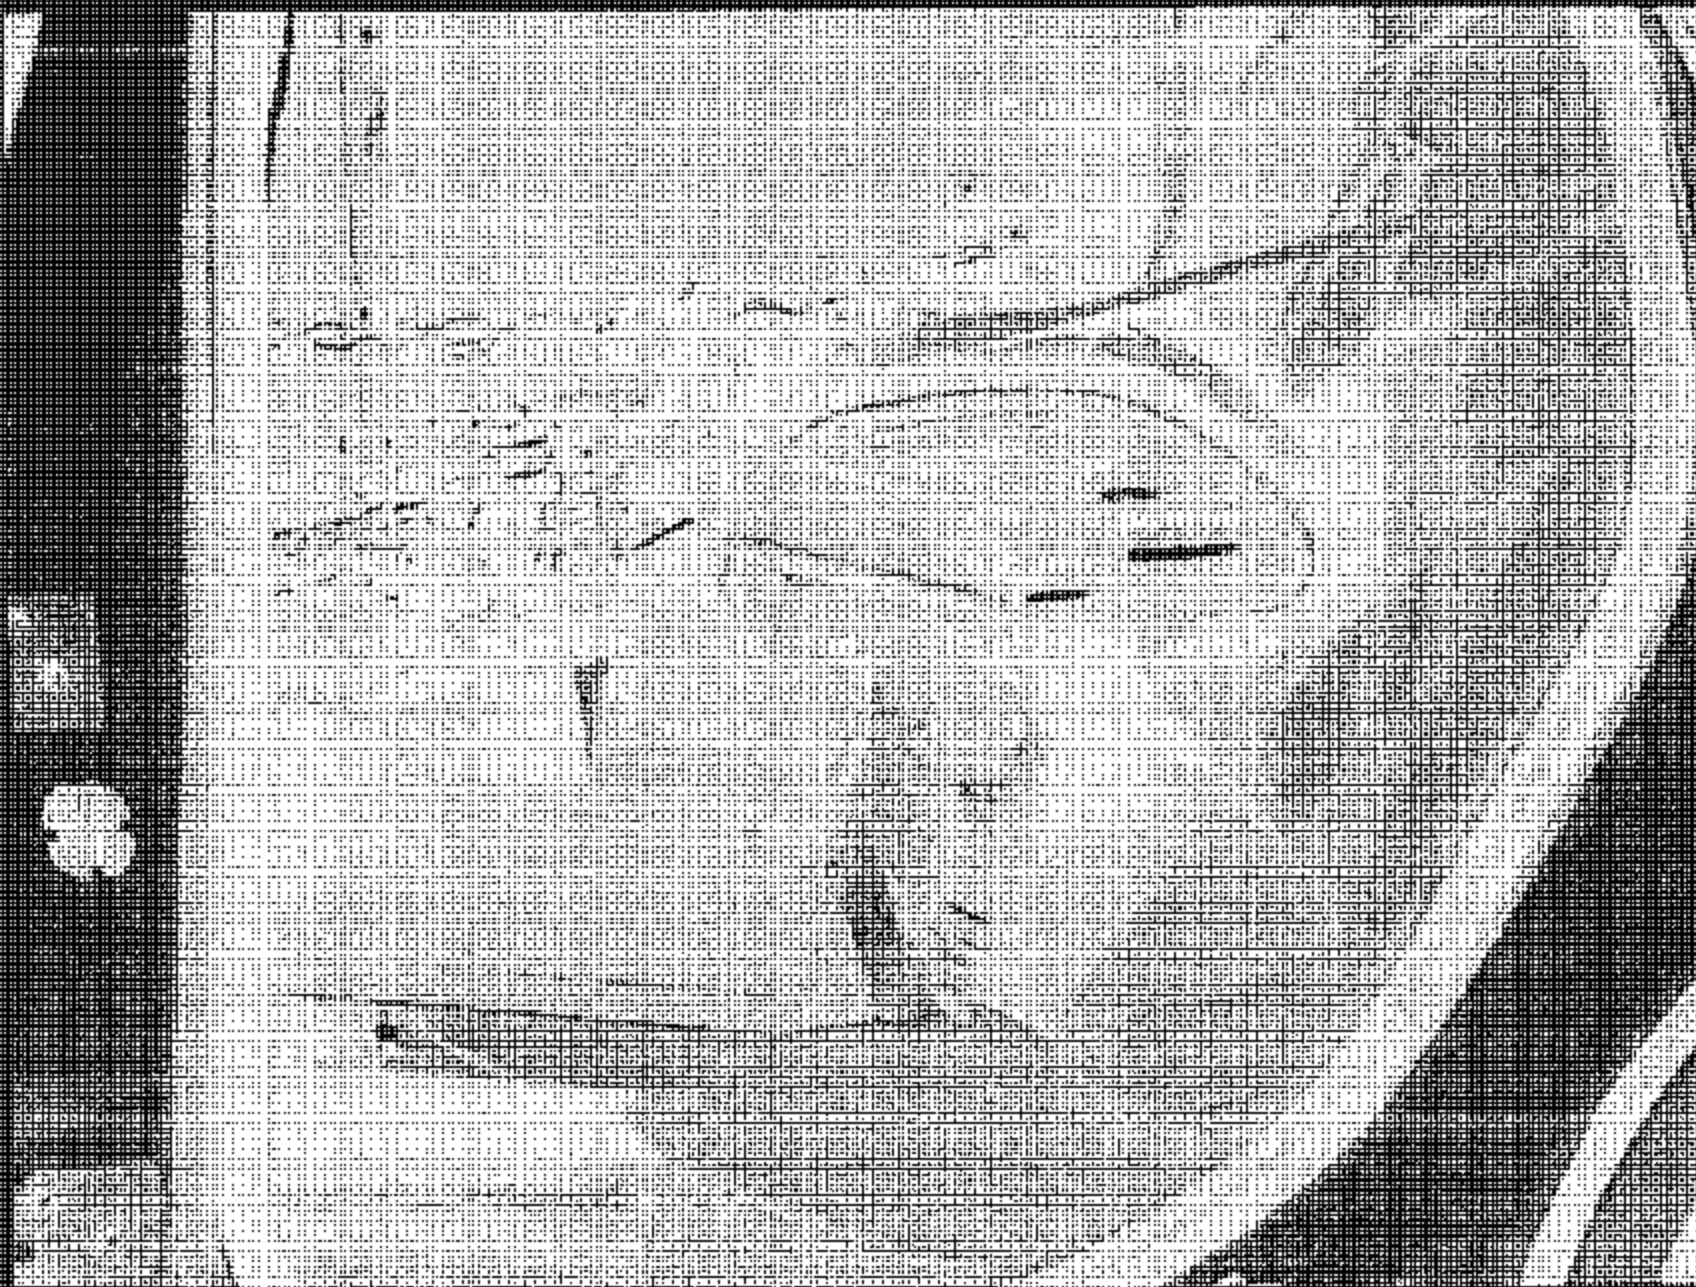
2004 BUICK LACROSSE  
NHTSA NCJ C60103  
FMVSS NO. 210

FIGURE 5.37  
POST TEST ROW 2, 1/4 LEFT FRONT VIEW

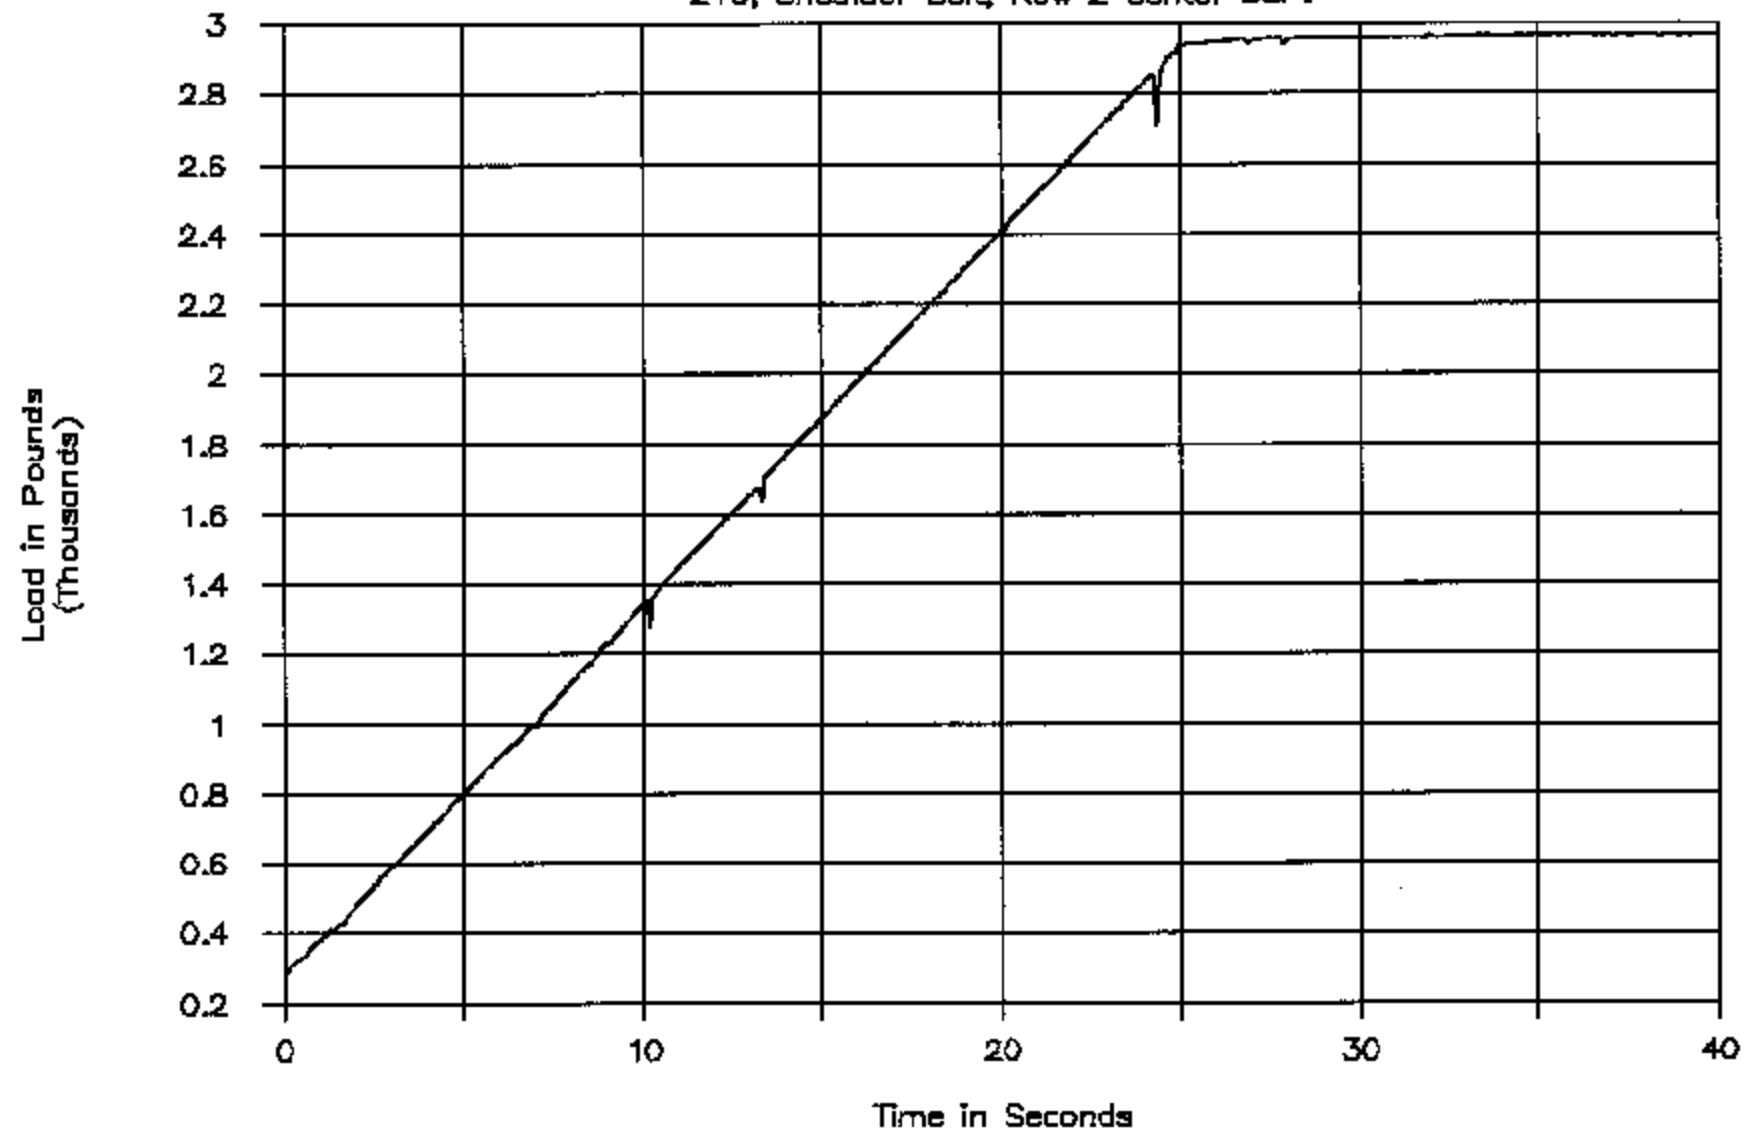
GTL 5312, NHTSA C50103.

210, Shoulder Belt, Row 2 Center DSP.
