REPORT NUMBER: 201-CAL-05-01

**SAFETY COMPLIANCE TESTING FOR FMVSS 201  
OCCUPANT PROTECTION IN INTERIOR IMPACT**

**TOYOTA MOTOR CORPORATION  
2005 SCION XB**

FINAL REPORT

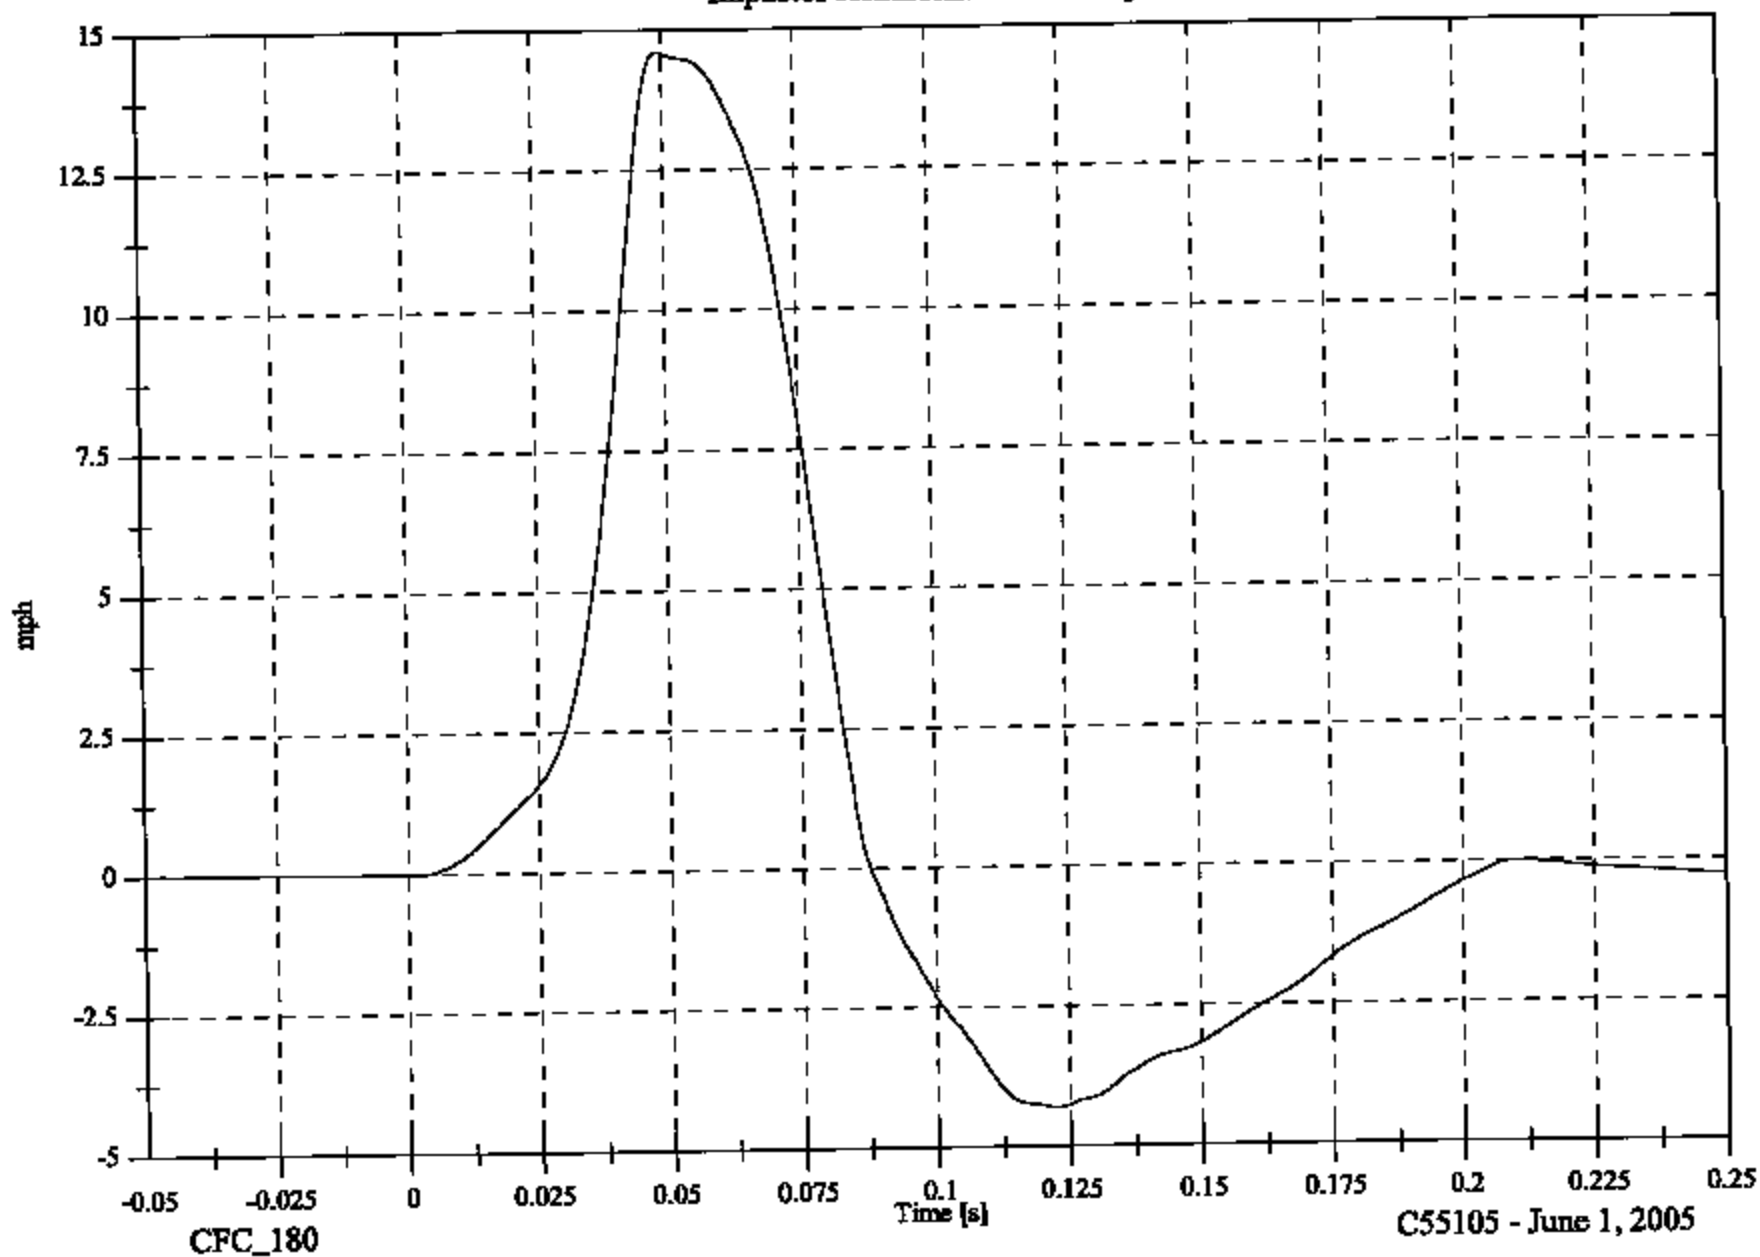
FMVSS 201 Linear Impact - 2005 Scion xB - Seat Back -20 Degrees  
Impactor Headform Ax Velocity

Max: 14.6 [mph] at 0.049 [s]  
Min: -4.3 [mph] at 0.122 [s]
