REPORT NUMBER: 301-MGA-2011-003

SAFETY COMPLIANCE TESTING FOR FMVSS 301R FUEL SYSTEM INTEGRITY – REAR IMPACT

GENERAL MOTORS LLC 2011 CHEVROLET CRUZE NHTSA NUMBER: CB0103

PREPARED BY:
MGA RESEARCH CORPORATION
5000 WARREN ROAD
BURLINGTON, WI 53105

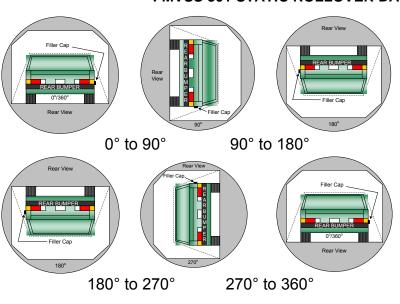
FMVSS 301 STATIC ROLLOVER DATA

- 1. The specified fixture rollover rate for each 90° of rotation is 60 to 180 seconds.
- 2. The position hold time at each position is 300 seconds (minimum).

3. Details of Stoddard Solvent spillage locations: Not Applicable

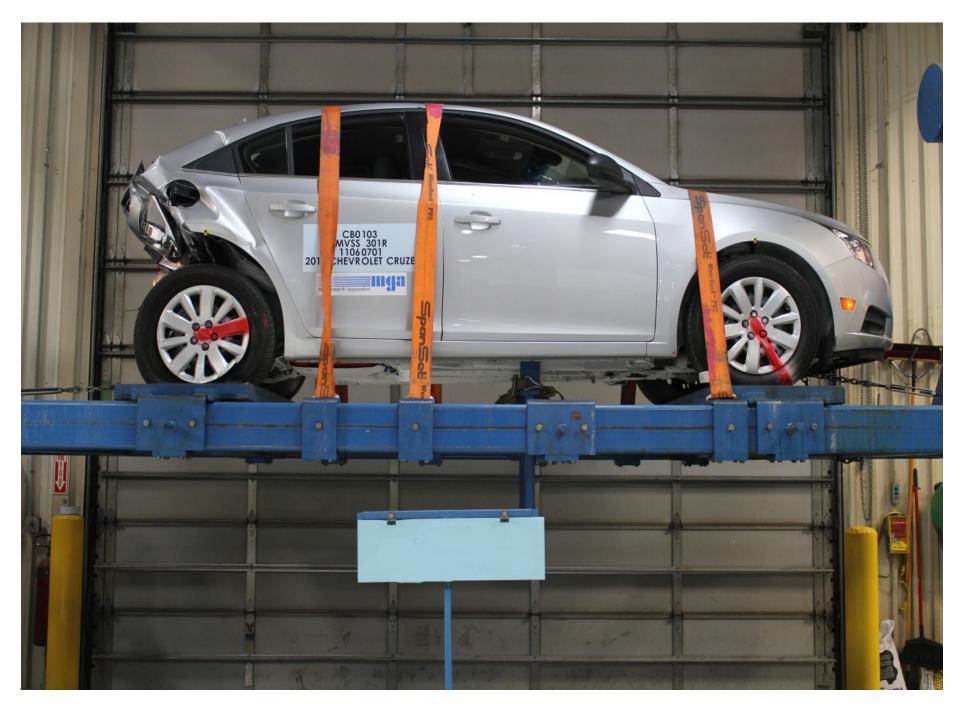
Static Rollover at 360 Degrees
