Rear Facing Child Safety Seat Air Bag Fatality Investigation/ Vehicle to Object Dynamic Science, Inc. / Case Number: DS04012 2003 Jeep Grand Cherokee Laredo California May, 2004 This document is disseminated under the sponsorship of the Department of Transportation in the interest of information exchange. The United States Government assumes no responsibility for the contents or use thereof.

Dynamic Science, Inc. Crash Investigation Case Number: DS04012

BACKGROUND:

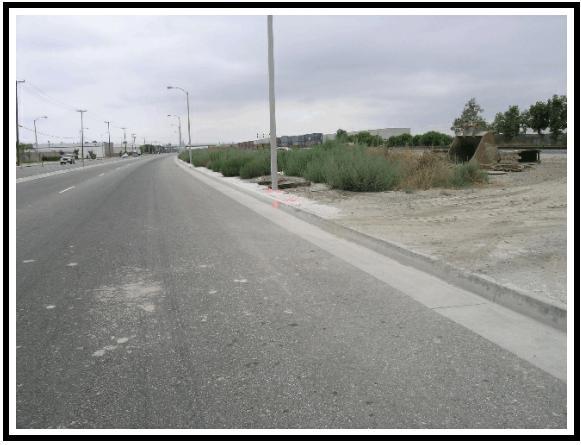
Figure 3. Approach to area of impact (south)

roadway was dry. The north/south roadway was configured with two lanes in each direction that were separated by a raised center median. The roadway is slightly curved to the right and there is a +1.3% grade at impact. The roadway edge for southbound travel was comprised of a 94 cm (37 in) concrete rain gutter and a 23 cm (9 in) high concrete curb. The 71 cm (28 in) diameter concrete pole was located 71 cm (28 in) off the road edge. The poles are spaced 42 m (137 ft) apart. The posted speed limit was 72 km/h (45 mph).

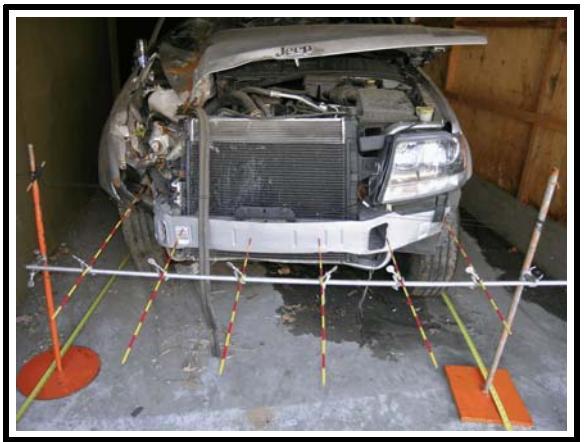
Figure 4. Front, 2003 Jeep Cherokee

The 2003 Jeep Cherokee sustained minor rim damage from the impact with the curb (12FRWN3). The vehicle sustained moderate front end damage as a result of the impact with the concrete pole (12FREE3). The direct damage began at the right front bumper corner and extended laterally 32.0 cm (12.5 in). The maximum crush at the right bumper corner backing bar was 28.0 cm (11.0 in). The front end damage extended rearward in a pole shaped pattern 277.0 cm (109.0 in) across the hood, windshield and roof as the pole fractured and fell down onto the vehicle (00TYGN4). The right A pillar was crushed

vertically 22.0 cm (8.7 in).

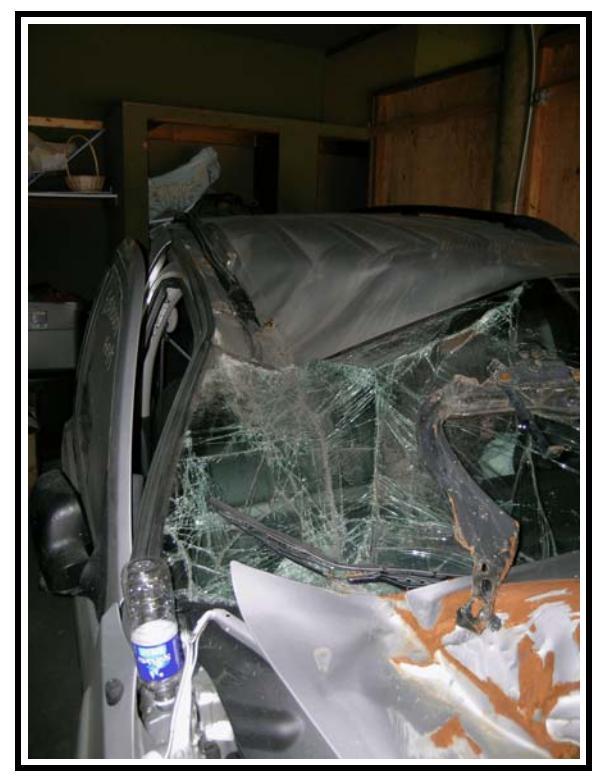
Figure 5. Roof, windshield, hood crush

The 2003 Jeep Grand Cherokee sustained significant interior damage as a result of passenger compartment intrusion. The windshield header, roof, visor, window frame, and A/B pillars sustained vertical intrusion to the center and right front seating areas.

Position	Intruded Component	Magnitude of Intrusion	Direction
FR	Windshield	13.0 cm (5.1 in)	Vertical
FR	Windshield header	14.0 cm (5.5 in)	Vertical
FR	Roof	21.0 cm (8.3 in)	Vertical
FR	Visor	25.0 cm (9.8 in)	Vertical
FR	Window frame	15.0 cm (5.9 in)	Vertical
FR	A pillar	10.0 cm (3.9 in)	Vertical
FR	B pillar	2.0 cm (0.8 in)	Vertical
RR	Window frame	3.0 cm (1.2 in)	Vertical
FC	Windshield header	\geq 15 cm but < 30 cm	Vertical
FC	Roof	\geq 15 cm but < 30 cm	Vertical

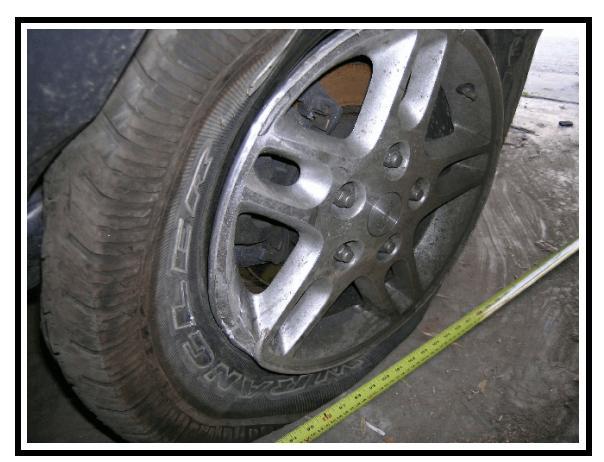
Figure 6. Front right rim damage

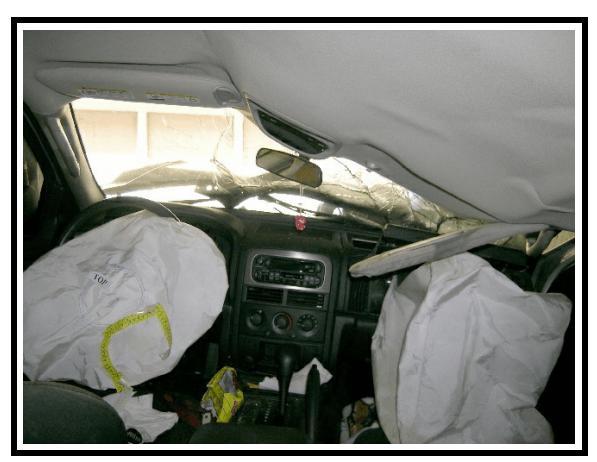
Figure 7. Overview of front seating area

These listed intrusions seem to be less severe than the interior photographic evidence would indicate. However, a review of the exterior photos show that the front-right roof is not as vertically displaced as the interior photos suggest.

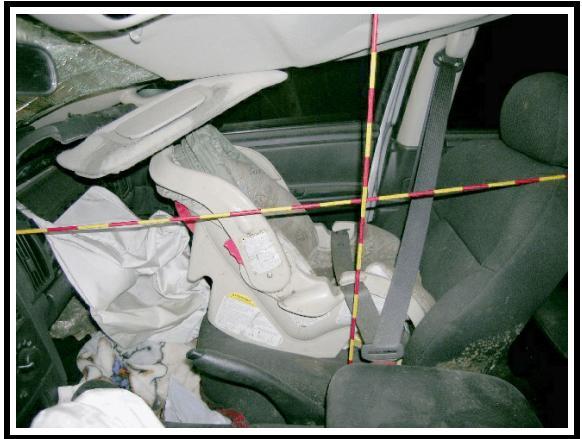
Figure 8. Graco SnugRide RFCSS

A Graco SnugRide RFCSS was positioned in the front right seat of the Jeep. The model number was 7456 MON and the date of manufacture was April 30, 2003. The seat was given to the driver as a gift. The RFCSS seat was configured with a fivepoint harness system. The seat was designed for use with or without a stay-in-vehicle base. The base was not present during this crash. The manufacturer recommends that the seat be used for children weighing up to 9.0 kg (19.8 lbs) and who are less than 66 cm (25.9 in) in height. The child in this crash was 2.2 kg (6.0 lbs) too heavy and 13.0 cm (5.1 in) too tall for this seat.

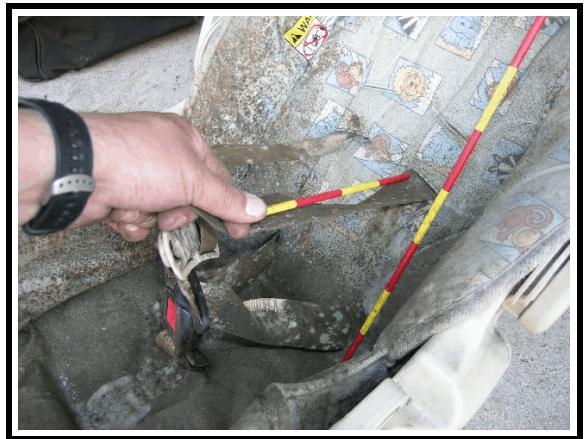
Figure 9. Harness length and slot routing

At the time of inspection, the harness straps were routed through the bottom set of harness slots. The harness retainer clip was position 26.0 cm (10.2 in) below the harness slots, which resulted in a remaining shoulder harness length of 5.0 cm (1.9 in) between the retainer clip and the RFCSS latch plates. The length of the crotch strap was 9.0 cm (3.5 in).

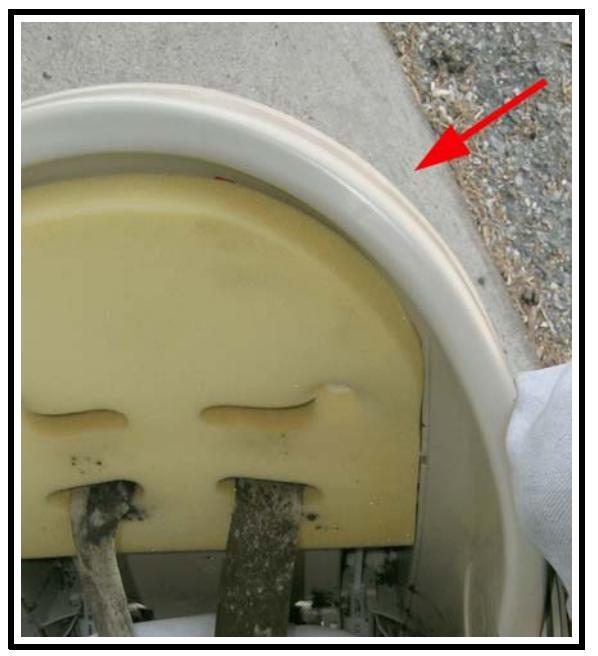
Figure 10. Stress mark to seat back shell

The child seat sustained minor damage as a result of the crash. A small, faint stress mark was present on the outboard aspect of the upper left side of the seat under the fabric cover. The harness straps did not exhibit any deformation from the crash.
