PUBLIC ROADS

JULY 1937

LABORATORY, EXPOSURE, AND SIMULATED SERVICE TESTS OF SLOW-CURING LIQUID ASPHALTS

BY THE DIVISION OF TESTS, BUREAU OF PUBLIC ROADS

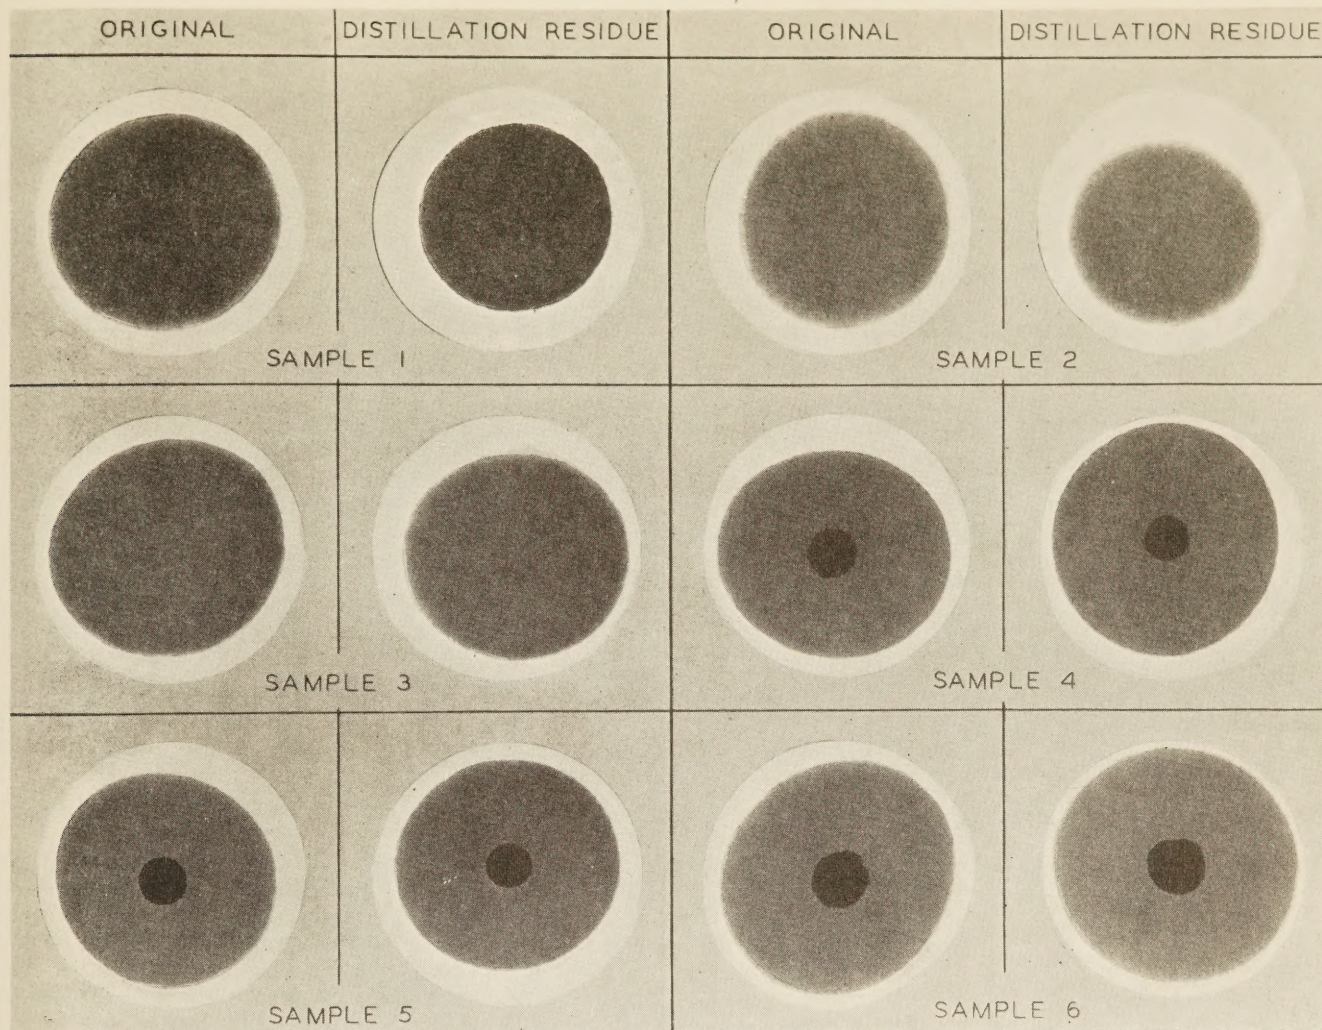
FIGURE 1.—APPEARANCES OF OLIENSIS SPOTS OF ORIGINAL MATERIALS AND THEIR DISTILLATION RESIDUES.

The three steam-reduced products, samples 1, 2, and 3, had lower specific gravities than did samples 4, 5, and 6 and both the original materials and their distillation residues were homogeneous in the Oliensis test. When viewed under the microscope at 200 magnifications, samples 1 and 3 had clear fields both when undiluted and when diluted with 6 parts of carbon tetrachloride. Sample 2 showed a few carbonaceous particles under both conditions. The two cracked products, samples 4 and 5, and the blend, sample 6, had the highest specific gravities, were heterogeneous in the Oliensis test, and all contained a number of carbonaceous flecks when viewed microscopically.

Photographs of the Oliensis stains are given in figure 1, and photomicrographs of samples 2, 4, 5, and 6 are shown in figure 2.

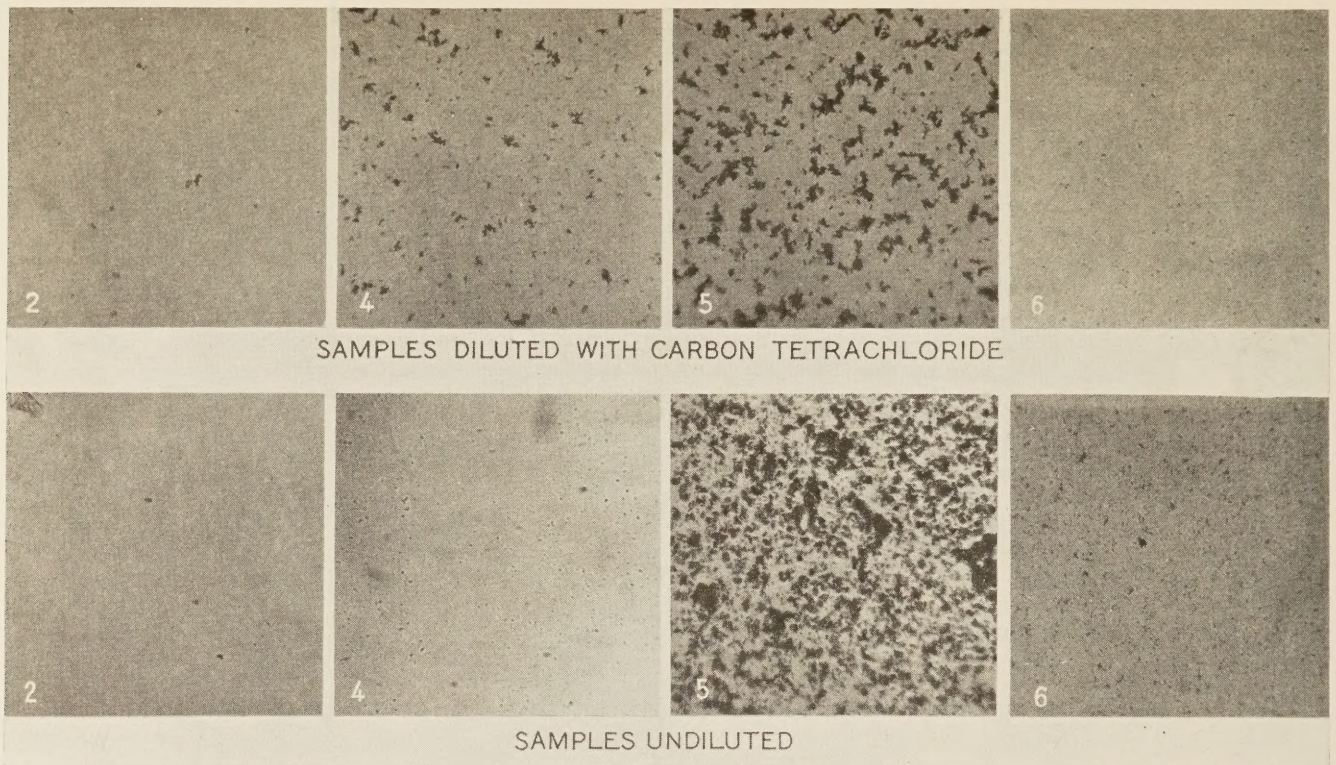
FIGURE 2.—PHOTOMICROGRAPHS OF DILUTED AND UNDILUTED ASPHALTIC MATERIALS. MAGNIFIED 115 DIAMETERS.

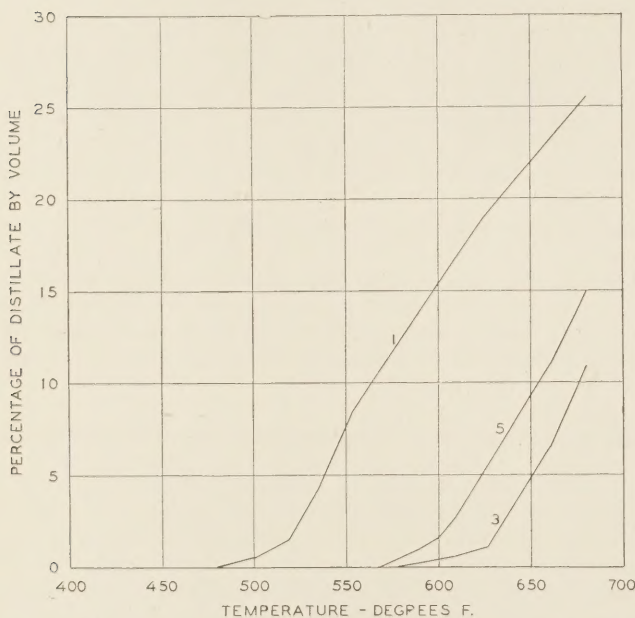
FIGURE 3.—DISTILLATION CURVES OF SAMPLES 1, 3, AND 5.

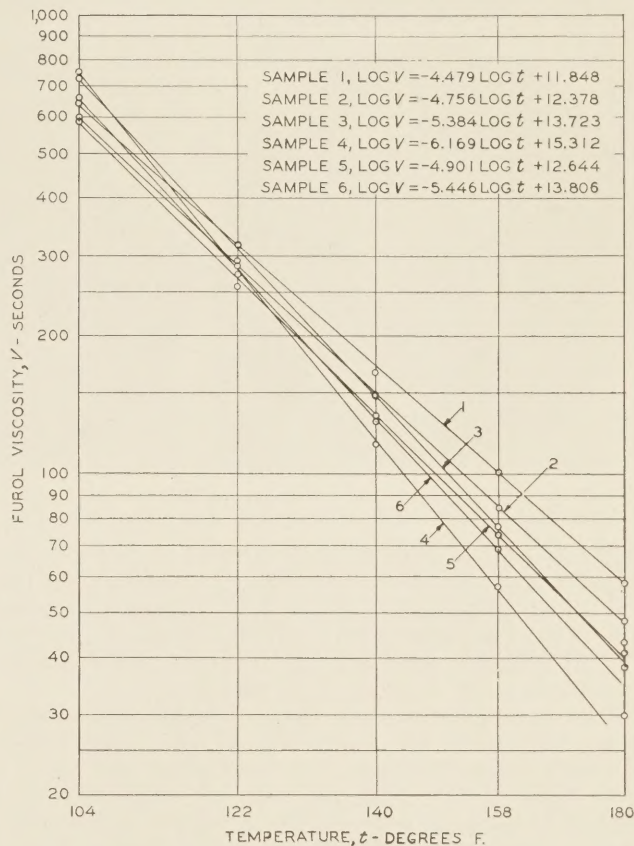
FIGURE 4.—RELATIONS BETWEEN FUROL VISCOSITY AND TEMPERATURE FOR THE VARIOUS SAMPLES.

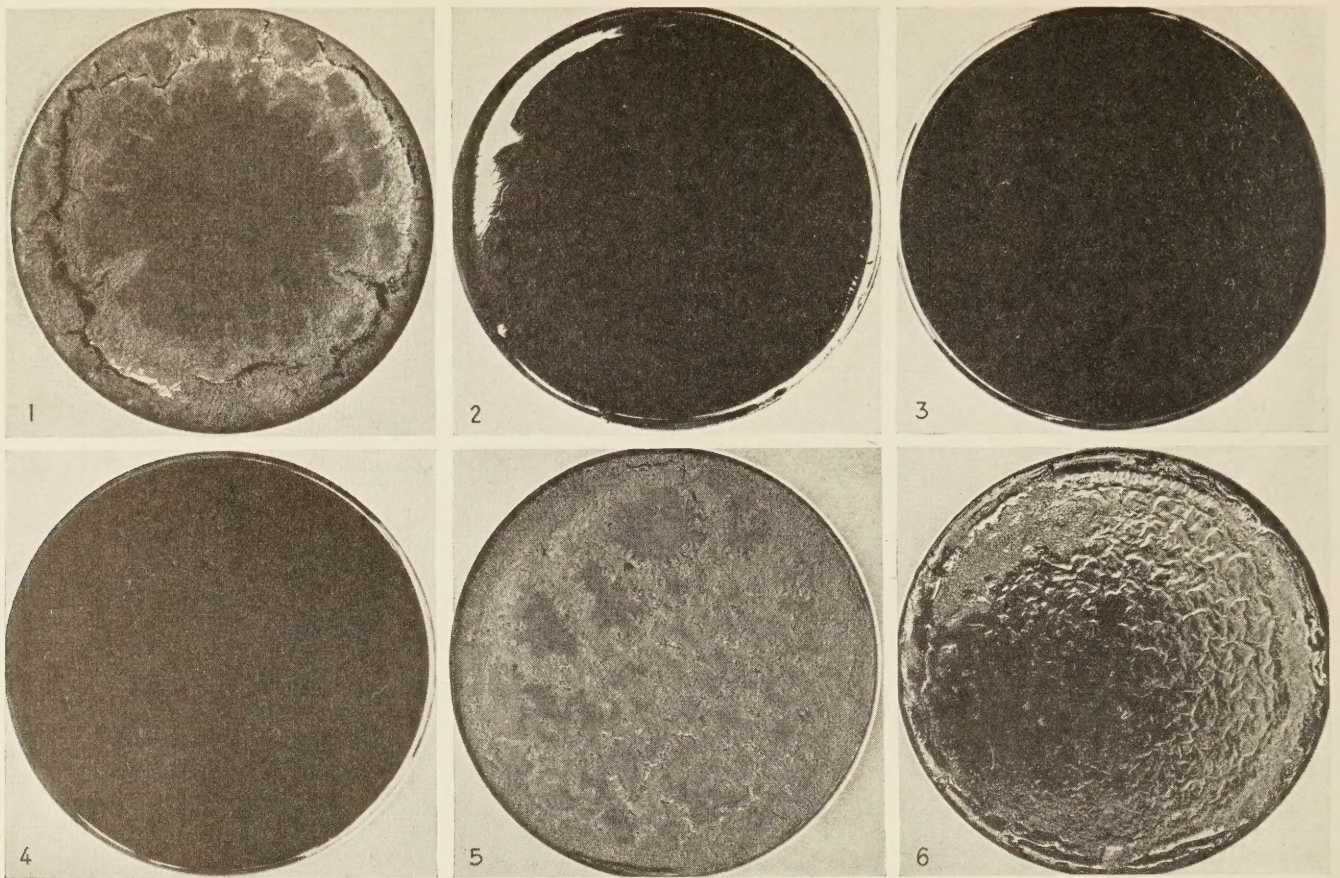
FIGURE 5.—APPEARANCES OF SURFACES OF THE $\frac{1}{8}$ -INCH FILMS OF LIQUID ASPHALT AFTER 15 WEEKS OF EXPOSURE.

- Sample 1: Rough, dull center, brown streak when scratched, some glossy material around edges in cracks.
- Sample 2: Smooth, glossy, greasy, slightly mottled.
- Sample 3: Smooth, glossy, sticky.
- Sample 4: Smooth, glossy, slightly sticky.
- Sample 5: Rough surface, raised portions dull, depressions slightly glossy.
- Sample 6: Generally glossy, rough; cracks filled with soft material which was fluid and greasy.

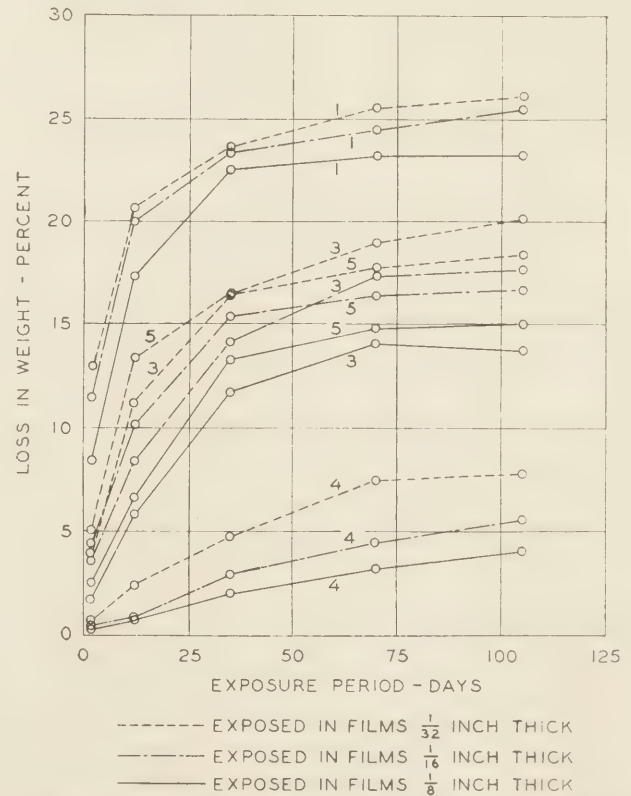
FIGURE 6.—RATE OF LOSS BY ASPHALTIC MATERIALS EXPOSED IN THIN FILMS.

In figure 6 the losses at various periods of exposure are plotted for samples 1, 3, 4, and 5. The losses at 2, 12, and 35 days are the averages for the three specimens of each sample originally exposed. The losses at 70 days are the averages for the materials tested at the end of 10 and 15 weeks, while the losses at 105 days are the losses for the specimens of each sample tested at the end of 15 weeks. This accounts for the fact that the 1/8-inch film of sample 3 appeared to have lost more in 10 weeks than in 15 weeks.

Sample 1 not only lost more than the other samples but lost at a faster rate. In 12 days sample 1 had lost, depending upon the film thickness, from 75 to 79 percent of its total loss in 15 weeks. In the same time

sample 5 had lost from 45 to 72 percent of its total loss; sample 3 lost from 43 to 56 percent; and sample 4 lost from 14 to 30 percent. In 35 days sample 1 had lost from 90 to 97 percent of its total loss; sample 5 lost from 89 to 91 percent; sample 3 lost from 80 to 86 percent; and sample 4 lost from 49 to 61 percent.

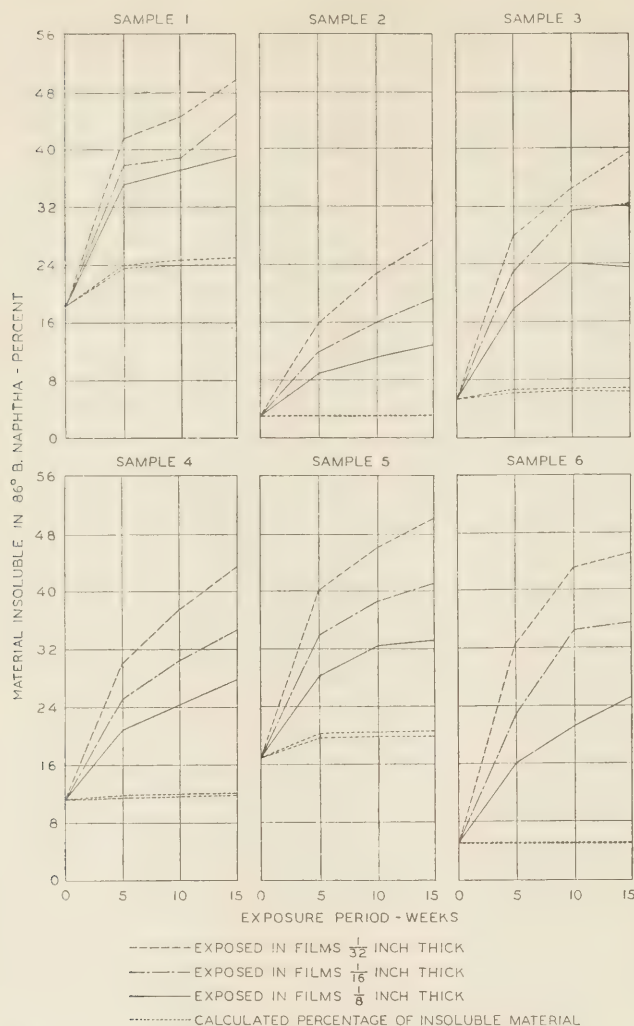
FIGURE 7.—PERCENTAGES OF MATERIAL INSOLUBLE IN 86° B. NAPHTHA IN THE RESIDUES AFTER VARIOUS PERIODS OF EXPOSURE.

The percentages of material insoluble in 86° B. naphtha in the residues after exposure are plotted in figure 7. As the volatile constituents of the liquid asphalts evaporated, the material insoluble in naphtha was concentrated in the residues. Assuming no change except that resulting from loss of volatile matter, the theoretical percentages of material insoluble in naphtha that should be present in the different residues are shown in figure 7. Only in the case of samples 1 and 5 was there an appreciable theoretical increase in insoluble material caused solely by loss of volatile matter and the resulting concentration.

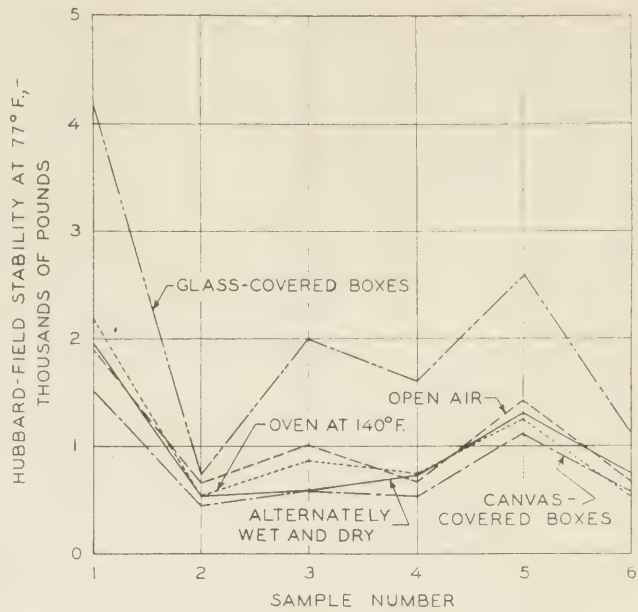
FIGURE 8.—FINAL STABILITIES OF HUBBARD-FIELD CYLINDERS AFTER VARIOUS METHODS OF AGING. ALL CYLINDERS TESTED AFTER AGING FOR 20 WEEKS EXCEPT THOSE AGED IN OVEN WHICH WERE TESTED AFTER 5 WEEKS.

The final stabilities under each method of aging, plotted in figure 8, show that aging in the glass-covered exposure boxes gave the highest stability, and aging in the canvas-covered boxes generally gave the lowest stability. The stabilities obtained by aging in the oven at 140° F. for 5 weeks, by aging in the open air for 20 weeks, and by aging under alternately wet and dry conditions for 20 weeks, were all about the same except in the case of sample 3. The stabilities of the specimens of sample 3, exposed alternately wet and dry, were as low as those of the specimens exposed under canvas covers.

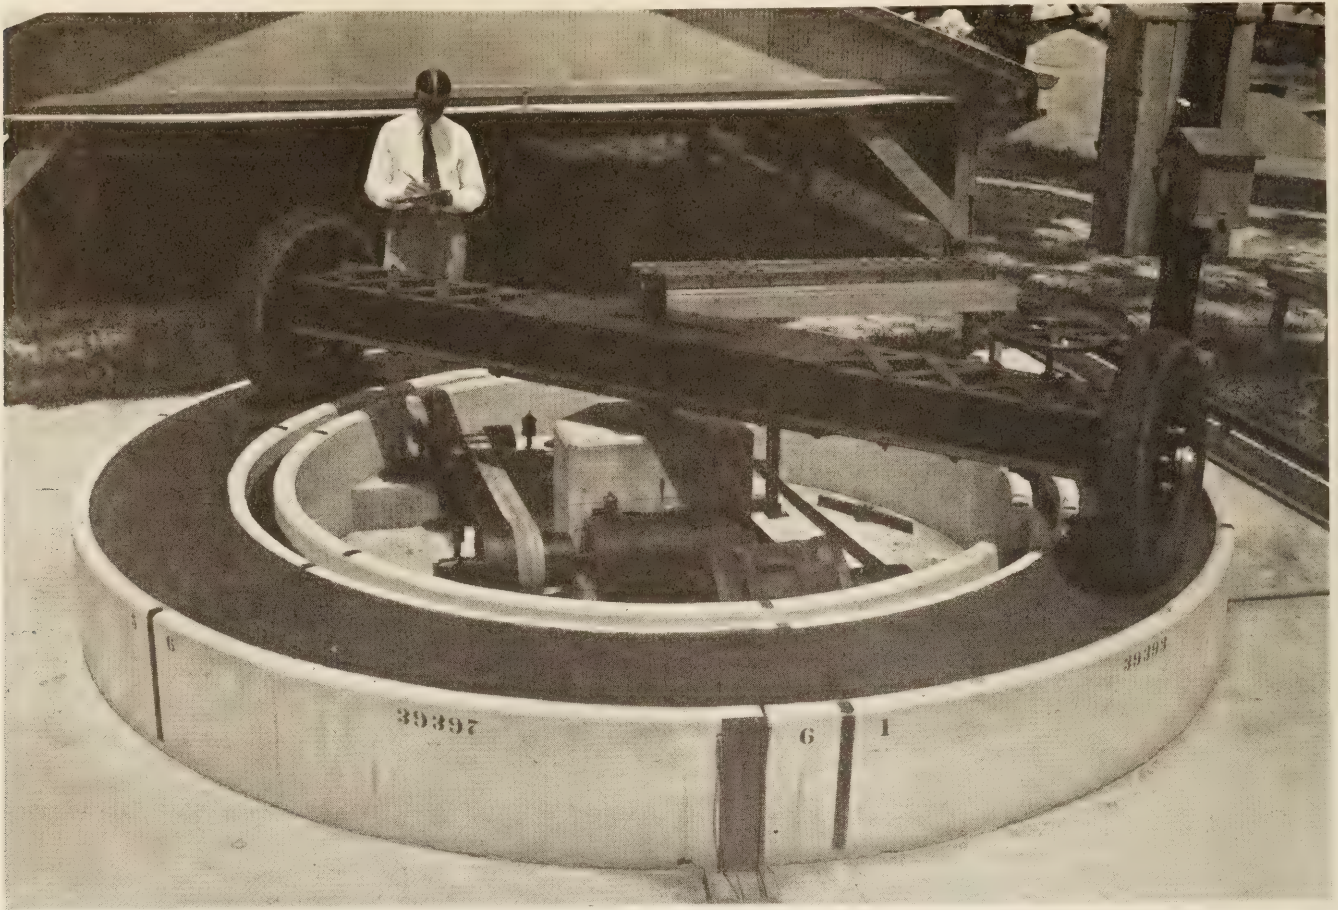
FIGURE 9.—OUTDOOR CIRCULAR TRACK USED IN THE WEATHERING TESTS.

4. The greater portions of these prepared mixtures were placed as wearing surfaces on a small circular track and subjected to weather conditions and con-

trolled traffic of rubber-tired wheels. The behavior of the surfaces was noted and the different sections were cored from time to time to determine the changes in stability of the mixtures.

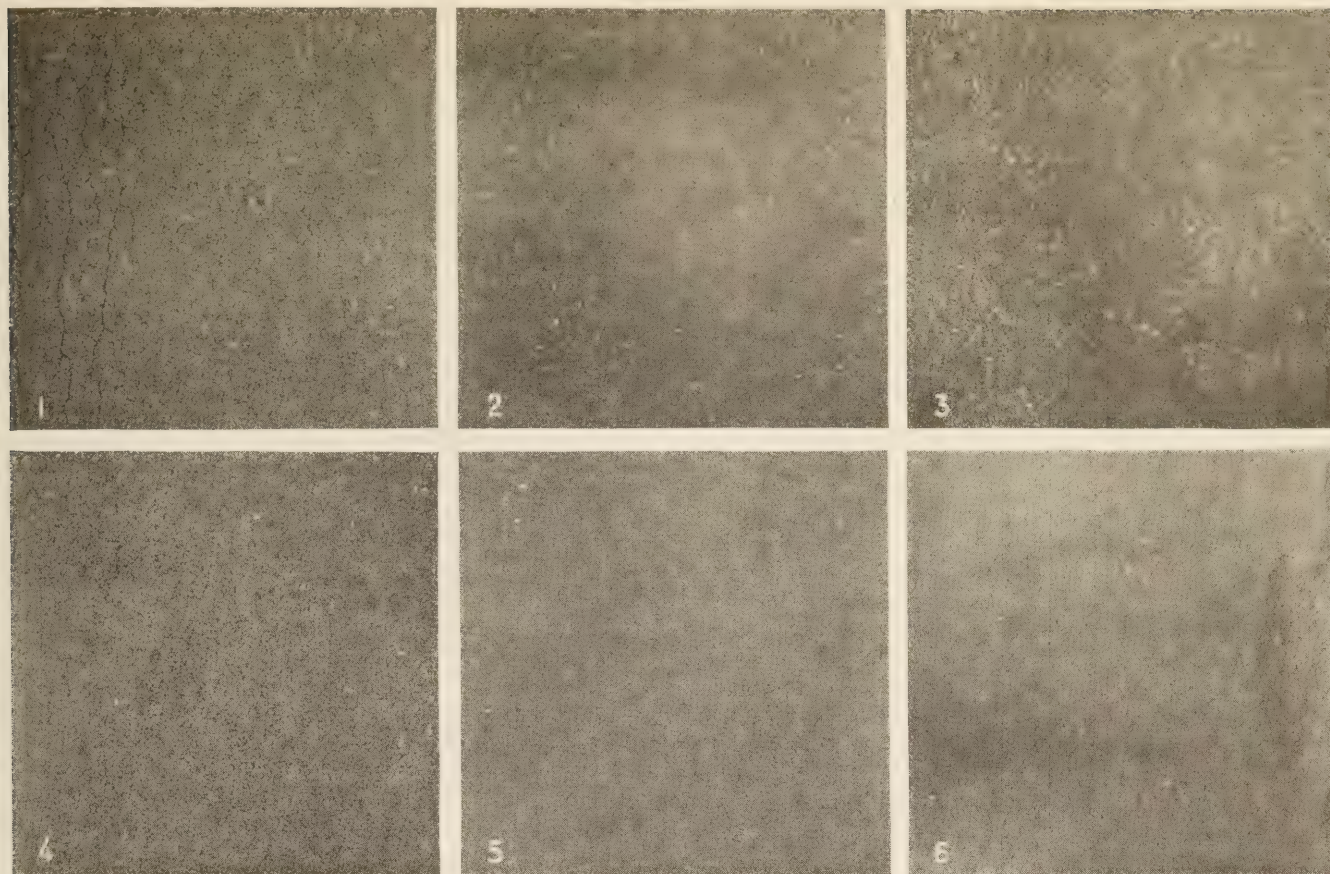
FIGURE 10.—APPEARANCES OF THE TRACK SECTIONS AFTER THE APPLICATION OF 70,000 WHEEL-PASSAGES OF TRAFFIC.

Since the surfaces had become fairly well bonded, the shed that had been used to protect the track at night and on rainy days was removed on the first of July for the balance of the test. No noticeable changes occurred in the appearance of the surfaces from week to week and on September 27, 1935, after 70,000 wheel-passages, the appearance and condition of the surfaces were good, as shown in figure 10.

Section 1: Gray, hard, and well-bonded, with open alligator cracks; soft and yielding underneath.

Section 2: Black and pliable with a thin, easily broken surface skin having very indistinct cracks; soft and yielding underneath; asphalt seeped through the hard cracks slightly under traffic.

Section 3: Grayish black, well-bonded and fairly tough with slight alligator cracks; soft and yielding underneath.

Section 4: Grayish black, firm and well-bonded with almost indistinguishable hair cracks; firm underneath.

Section 5: Grayish black, firm and well-bonded with indistinct hair cracks; a black hairline of asphalt along each crack showed a tendency to heal by seepage and hardening of the asphalt.

Section 6: Black and greasy; firm with no cracks but not well cemented; surface raveled if broken slightly; firm underneath.

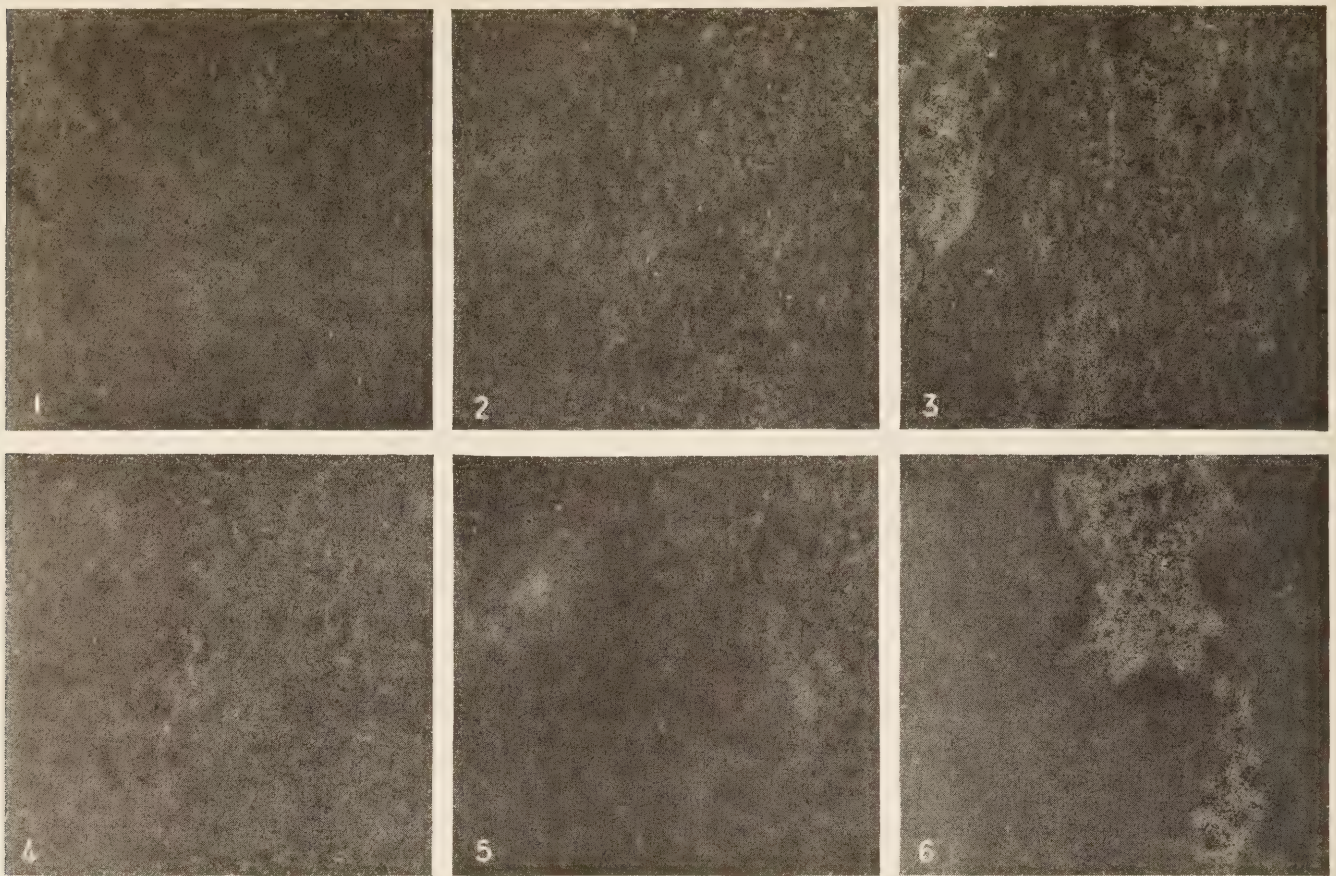
FIGURE 11.—APPEARANCES OF TRACK SECTIONS AT END OF TEST.

No changes were noted in the condition of the sections until the third application of traffic on the wet track when sections 2 and 6 began to ravel, section 2 raveling the most. This raveling diminished considerably the following day when the track was dry. The asphaltic material seemed to have been stripped from the sand particles on the surface. Section 3 started to ravel on the fourth application of traffic on the wet track, although the sand displaced from the surface of section 3 appeared to carry more oil than that thrown off the surfaces of sections 2 and 6. Sections 1, 2, 3, and 6, under continued traffic, tended to shove and push over the curb. This behavior was least pronounced on section 1. After the fourth application of traffic on the alternately wet and dry track, sections 2 and 6 had both raveled so extensively that the test was discontinued although sections 4 and 5 had still shown no tendency to displace or ravel. Tests showed that all of the sections were still impermeable to water. The appearance of the surface of each section is shown in figure 11.
