Public Roads

A JOURNAL OF HIGHWAY RESEARCH

Continuous longitudinal bar reinforcing steel in Indiana experimental concrete pavement

Vol. 26, No. 1 April 1950

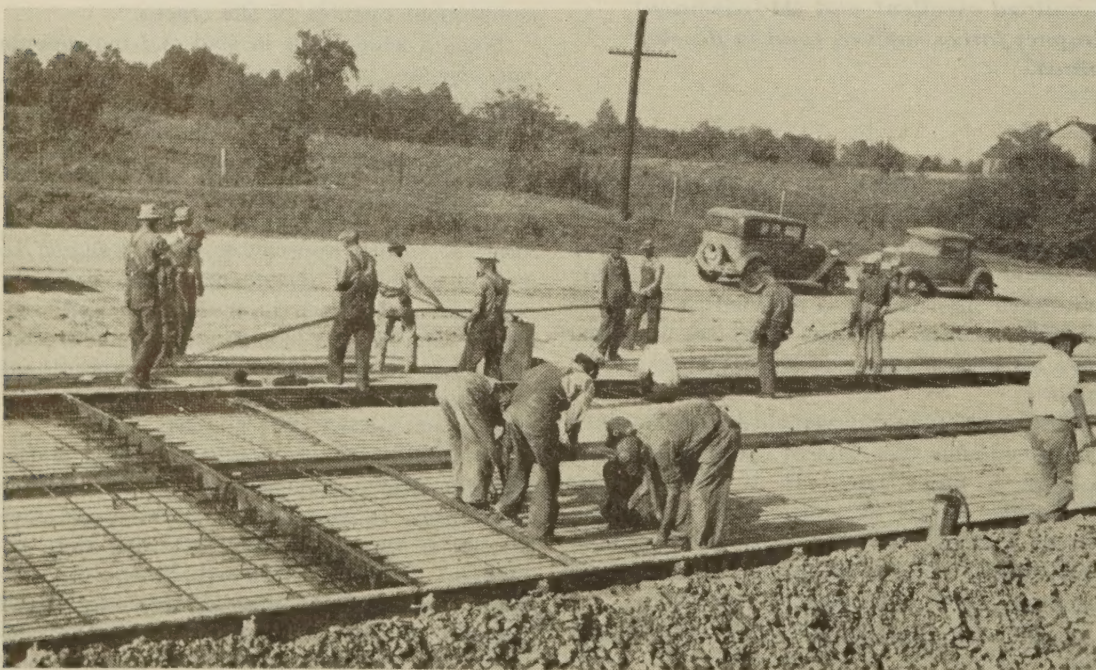
Installing one-fourth inch diameter longitudinal bar reinforcing steel.

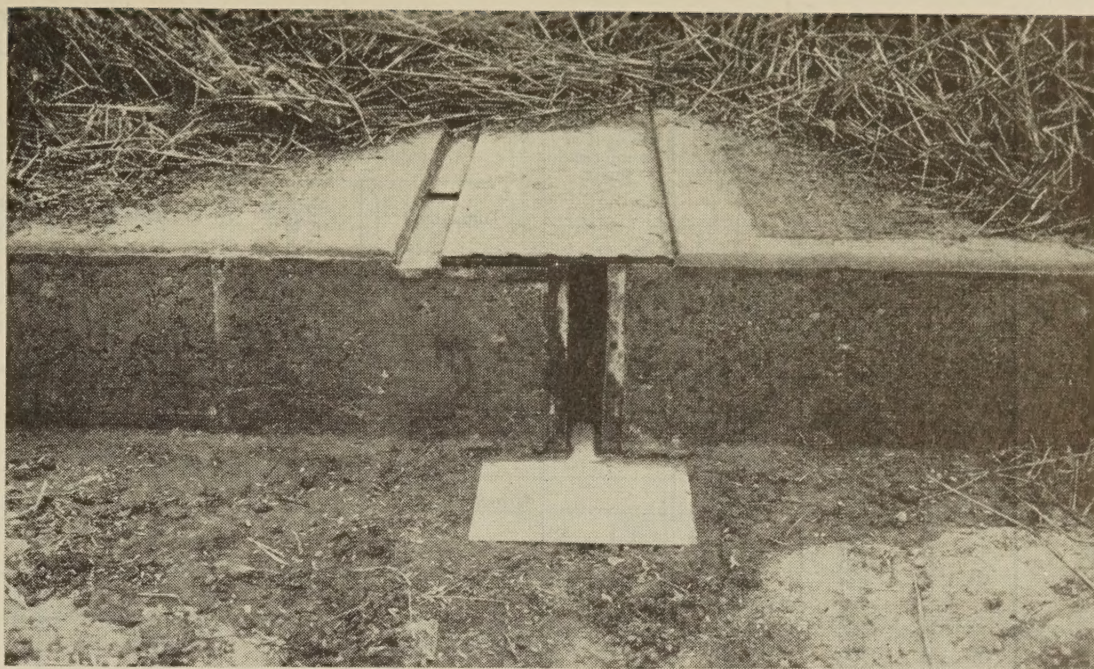
The bridge-type joint.

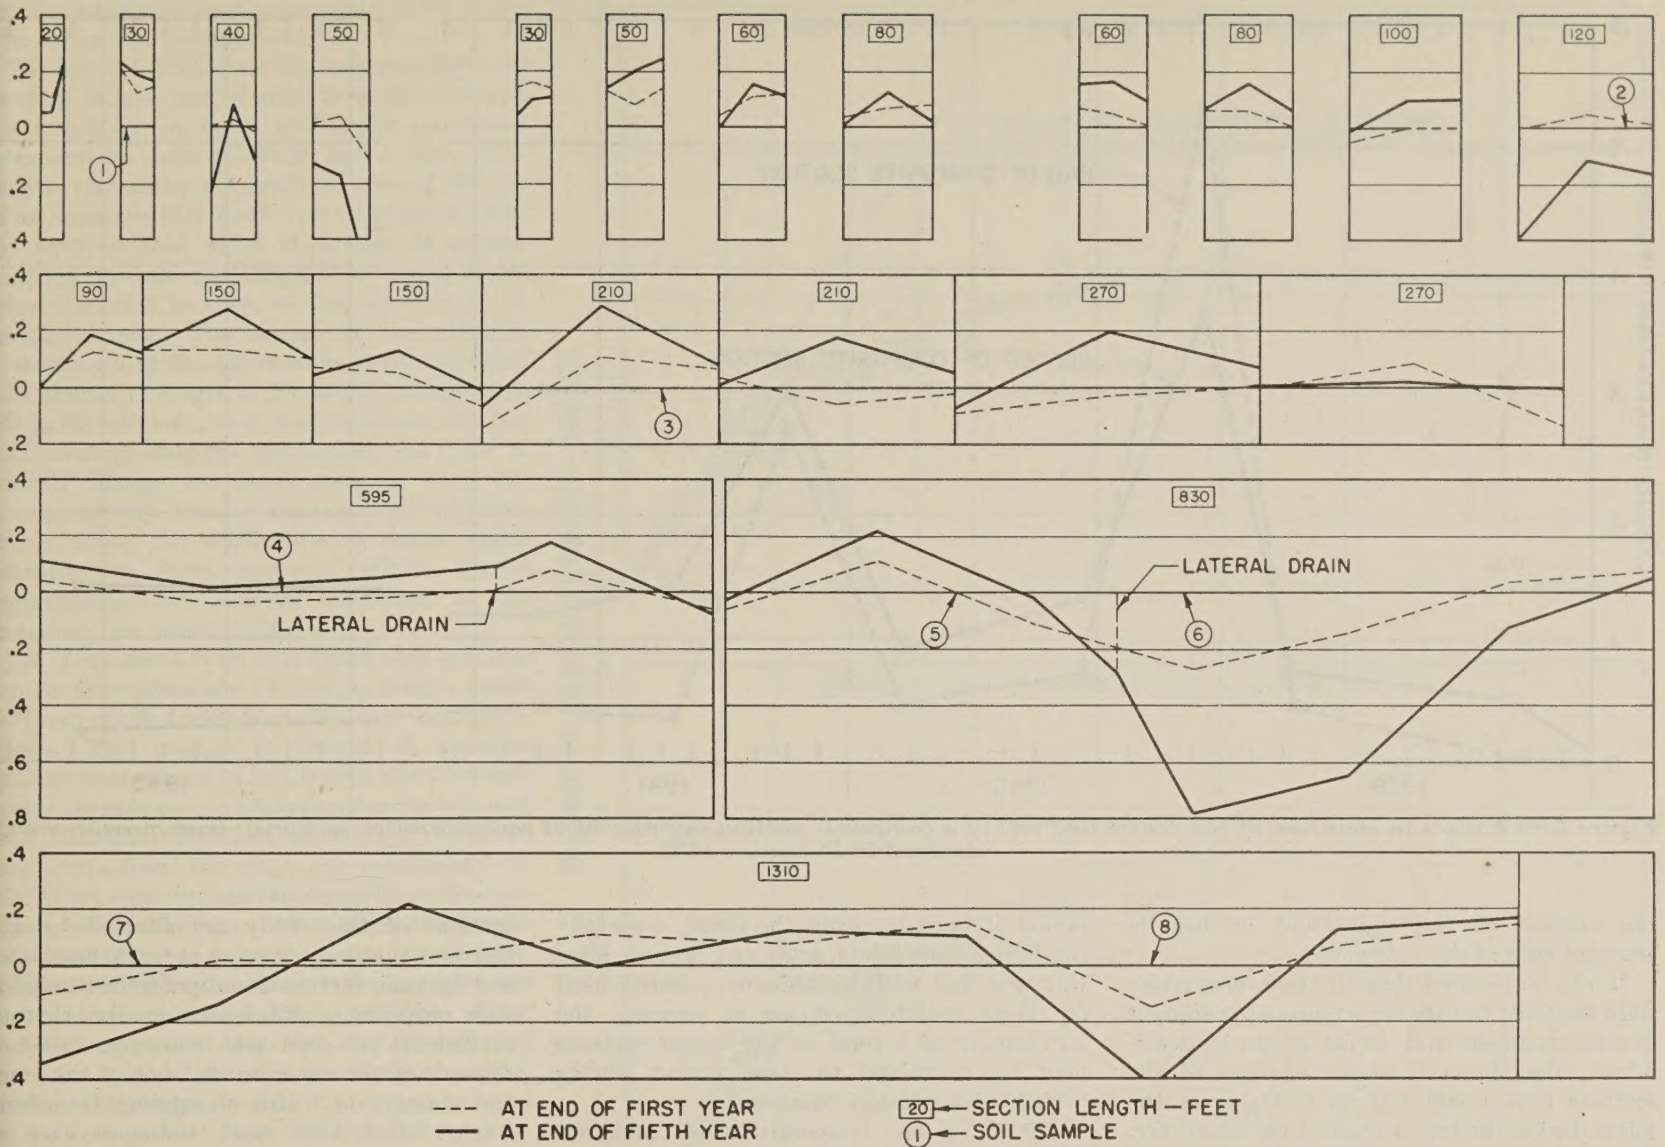
The elevation changes in figure 1 are those observed on selected sections in the fall at the end of the first and fifth years of pavement life, using as a base the elevations established shortly after construction. Subgrade soil data applicable at the time the pavement was placed are also given in this figure.

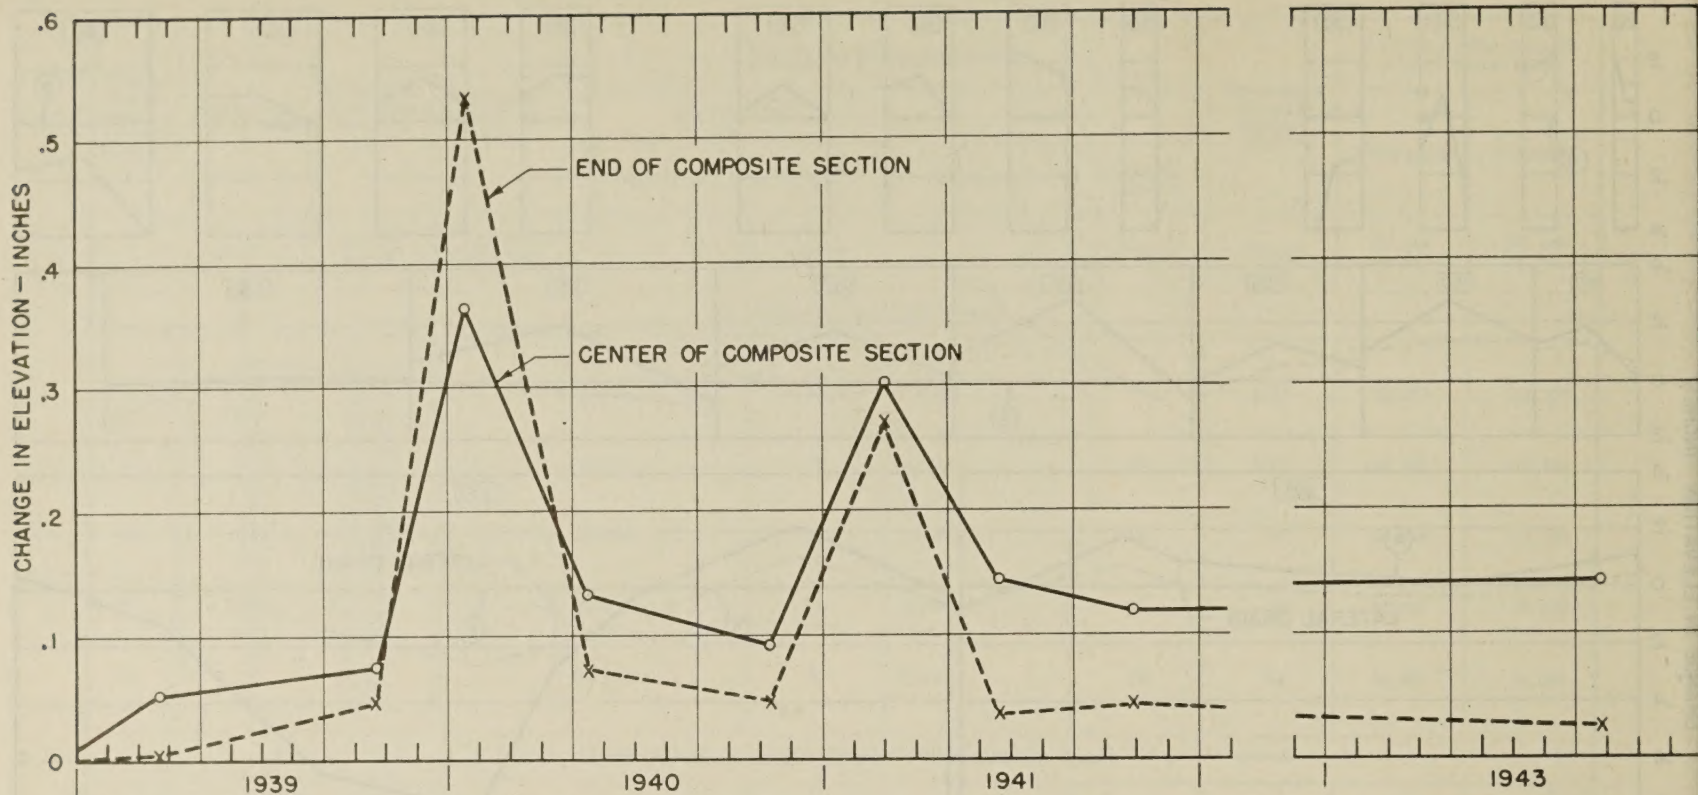
Figure 2.—Changes in elevation of the center and end of a composite section (average of 24 representative sections); base measurements obtained in December 1938.

the end, suggesting a permanent downward warping at the end of the composite section with respect to its center. It is believed that soil displacement resulting from pumping or consolidation of the subgrade at the joints may be primarily responsible for this condition of distortion.

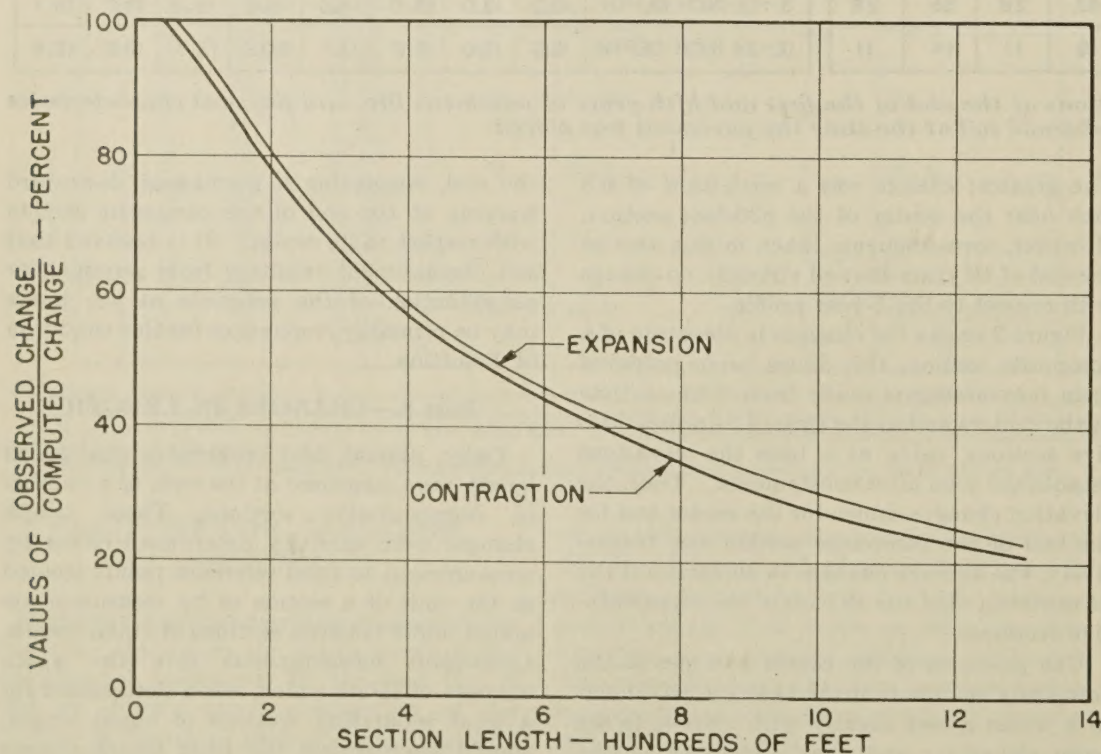
Figure 3.—Observed daily changes in section lengths expressed as percentages of the computed changes in length of equivalent unrestrained sections.

figure 7 in the same manner that figure 3 was obtained from figure 4. The curves of figure 8 show not only the magnitude of the restraint that was present in the various sections, but also that the sections expanded more freely

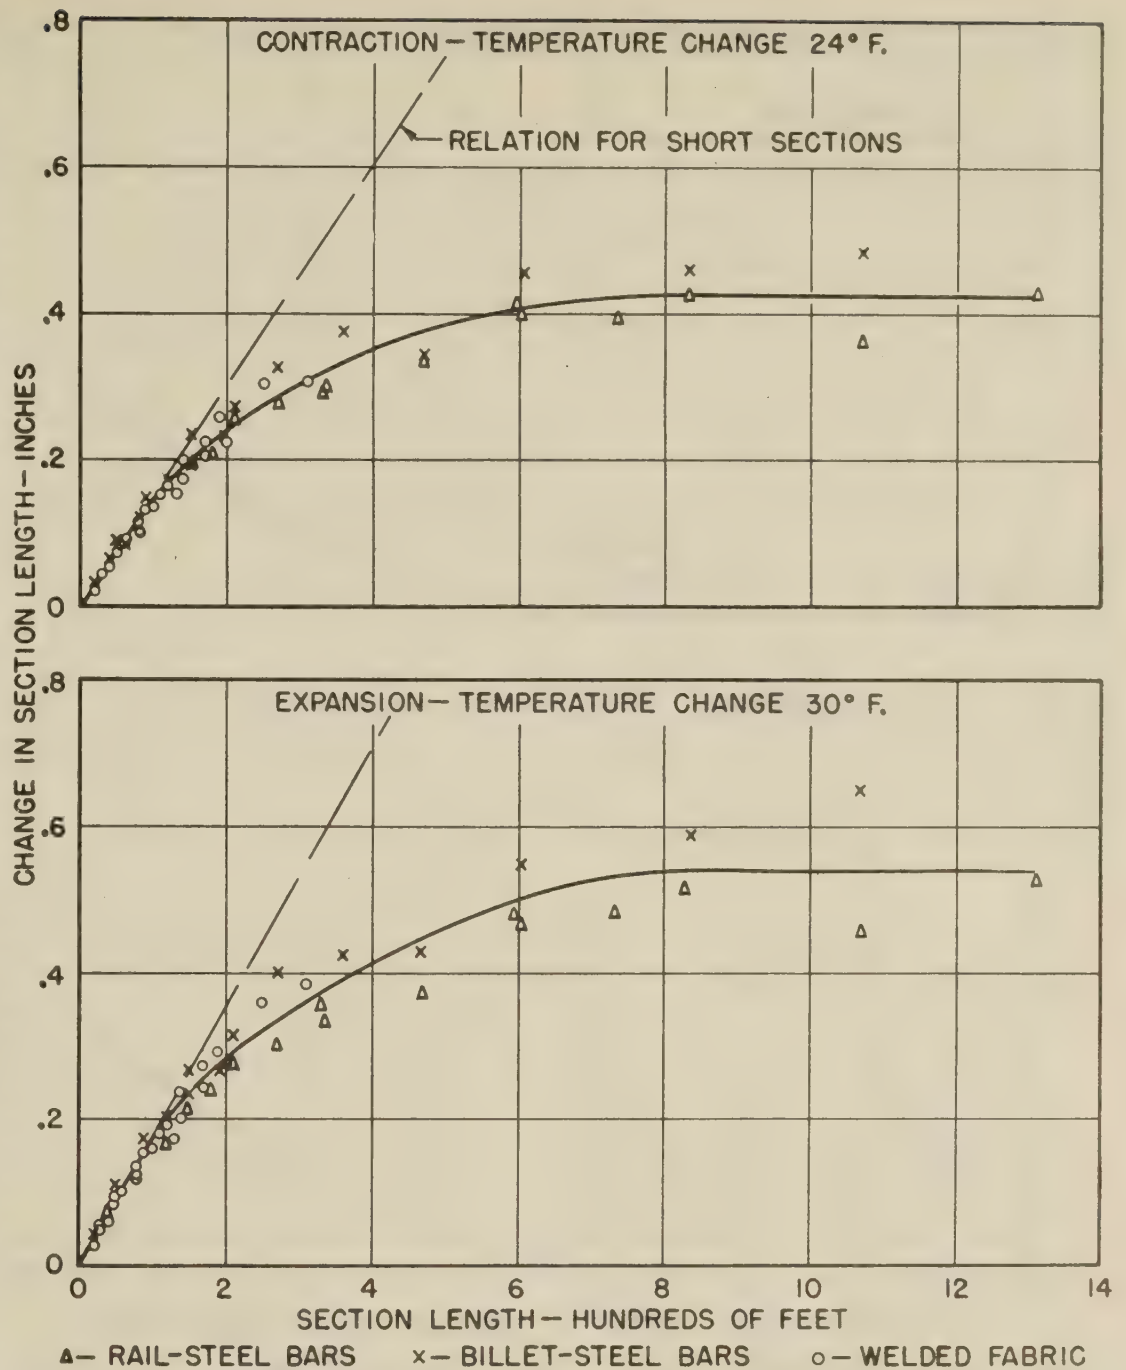
Figure 4.—Relation between section length and daily change in length.

the movement at the ends of the 1,310-foot section was about 20 percent and that at the quarter-points about 1 percent of the movement which would be found in an unrestrained section of the same length. Corresponding values for expansion were about 20 and 2 percent. It will be noted that between 500 and 550 feet of the central portion of the 1,310-foot section did not move during the daily cycle, this length being comparable to the 500±-foot length that was estimated from the results of figure 4.

The type of reinforcement used in the various sections is denoted by symbol. There appears to be some tendency for sections containing billet-steel bars to develop slightly greater annual length changes than equivalent-length sections reinforced with rail-steel bars. This same tendency was noted in the daily expansion and contraction data of figure 4. The cause for this difference is not known.

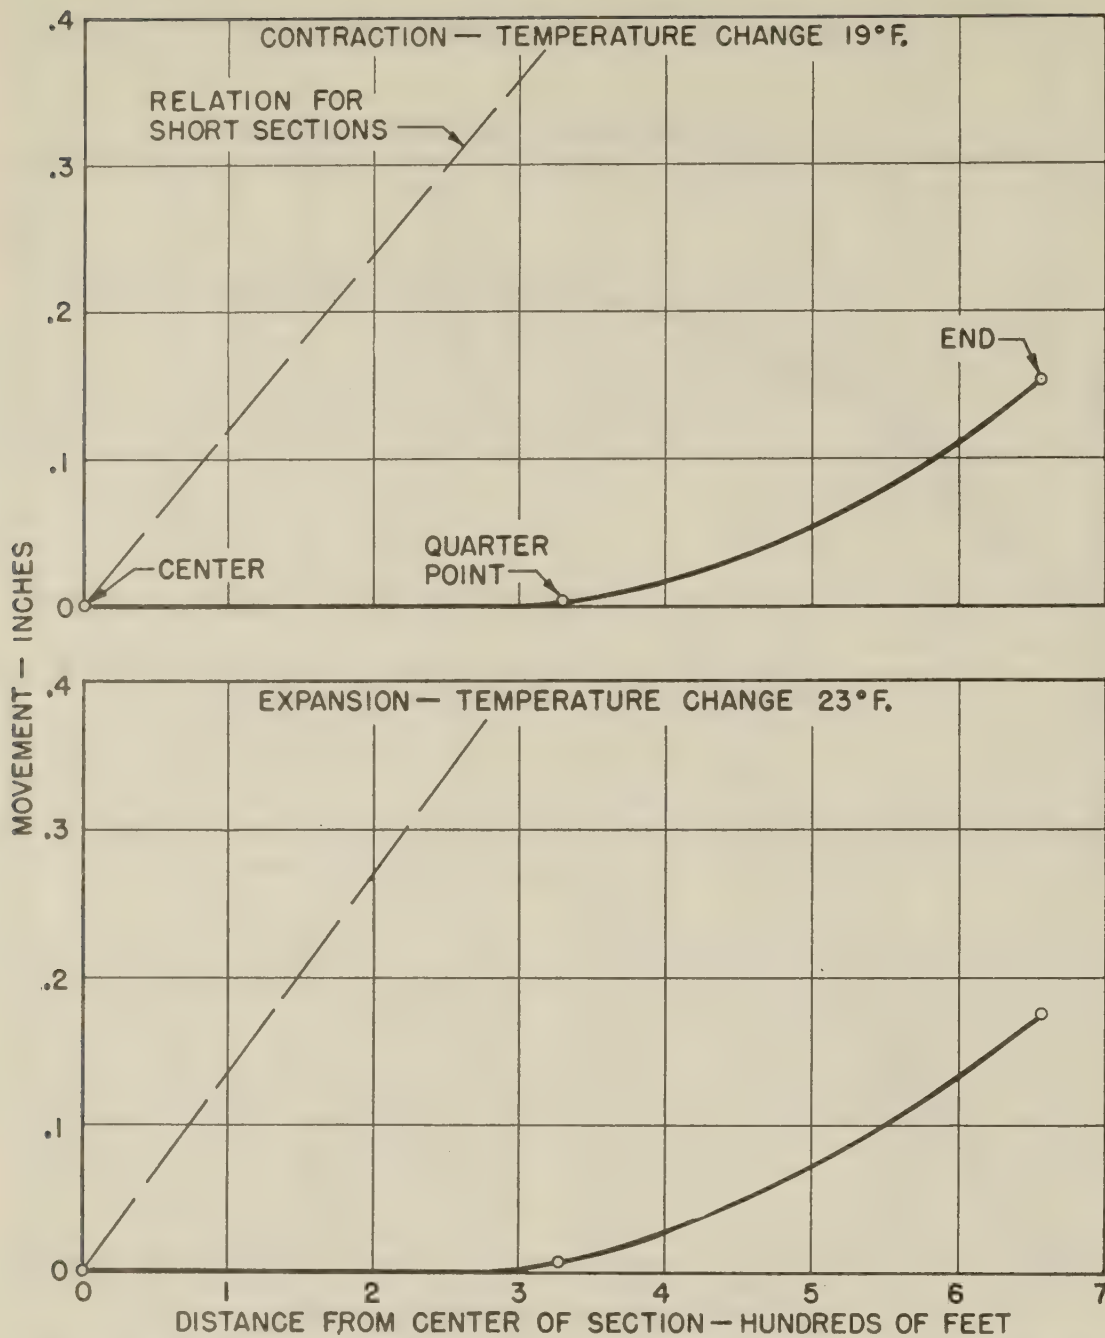
Figure 5.—Daily movement at the center, quarter point, and end of a 1,310-foot section.

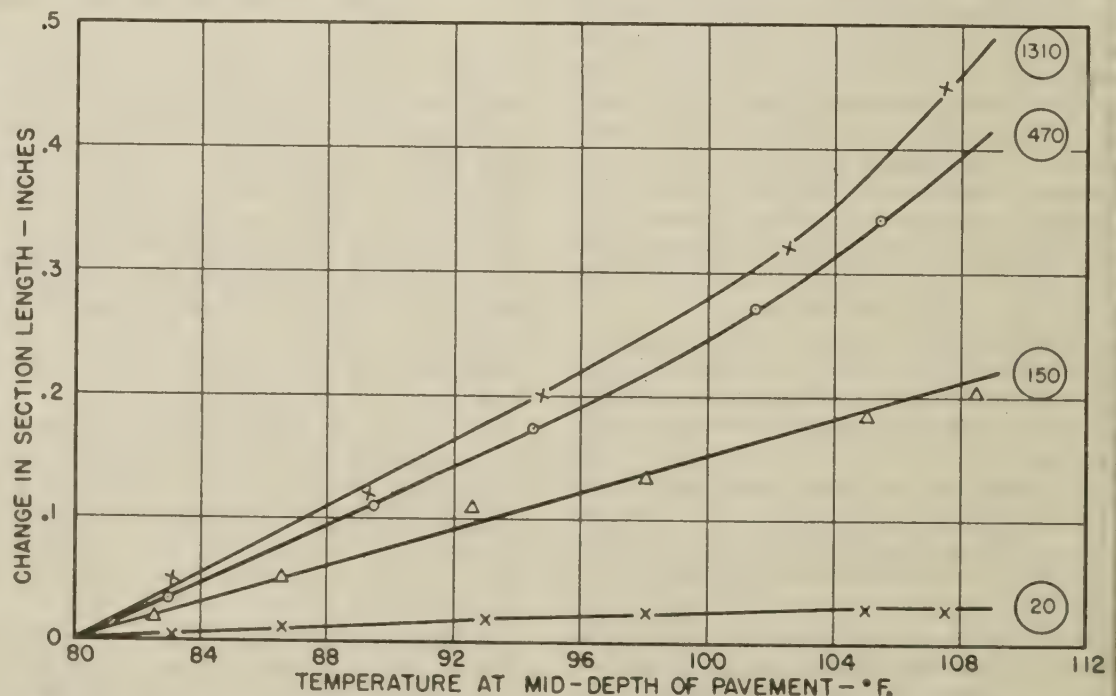
Figure 6.—Effect of a daily rise of the mean pavement temperature on the change in length of several sections (figures in circles indicate the length of sections in feet).

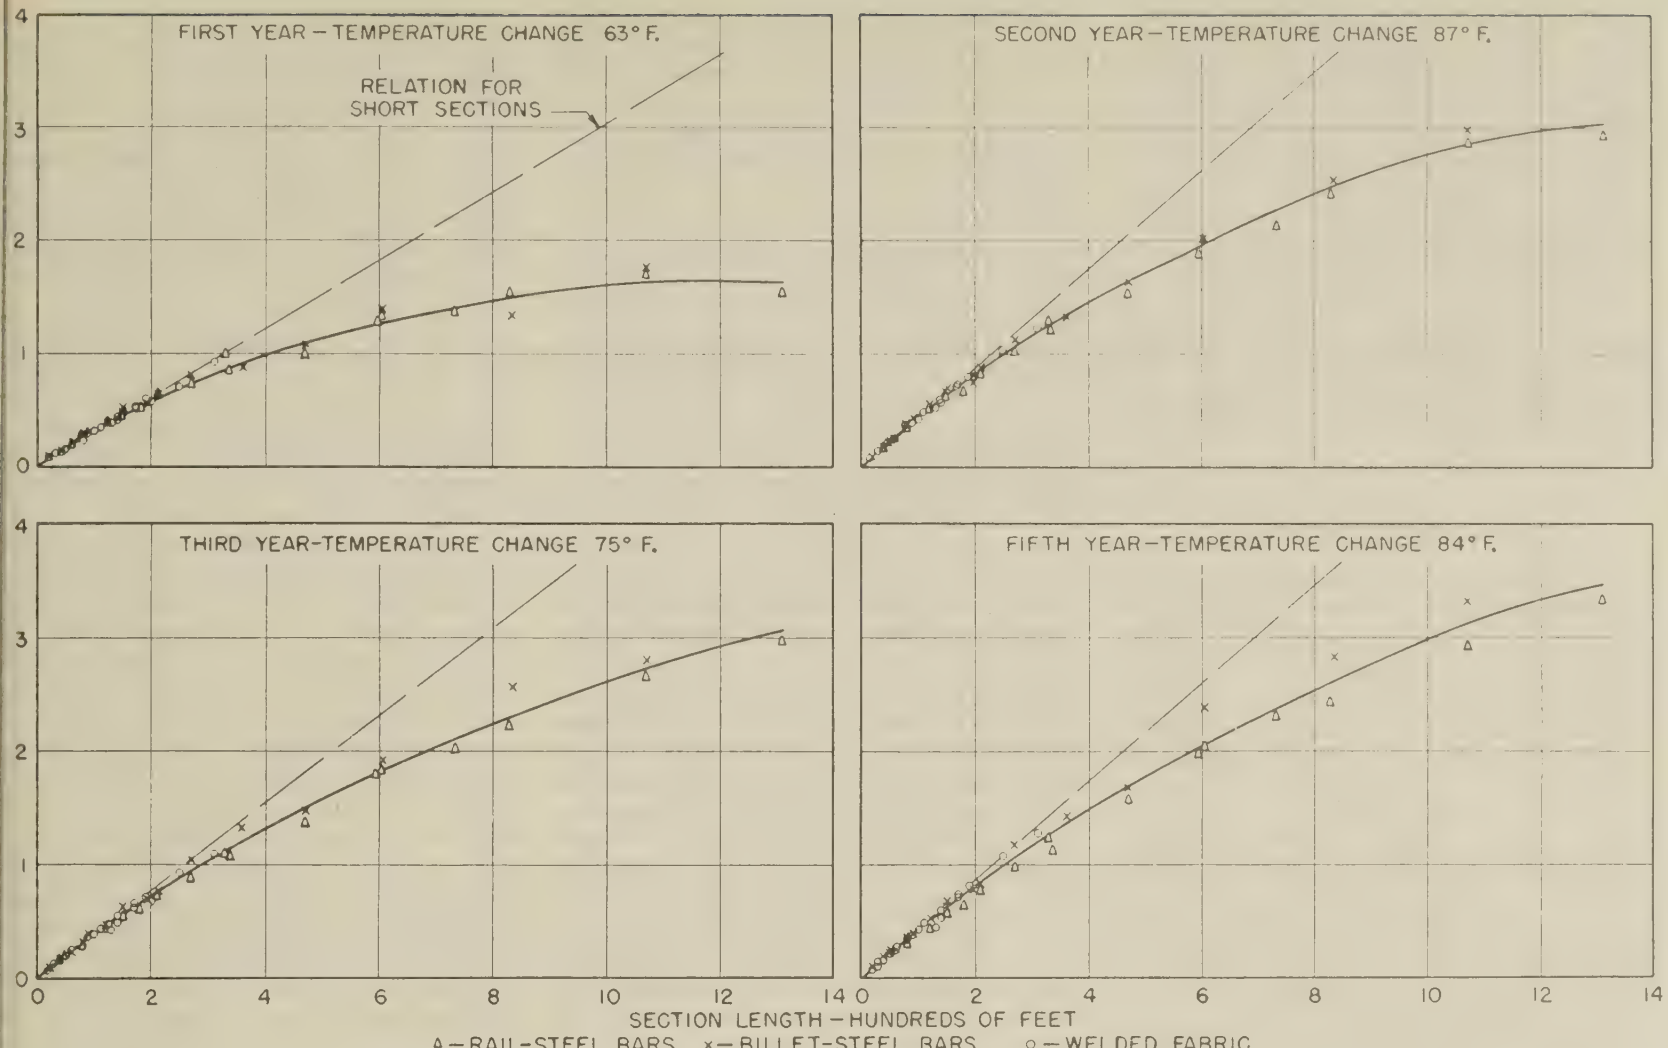
Figure 7.—Relation between section length and annual change in length.

It is indicated by the four curves of figure 7 that sections up to approximately 150 feet in length move with as much freedom during an annual cycle as do the very short sections. The length changes of sections greater than 50 feet are restrained by the subgrade, however, and this restraint increases progressively with increase in section length. The data of figure 4 indicated that daily restraint to free movement was first noticeable in sections about 75 feet long. It should be remembered that the annual length change data considered above include the effects of one daily cycle also. A probable explanation for the observed difference, just mentioned, is that, under the slowly developed temperature rise from winter to summer, sections up to at least 150 feet in length moved freely because they encountered less restraint from the subgrade than obtains during the more rapid daily cycle of length change. Hence, the small amount of daily restraint to free movement of sections between 75 and 150 feet in length, as shown in figure 4, while present is not apparent in the curves of figure 7.

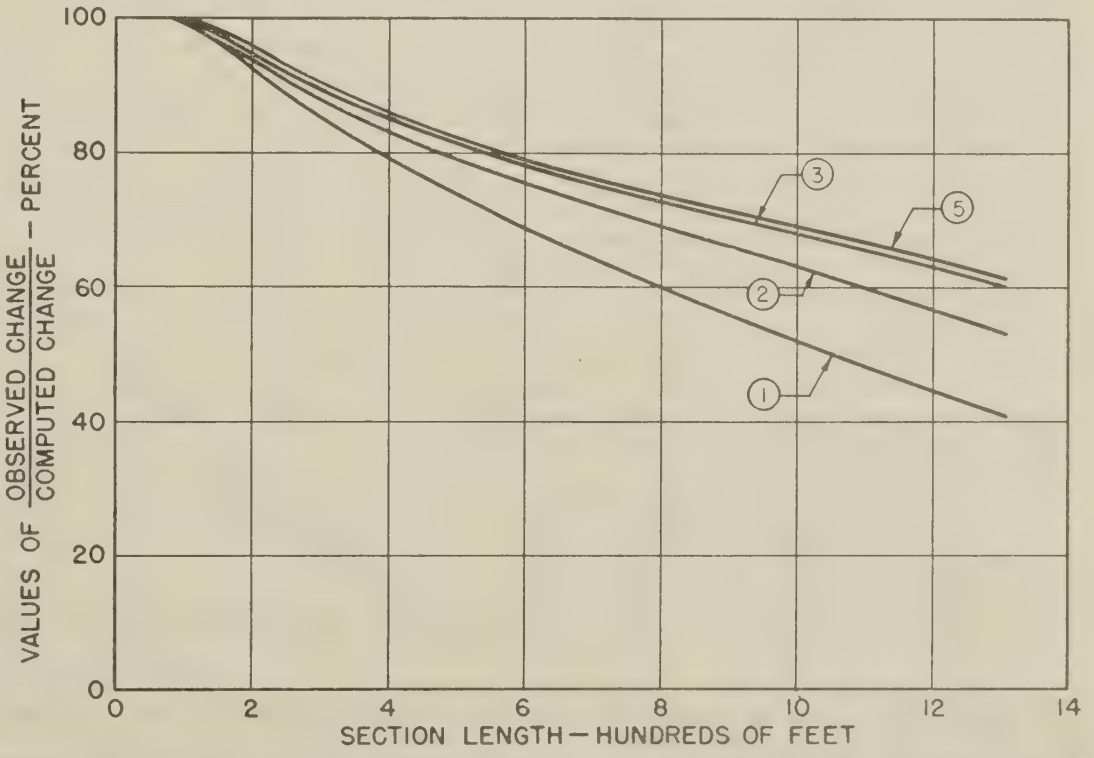
Figure 8.—Observed annual changes in section lengths expressed as percentages of the computed changes in length of equivalent unrestrained sections (figures in circles indicate age of pavement at time of observations).

progressively for each of the first three annual cycles. Thus, it appears that the sections encountered less subgrade resistance with each successive annual expansion period until, by the end of the third period, a condition of essential stability was reached.

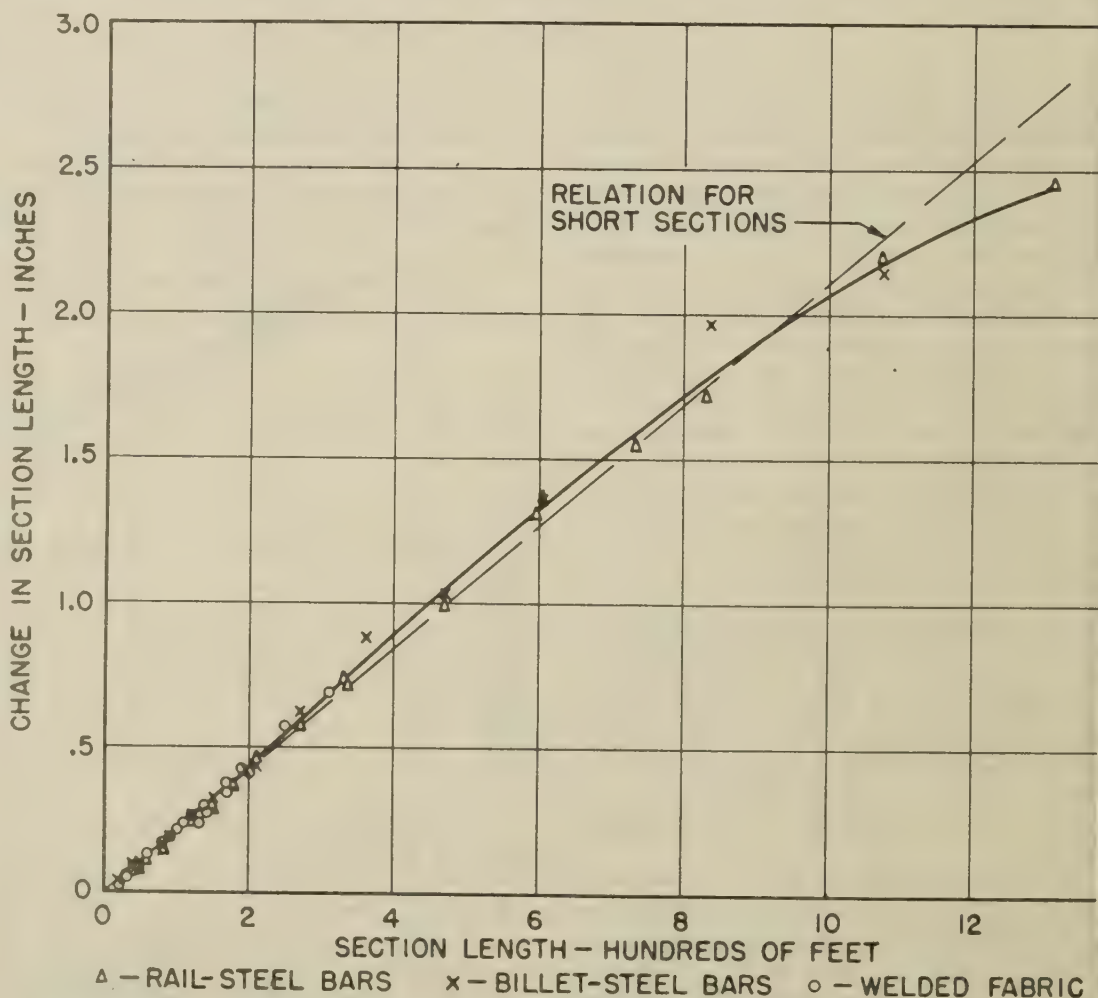
Figure 9.—Relation between section length and change in length from the morning of winter day to the morning of a summer day of the same year (mean pavement temperature change of 45° F.).

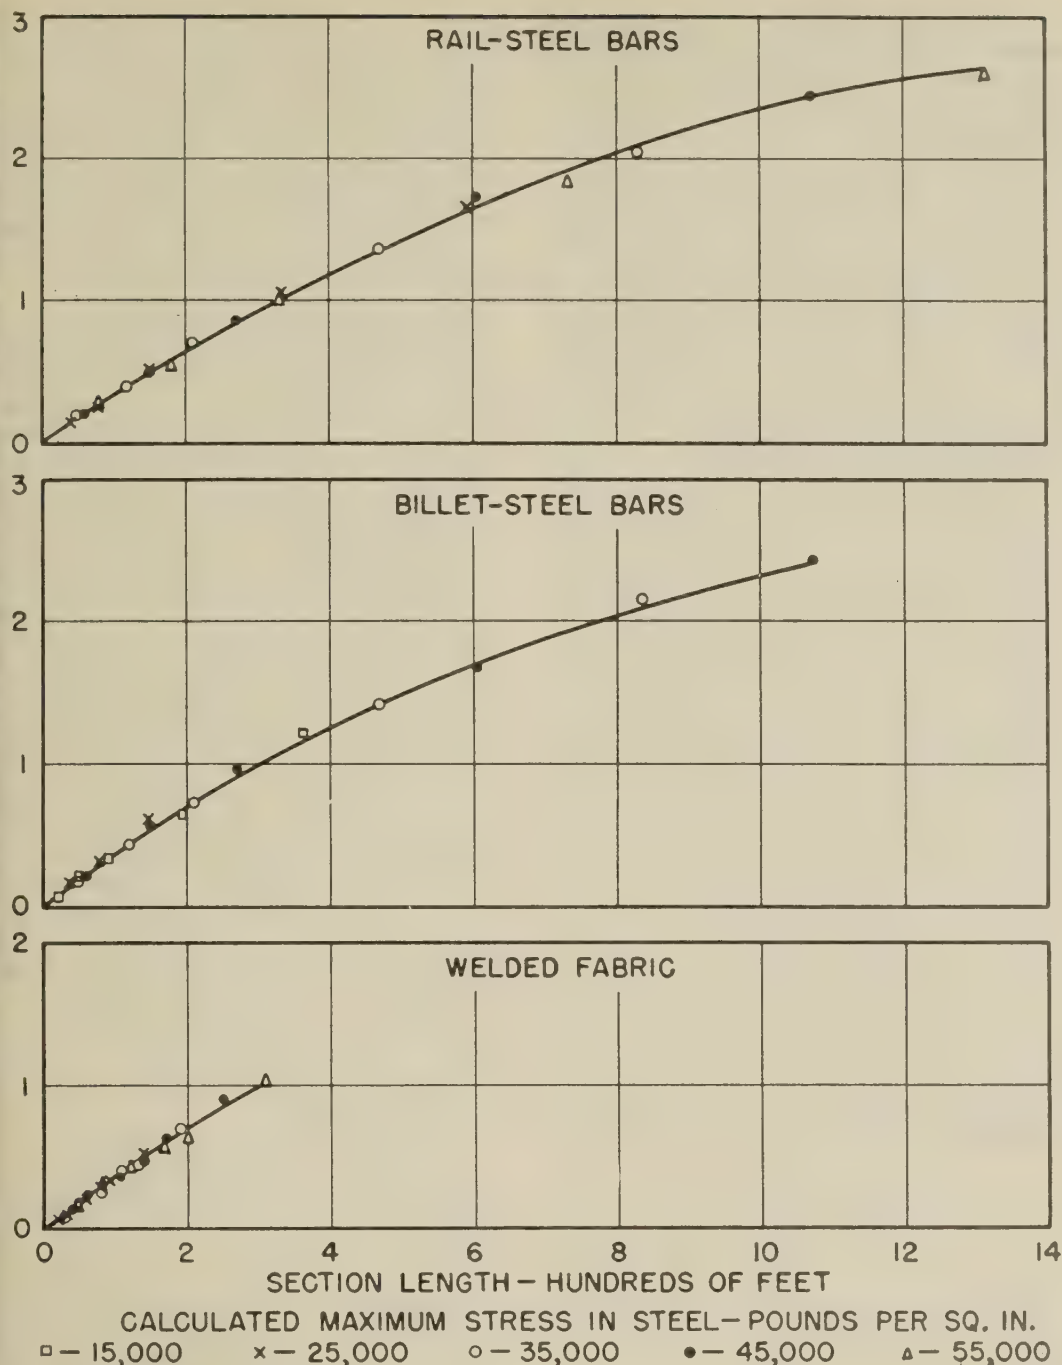
Figure 10.—Effect of type of reinforcement and calculated maximum steel stress on the relation between section length and annual contraction (77° F. temperature drop).

A comparison of the three curves of figure 10 indicates that, for a contraction period, the type of reinforcement had little influence on the observed length changes of the sections. For example, in the case of a 300-foot section the measured length changes for the rail-steel bars, the billet-steel bars, and the welded fabric were 0.92, 0.98, and 1.00 inch respectively.

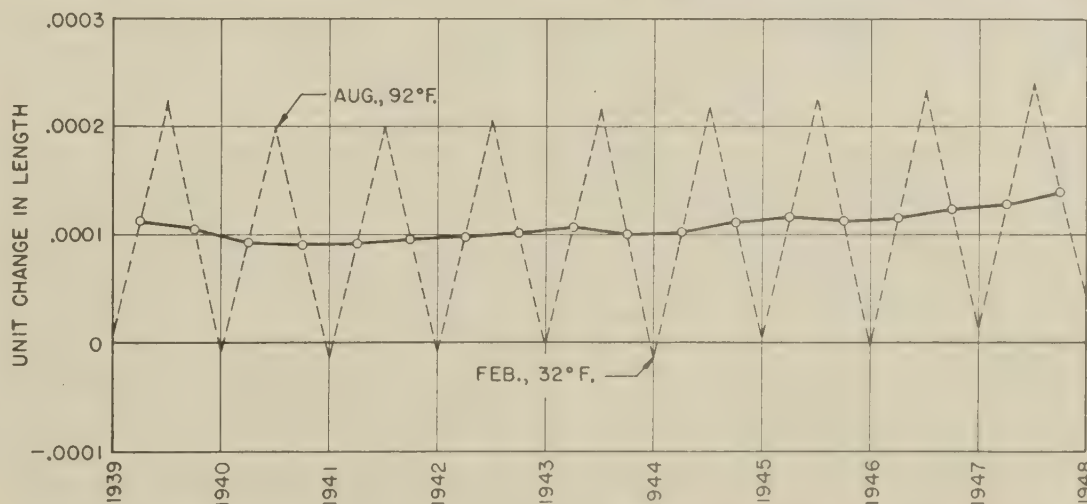
Figure 11.—Annual cycles of length change and progressive growth of short, uncracked sections expressed as unit changes in length.

points of the cyclic variations of figure 11 indicates a progressive permanent growth or increase in the length of the sections, this growth being more pronounced after the fifth year of pavement life. In fact, the growth was so small during the early life of the pavement that in the 5-year report it was stated that "no definite indication of a permanent change in the length of the short sections was observed". Since these short sections are structurally intact there can be little doubt that a permanent increase in length is developing. This appears to be another instance of the tendency of some concretes, at least, to grow when subjected to repeated cycles of temperature and moisture change.

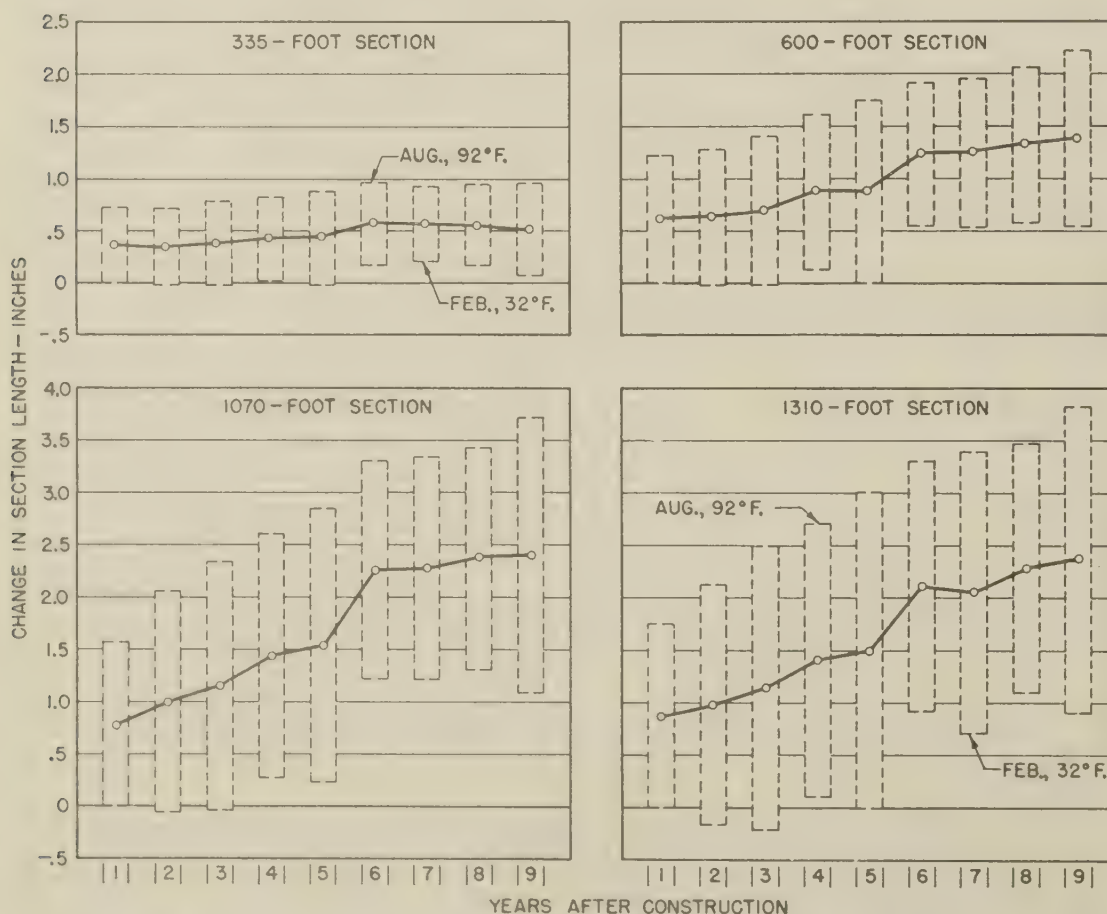
Figure 12.—Annual and progressive length changes of several of the longer sections.

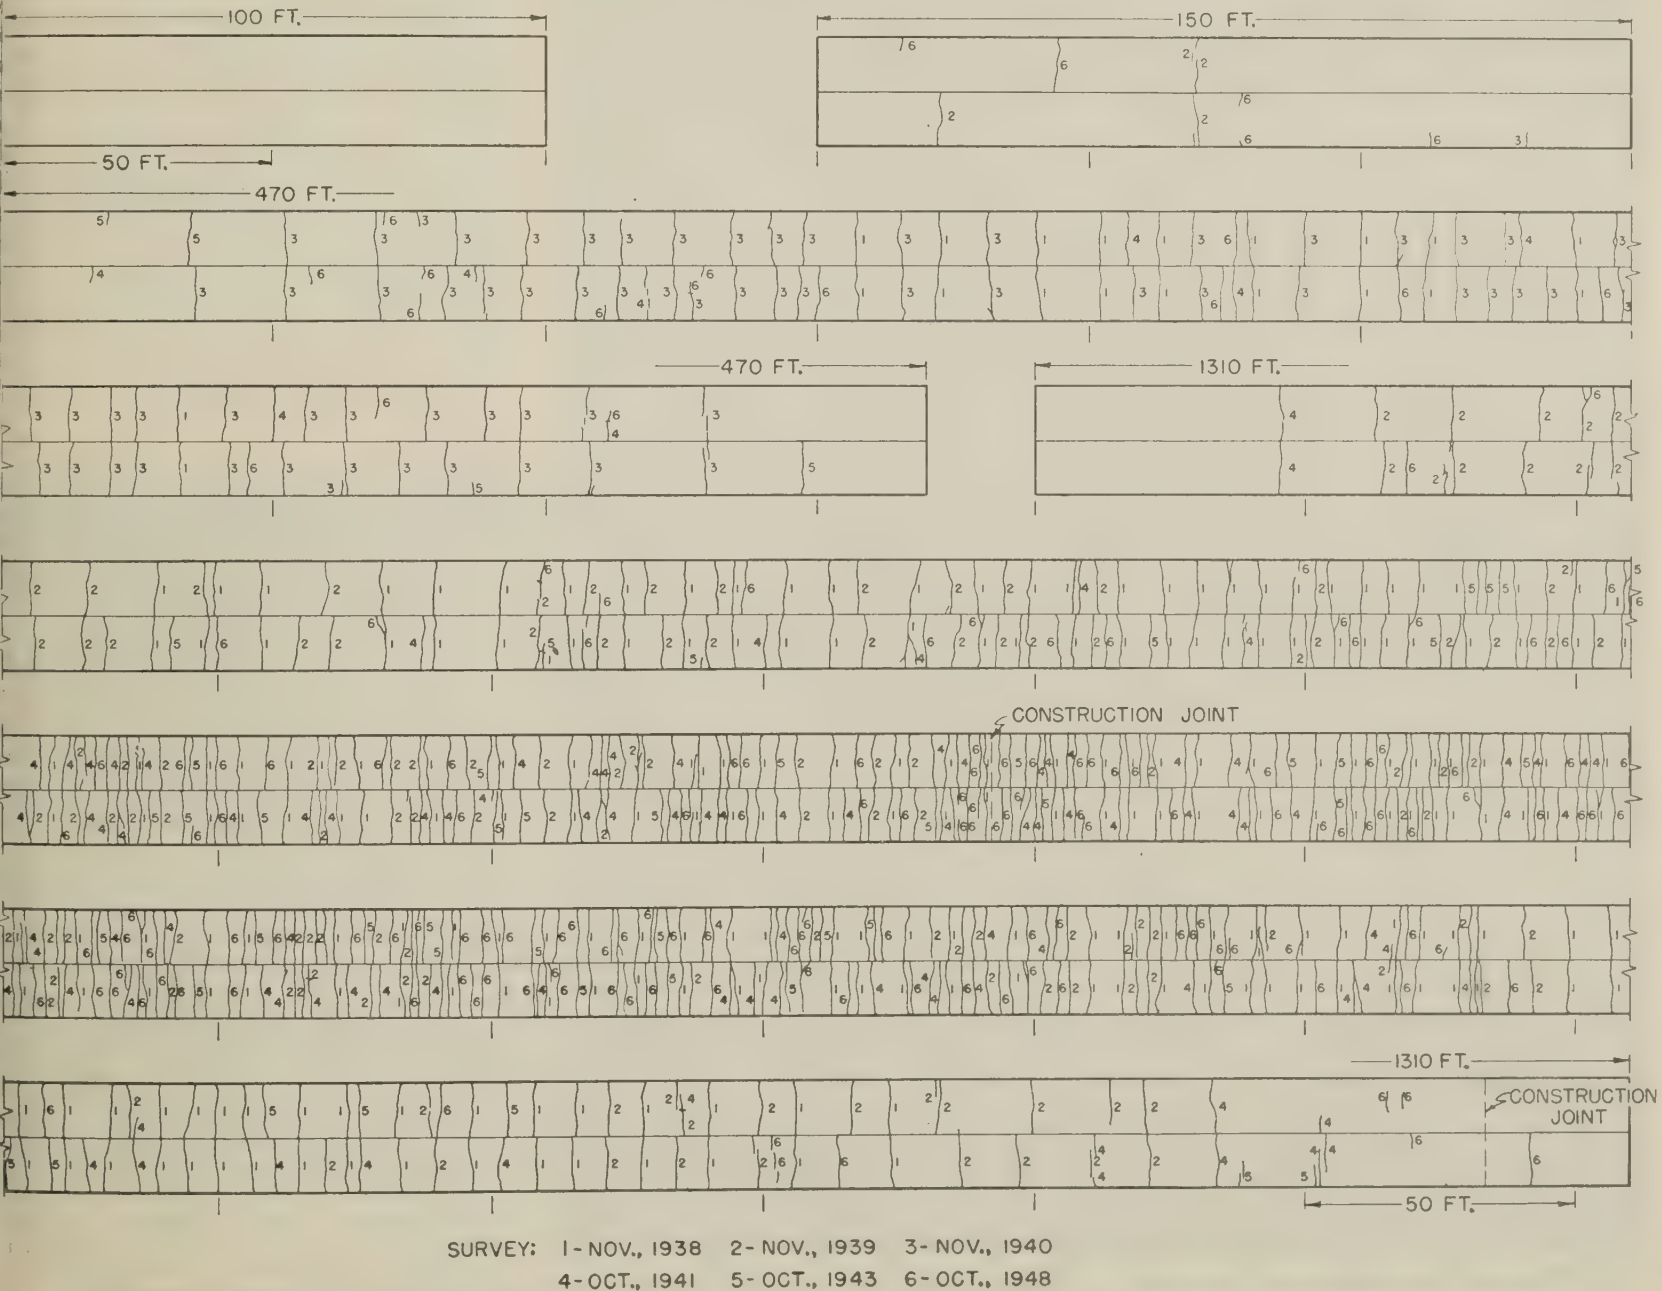
Figure 13.—Typical formation of cracks during the first 10 years of pavement life (sections placed September–October 1938).

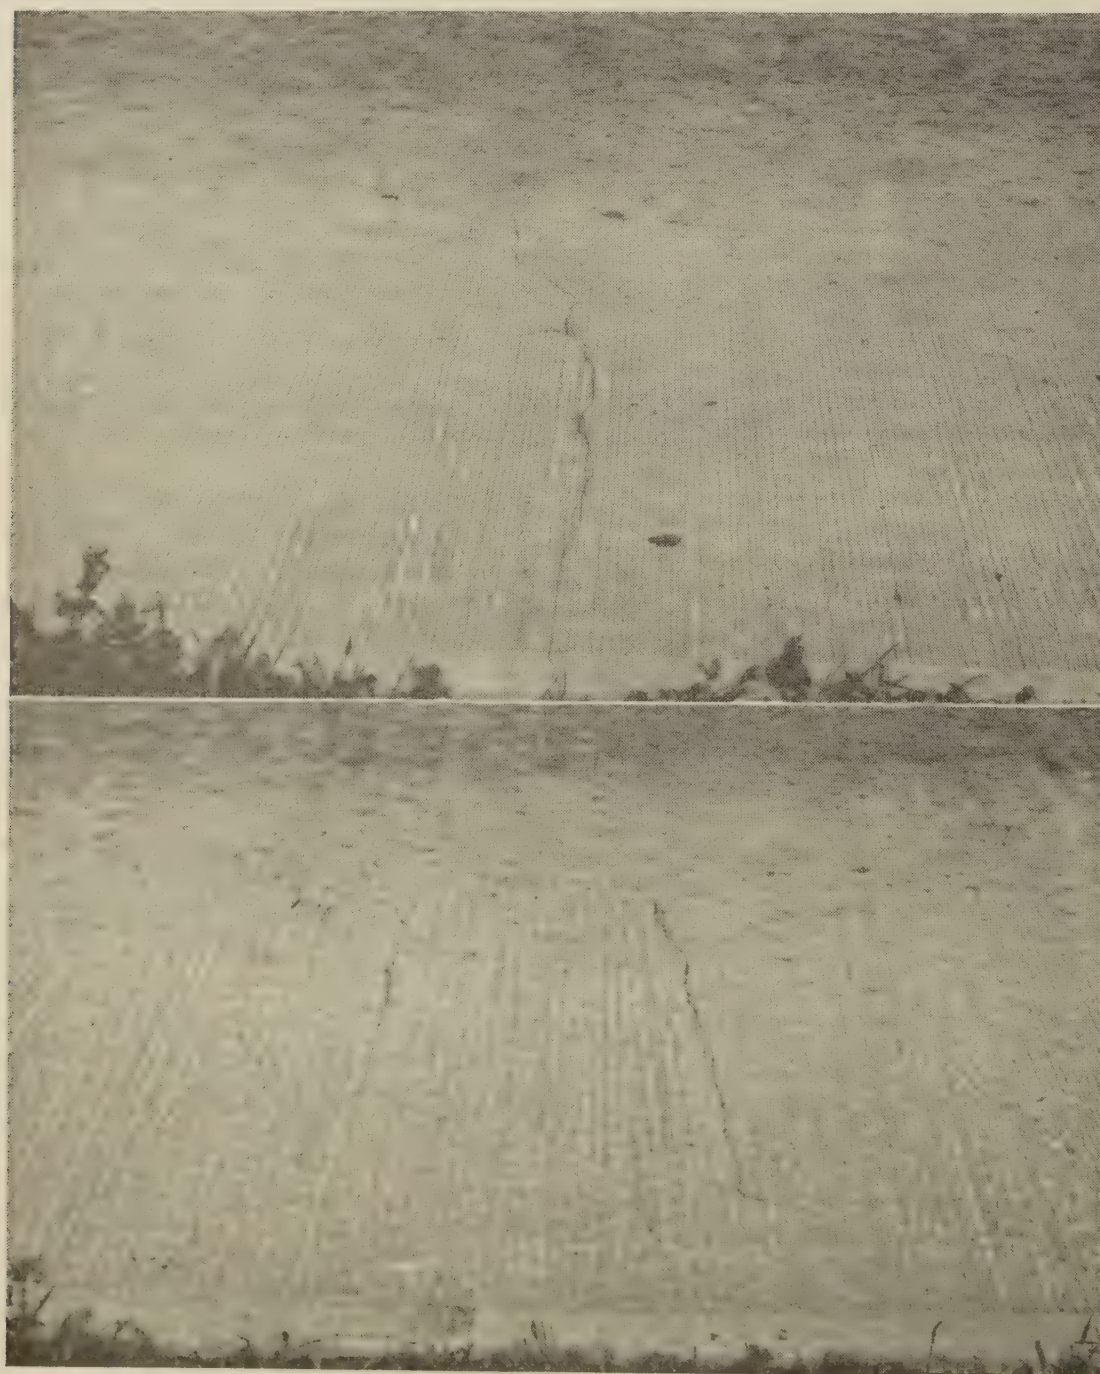
Figure 14.—Surface condition of pavement in vicinity of the widest cracks observed in the central portion of the heavily reinforced sections (heavily traveled lane after 7 years of service).

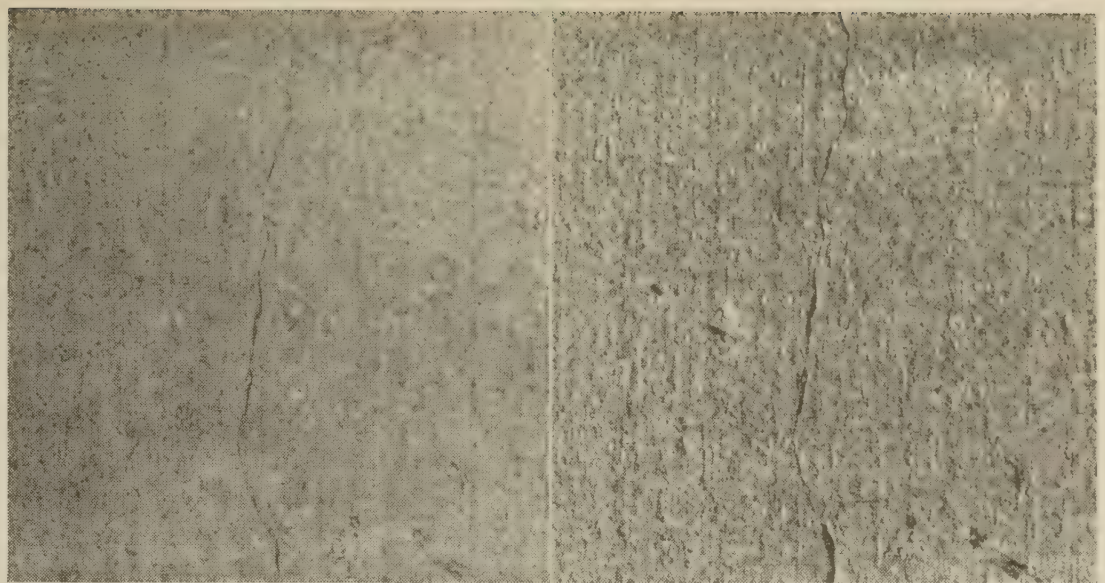
Figure 15.—Surface condition of cracks typical of those that developed at an early age in the central portion of the longest section reinforced with: (left) 1-inch diameter bars (1.82 percent steel); and (right) 1/2-inch diameter bars (0.45 percent steel). These were in the heavily traveled lane after 10 years of service.

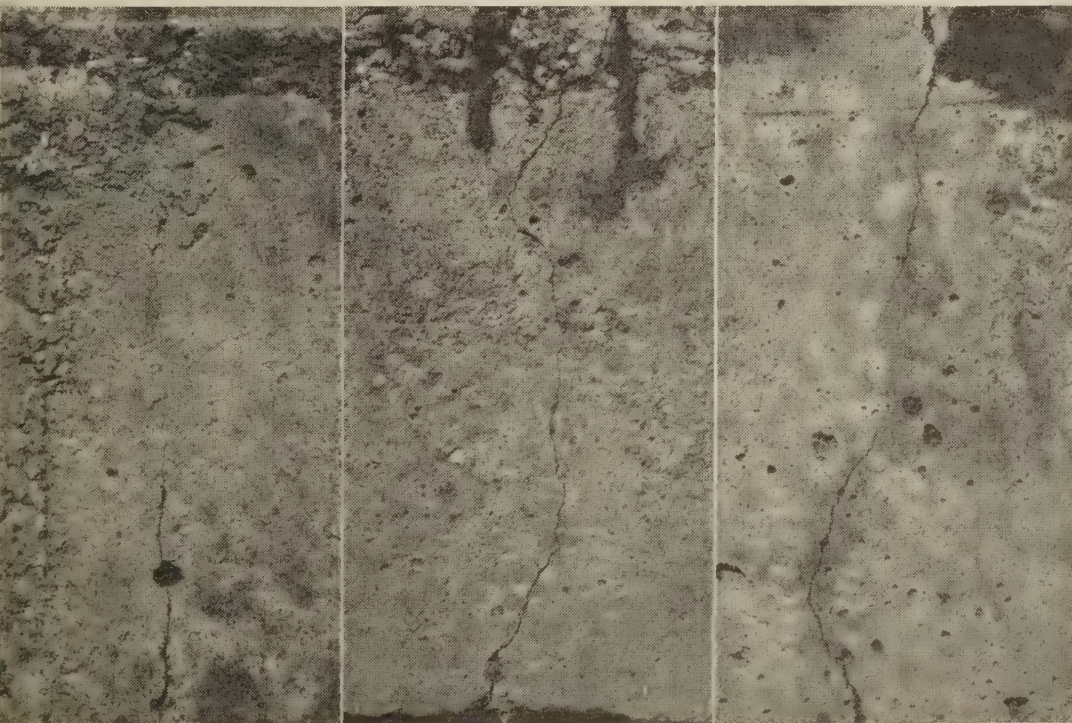
Figure 16.—Edge (vertical face) condition of cracks typical of those that developed at an early age in the central portion of the longest section reinforced with: (left) 1-inch diameter bars (1.82 percent steel); (center) 1/2-inch diameter bars (0.45 percent steel); and (right) 91-pound wire fabric (0.24 percent steel). These were in the heavily traveled lane after 10 years of service.
