Public Roads

A JOURNAL OF HIGHWAY RESEARCH

Continuous longitudinal bar reinforcing steel in Indiana experimental concrete pavement

Vol. 26, No. 1 April 1950

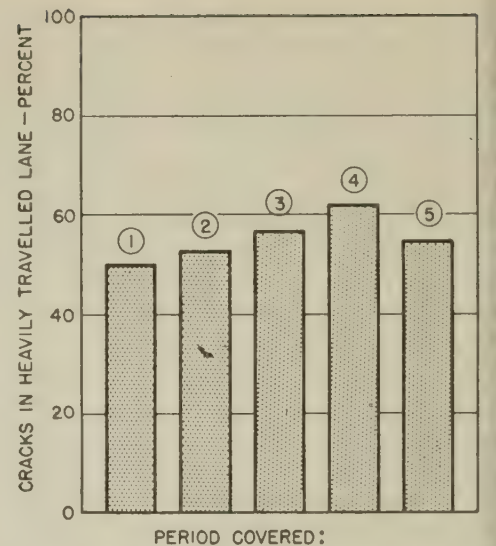
- PERIOD COVERED:
- ① SEPT.-OCT., 1938 (SECTIONS PLACED) TO NOV., 1938
 - ② NOVEMBER, 1938 TO NOVEMBER, 1939
 - ③ NOVEMBER, 1939 TO NOVEMBER, 1941
 - ④ NOVEMBER, 1941 TO OCTOBER, 1943
 - ⑤ OCTOBER, 1943 TO OCTOBER, 1948

Figure 17.—Effect of traffic on the amount of cracking.

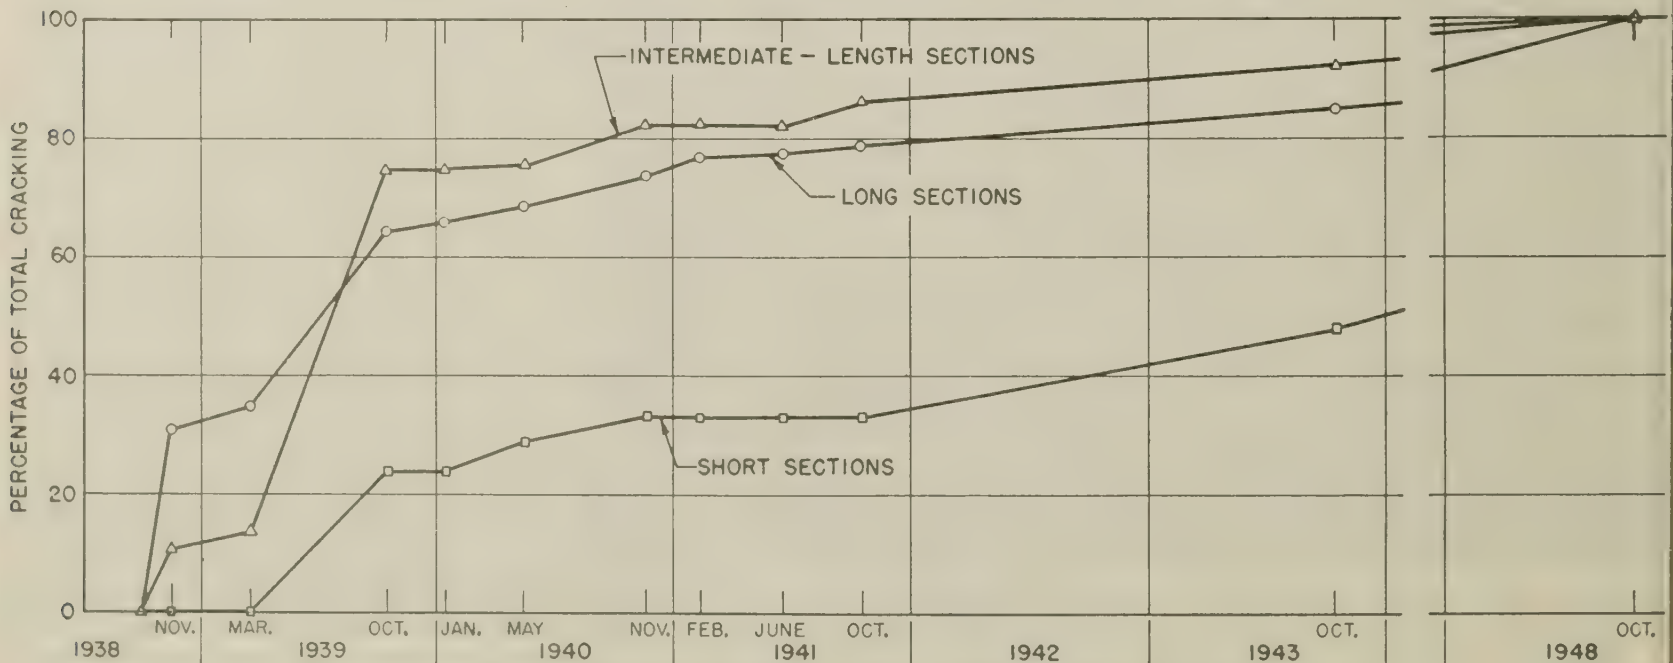
Figure 18.—Rate of crack development during the first 10 years of pavement life.

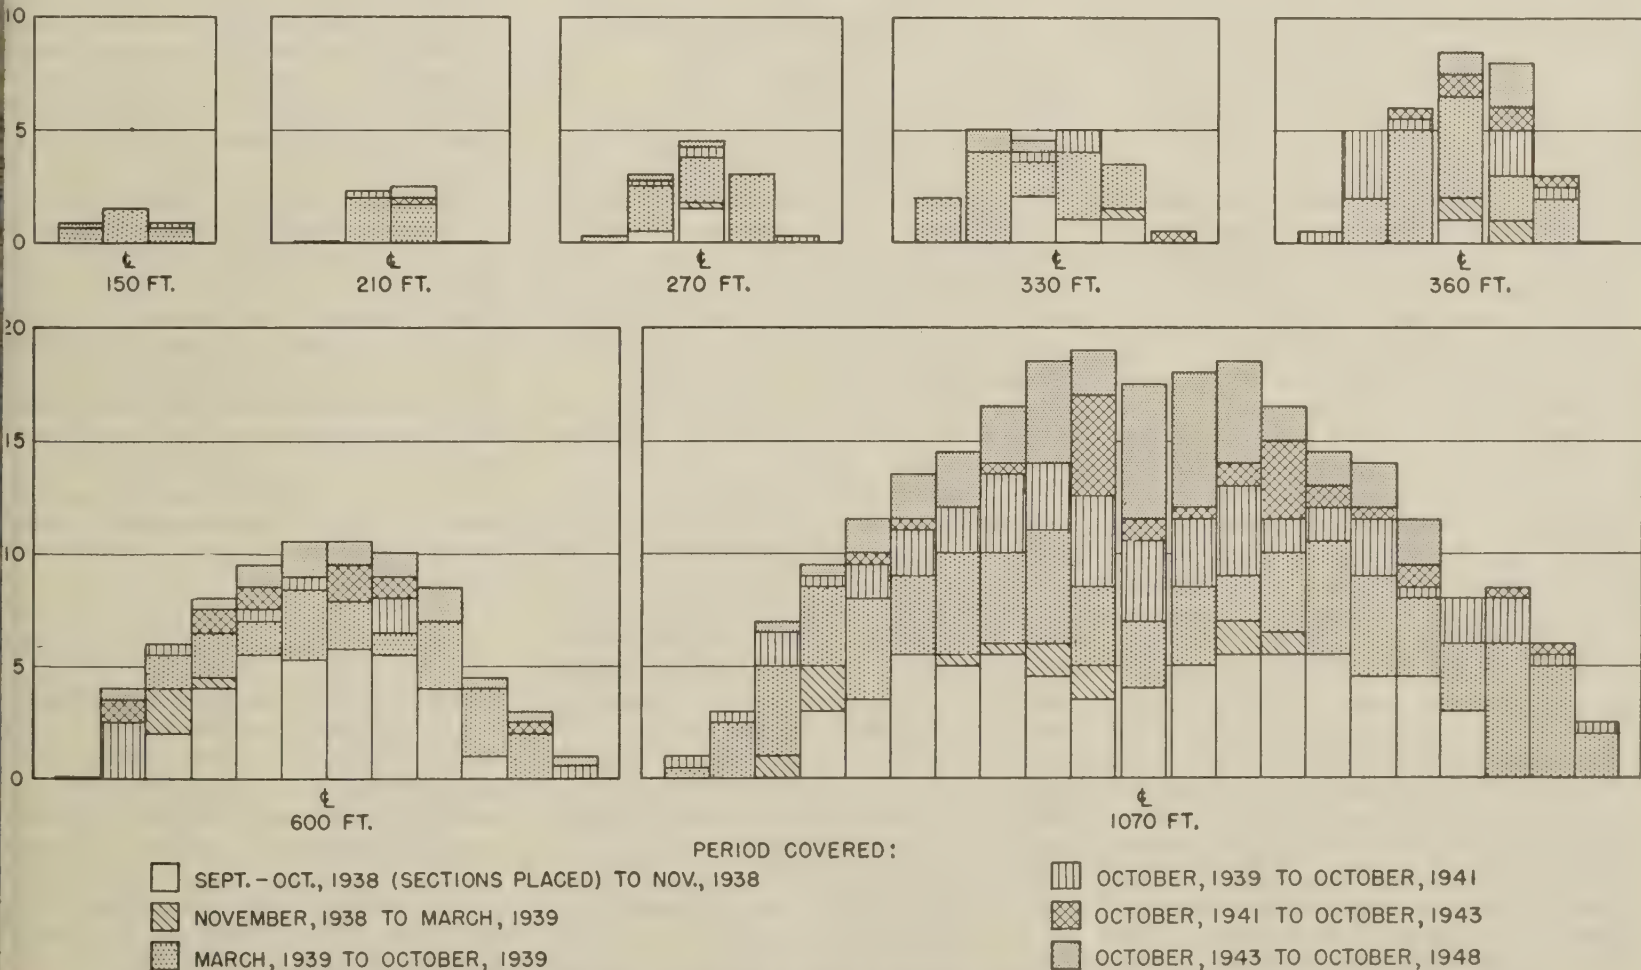
Figure 19.—Distribution of cumulative cracking per 50 feet of section length in the first 10 years of pavement life.

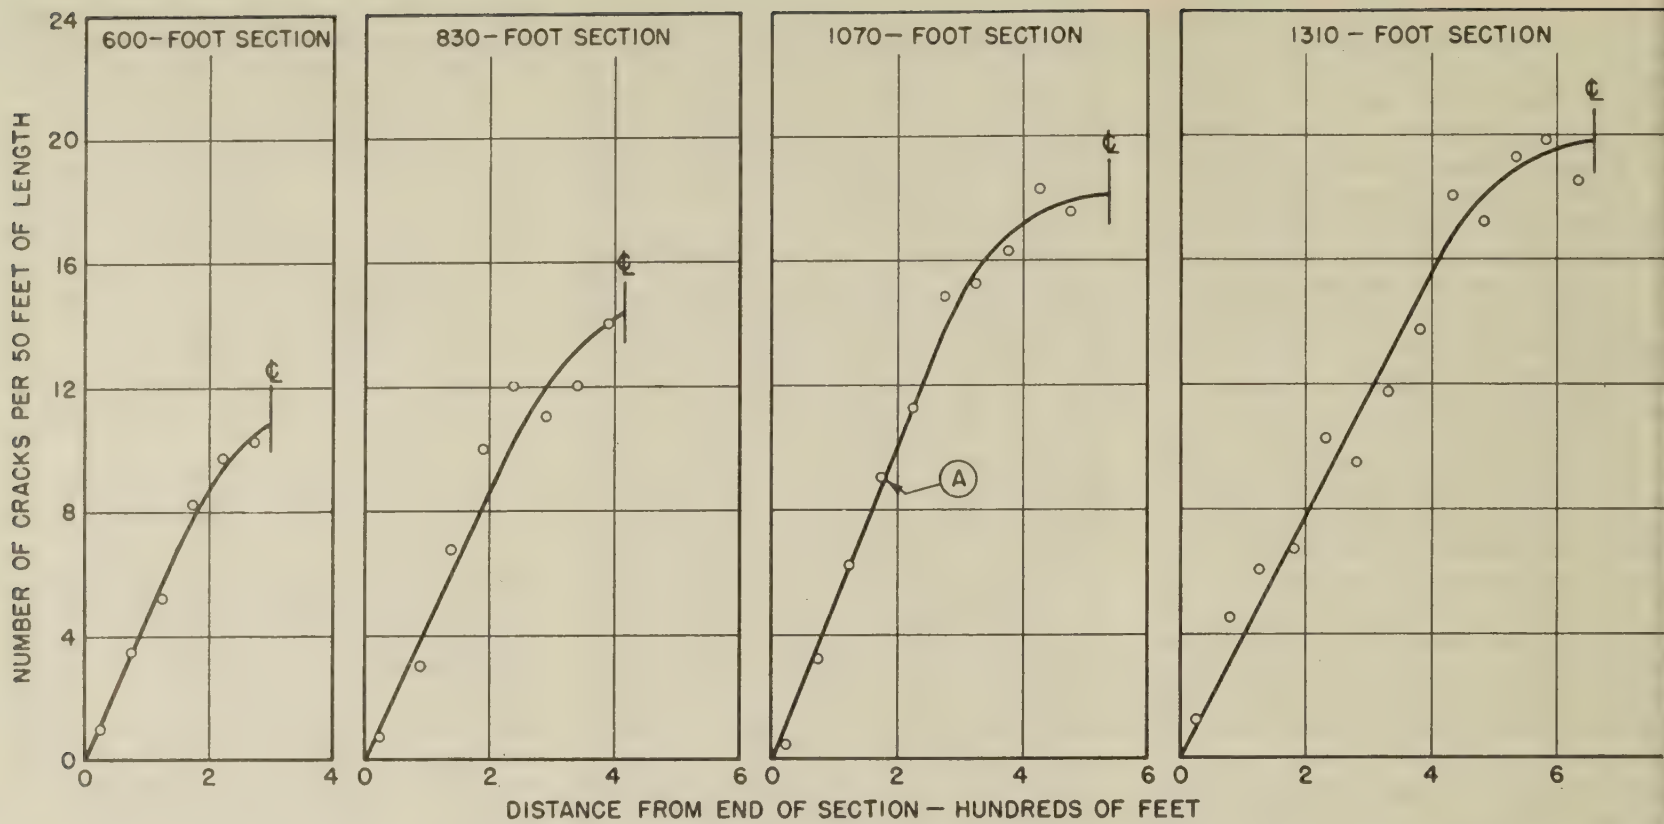
Figure 20.—Frequency distribution of cracking at the end of 10 years for sections reinforced with 1-inch diameter rail-steel bars (1.82 percent steel); average of both lanes.

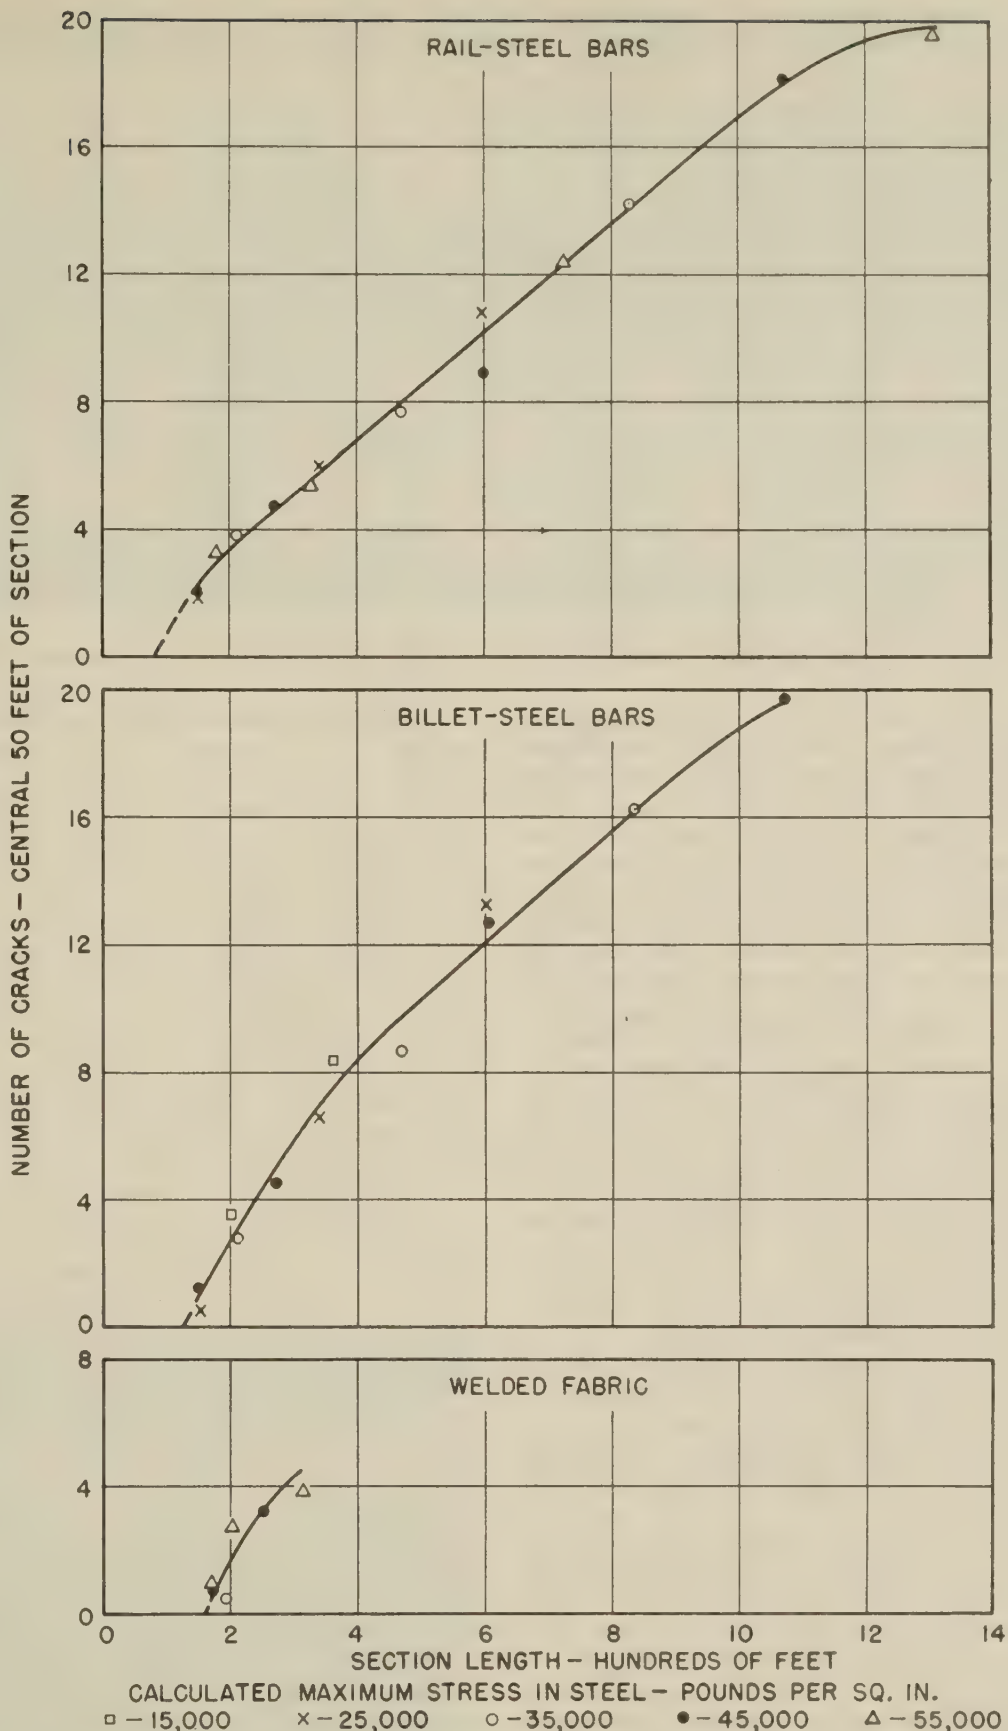
Figure 21.—Effect of type of reinforcement and of calculated maximum steel stress on the relation between section length and maximum cracking frequency at age of 10 years.

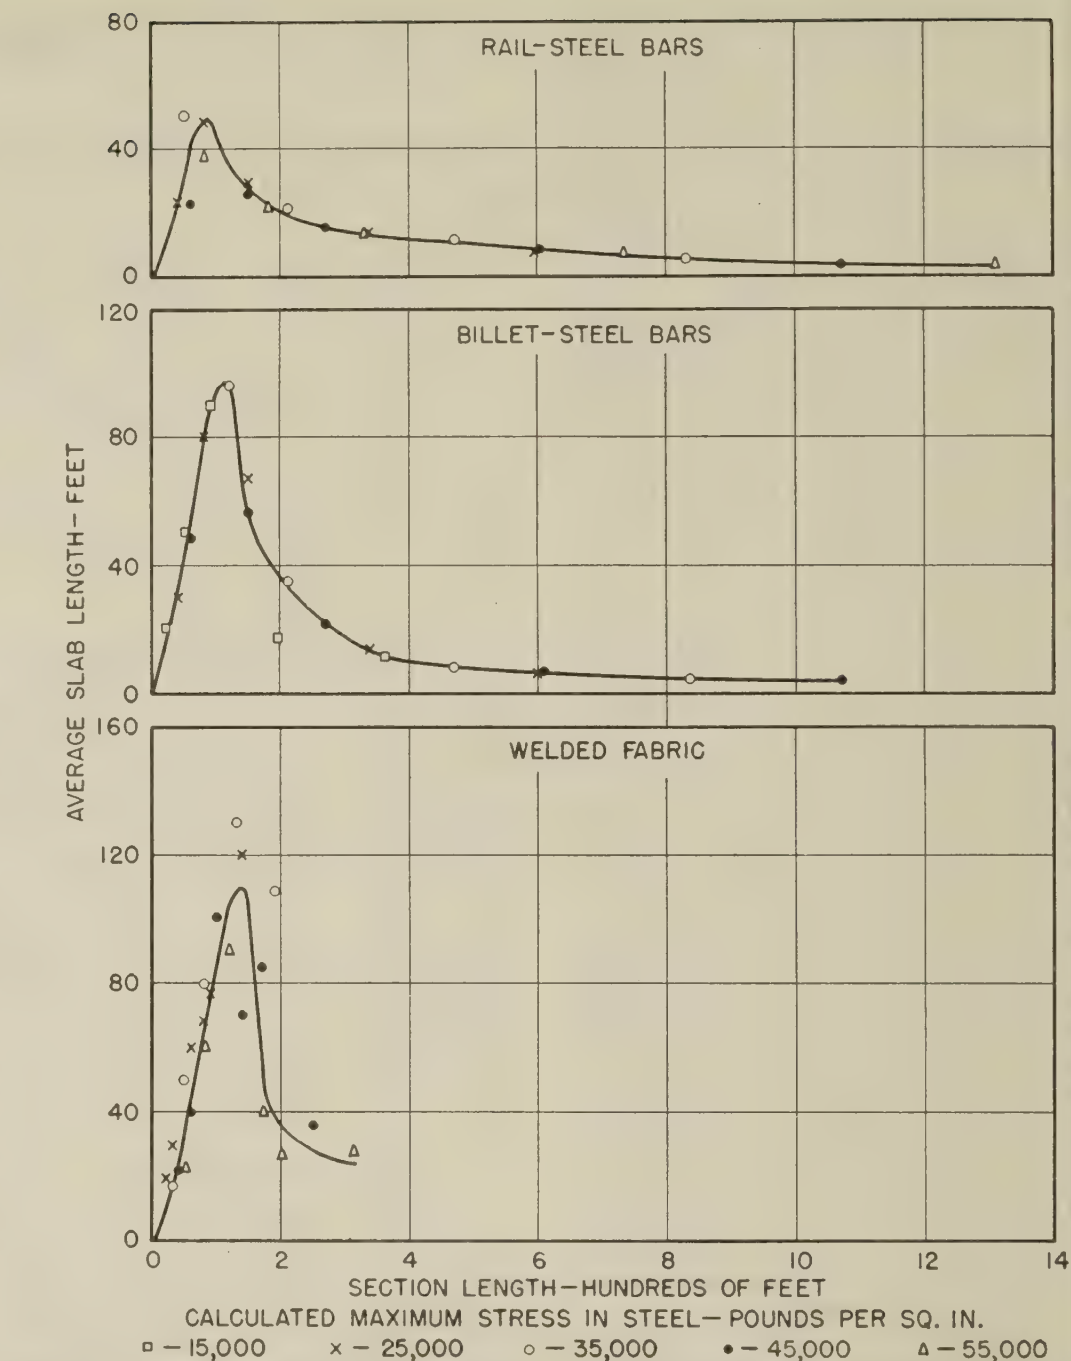
Figure 22.—Effect of type of reinforcement and of calculated maximum steel stress on relation between section length and average slab length at age of 10 years.

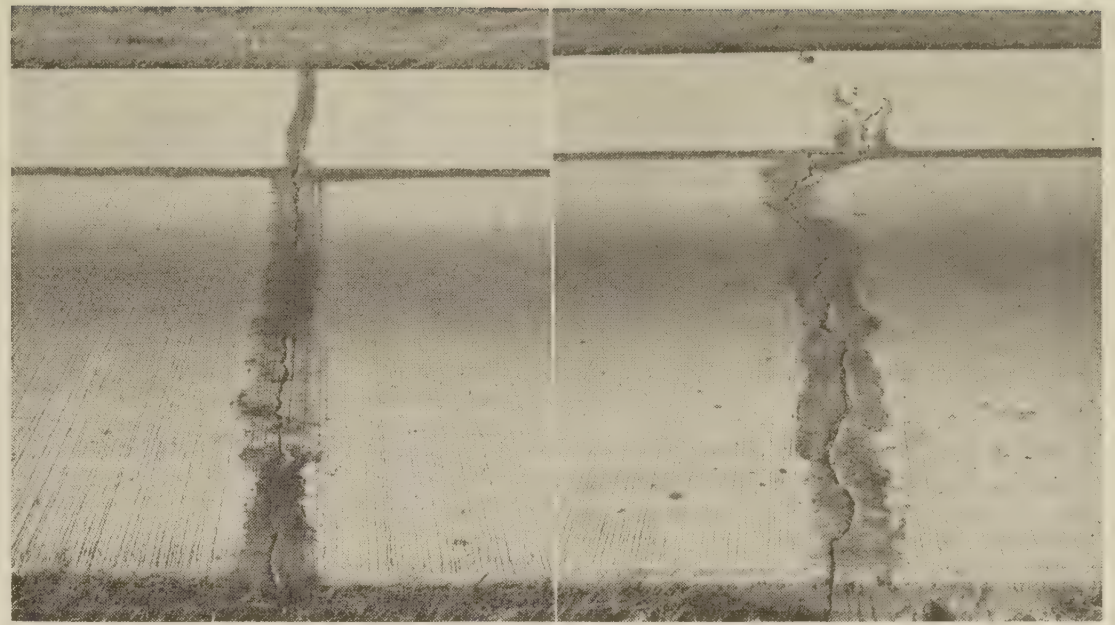
Figure 23.—Two of the submerged-type, weakened-plane joints after 10 years of service: Extreme cases of straight and irregular cracking over the bottom parting strip.

Figure 23 shows photographs, taken after 10 years, of two of the submerged type, weakened-plane joints at which the reinforcing steel was

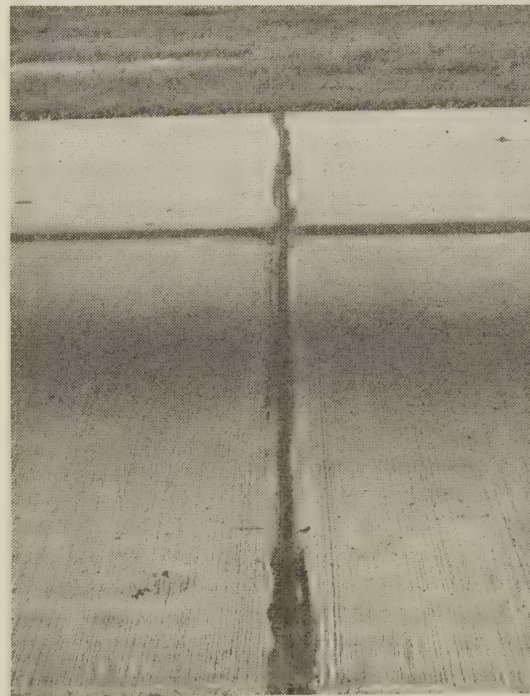
Figure 24.—Present condition of a surface-type, weakened-plane joint, typical of those at which the continuous reinforcement is structurally sound.

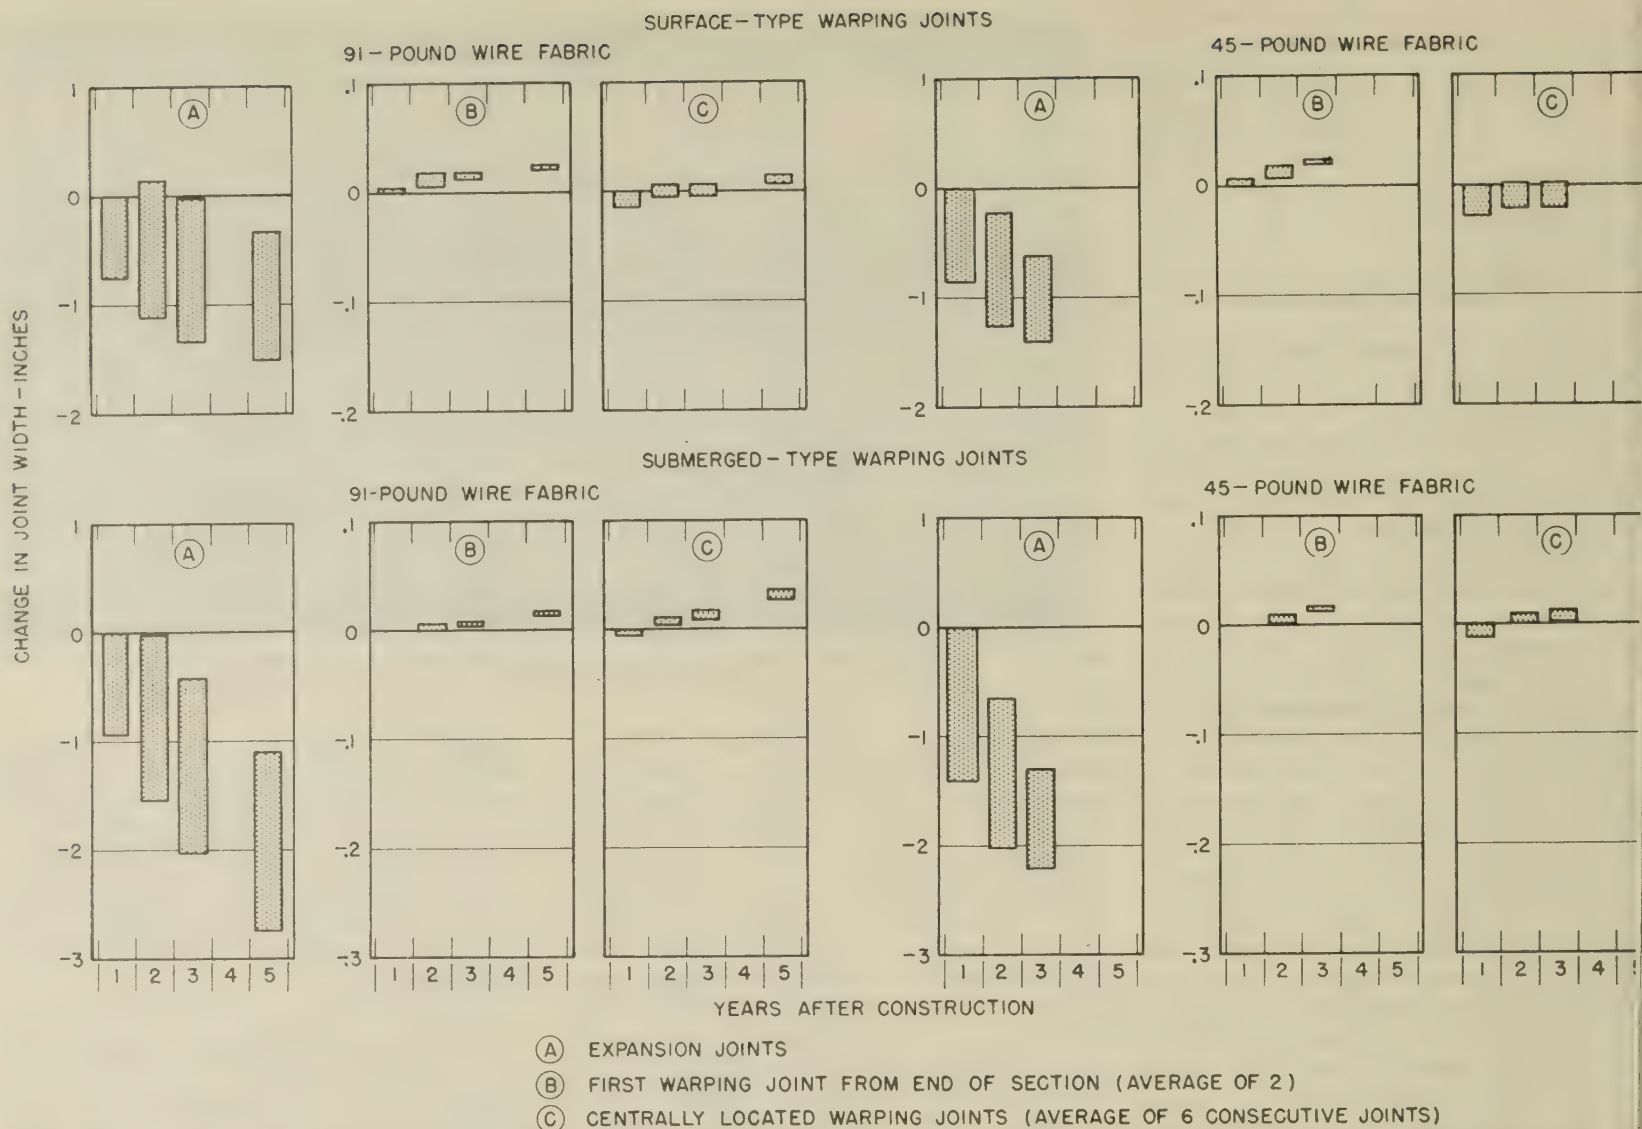
Figure 25.—Annual and progressive joint width changes of the 500-foot sections containing warping joints at 10-foot intervals: Values above the zero line denote opening; those below, closing, of the joint with respect to the base readings of December 1938.

It is apparent in figure 25 that, in spite of the continuity of the reinforcing steel throughout the length of a section, the expansion joints closed and the weakened-plane joints opened progressively with time. These progressive changes are in the same sense as those observed in plain concrete pavements built with expansion joints and closely spaced weakened-plane contraction joints. It has been observed, also, that the progressive clos-
