REPORT NUMBER 103-GTL-07-004

**SAFETY COMPLIANCE TESTING FOR
FMVSS NO. 103
WINDSHIELD DEFROSTING AND
DEFOGGING SYSTEMS**

**NISSAN MOTOR CO., LTD.
2007 NISSAN VERSA, PASSENGER CAR
NHTSA NO. C75201**

FINAL REPORT

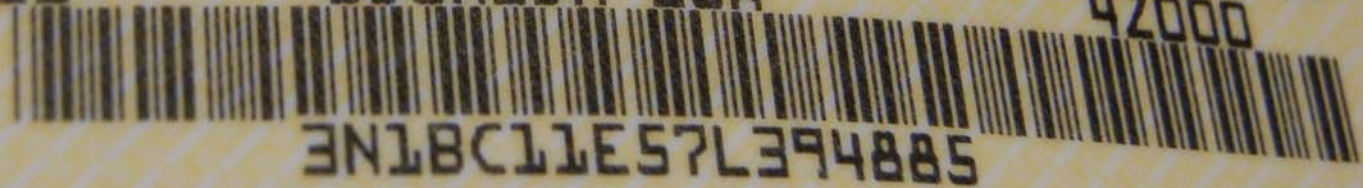
FIGURE 5.5
 VEHICLE CERTIFICATION LABEL

PASSENGER CAR.
 ENGINE

QML G RE4F03B FQ40 MR18DE 1798 CC
 MODEL : BDSALDA-EUA 42000

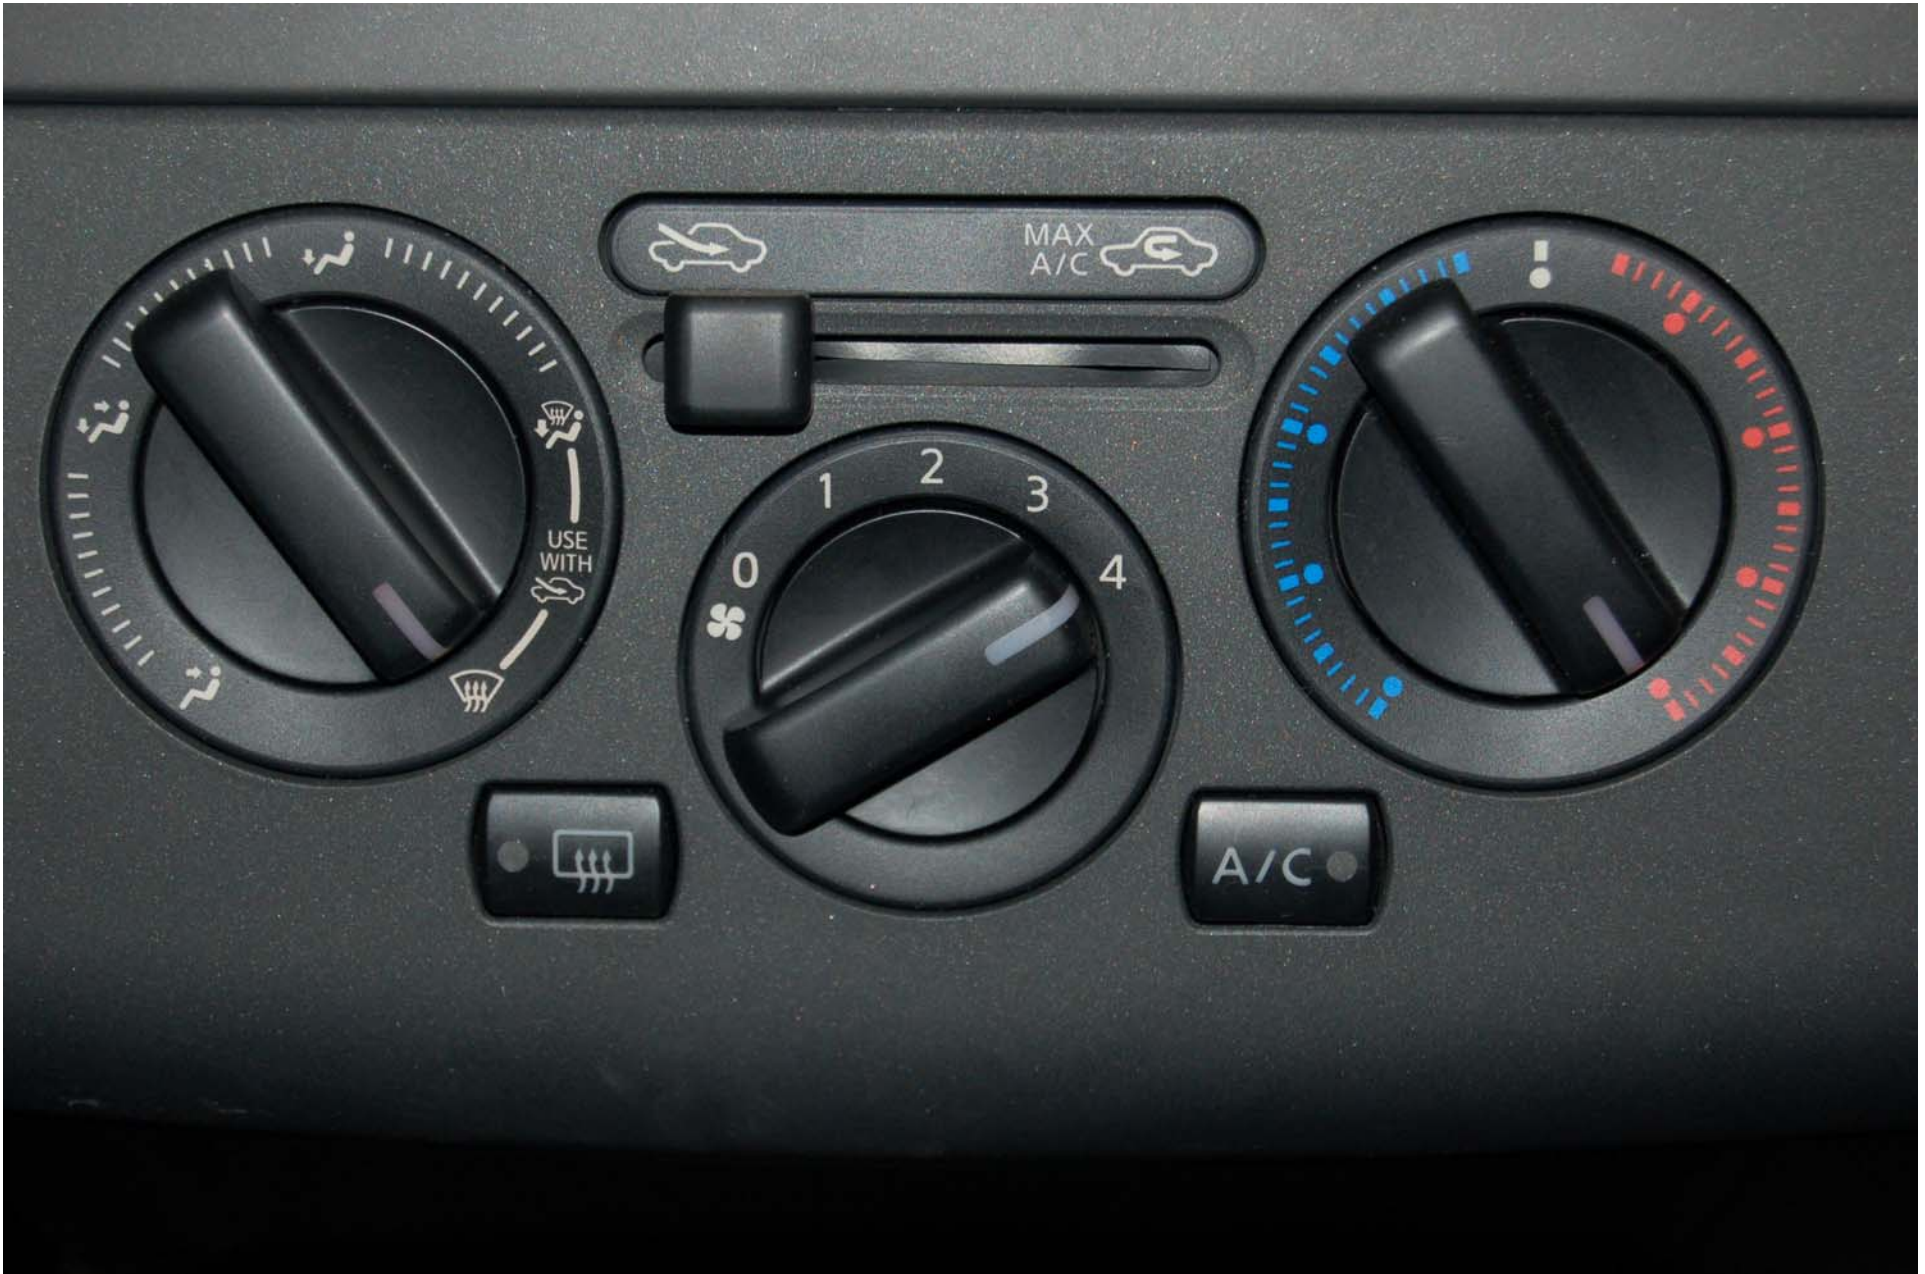
FIGURE 5.7
CLOSE-UP VIEW OF DEFROSTER CONTROL SETTING
ON DASH

At the conclusion of the additional soak time the vehicle's engine was started and operated at a target speed of 1500-1600 rpm or at the manufacturer's specification if different as noted on data sheets. The defroster blower was turned on to the high speed setting with the heater selector in the de-ice (defrost) position, and the temperature control in the maximum temperature position. All doors and windows were closed. The heater air intake was fully open and the vehicle's hood closed. At no time during the test were the windshield wipers used.

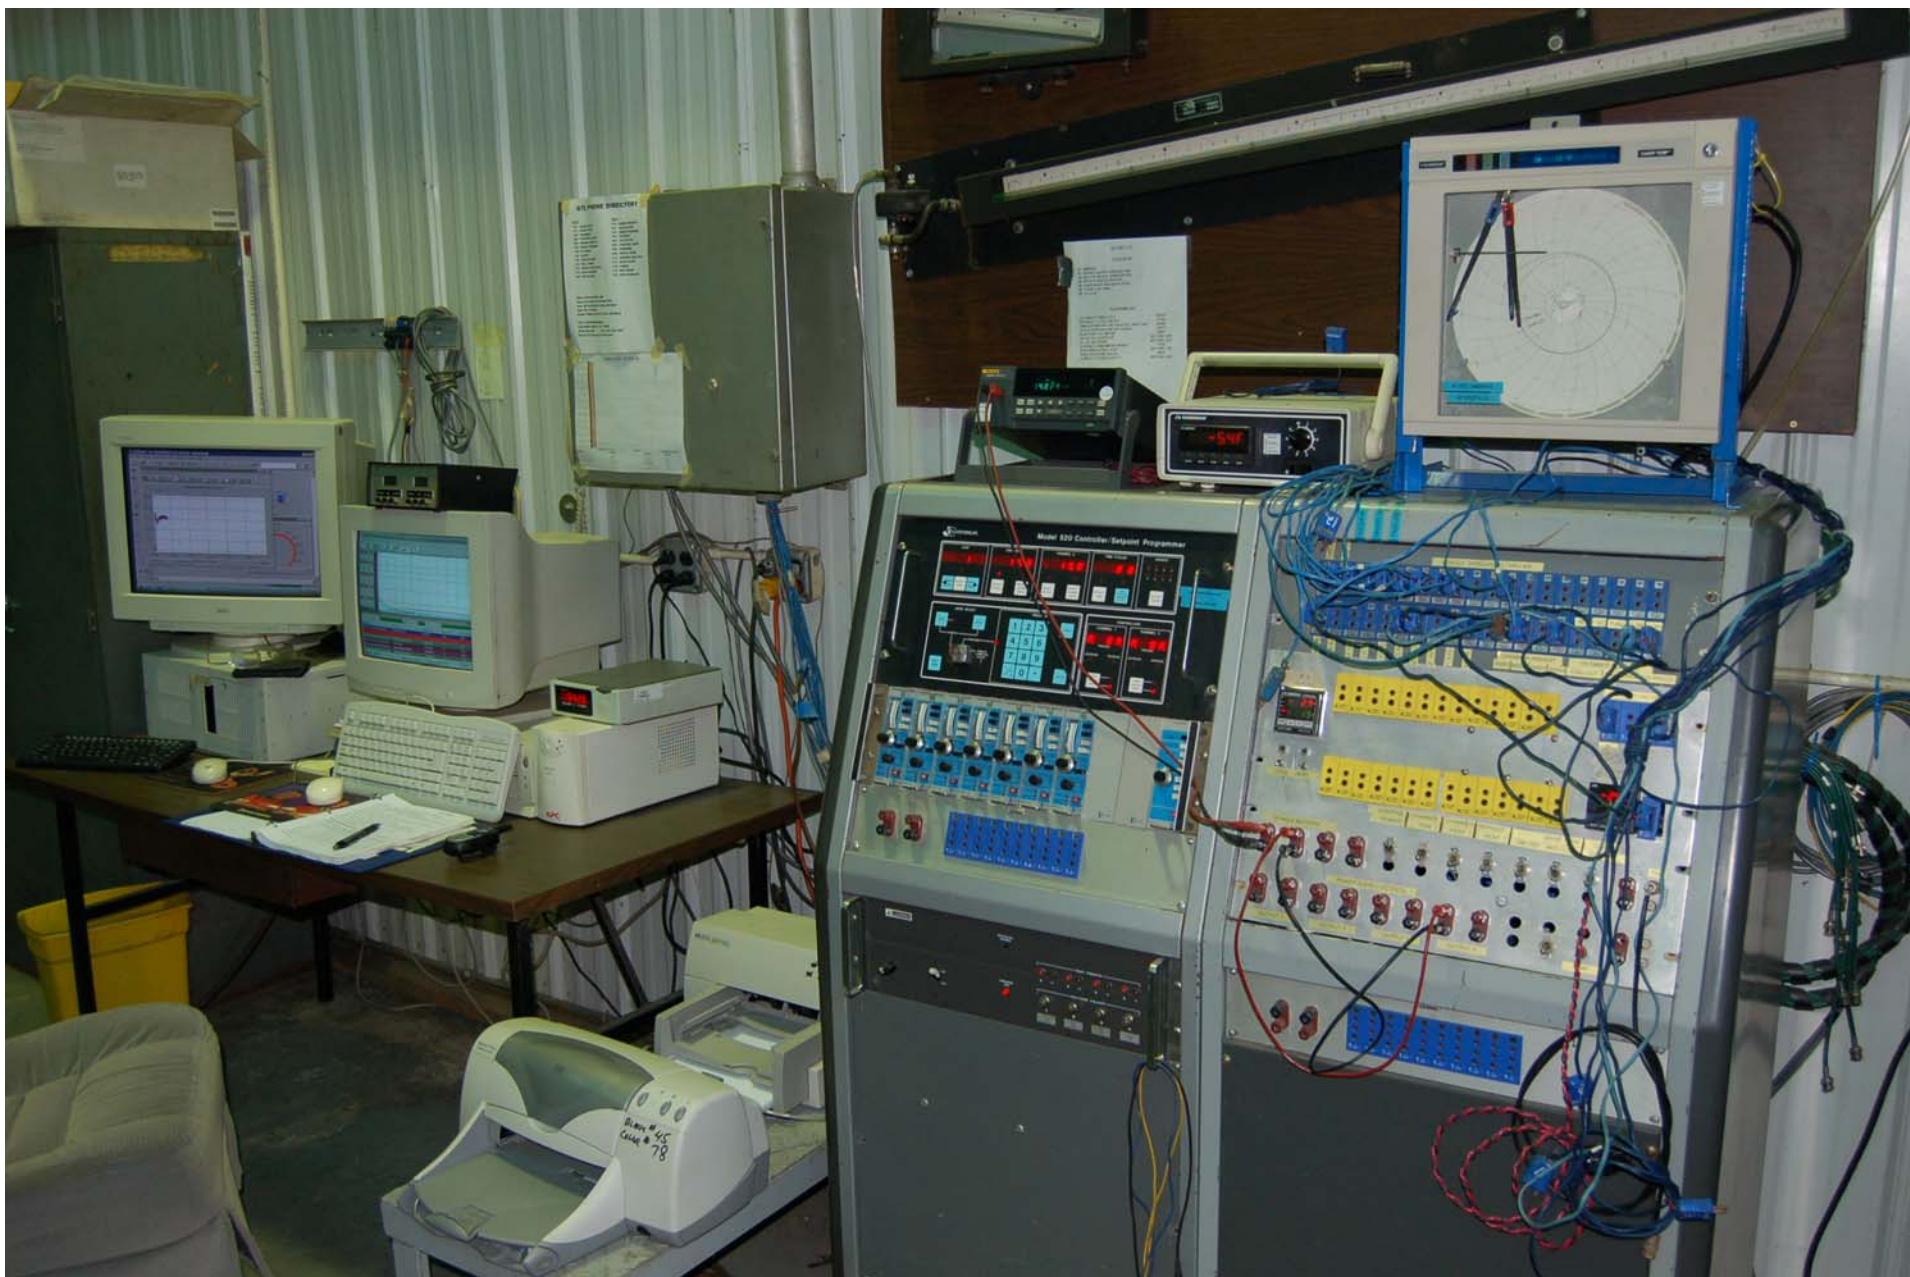
FIGURE 5.8
INSTRUMENTATION SET-UP

At start of testing and during test, at each 5-minute interval after engine start, cold chamber, engine coolant, heater coolant in and defroster air left/defroster air right temperatures were recorded. Likewise at each 5-minute interval the boundary of the defrosted area was marked on the inside surface of the windshield. The test was run for a maximum of 40 minutes from engine start, or until such time as 100 percent windshield clearance was achieved. Photographs were made of the windshield at the pre-test frosted state and 20-minute and 25-minute intervals. Post test actions included placing a vellum pattern on the windshield and tracing the windshield's 5-minute interval defrosted area boundary lines onto the vellum pattern.

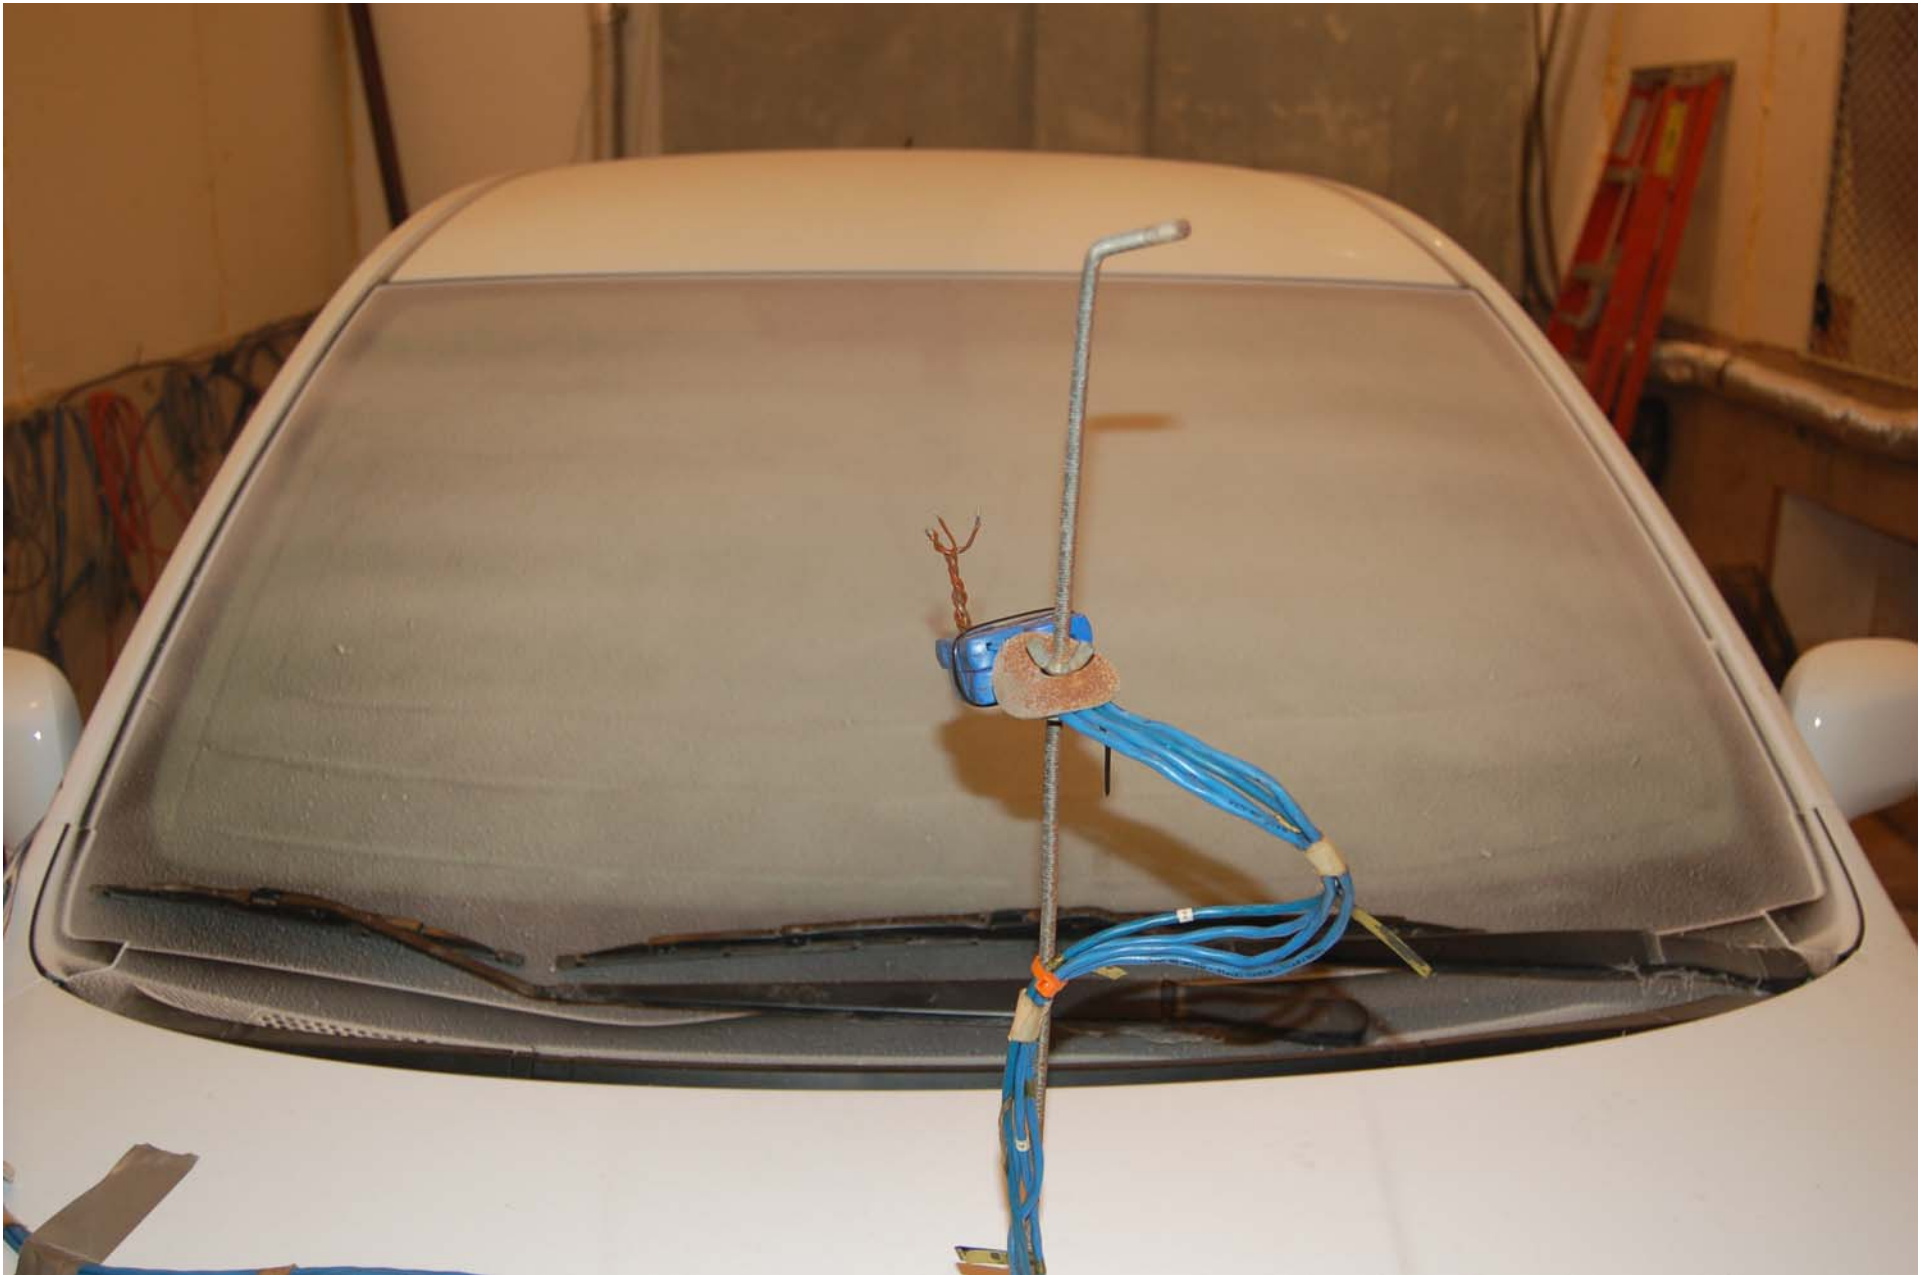
FIGURE 5.9
WINDSHIELD, PRE-TEST FROSTED STATE TEST #1

At the end of the 2-hour minimum stabilization period, the entire windshield was sprayed evenly with 0.010 ounces of water per square inch of glass area. Refer to Section 3, Compliance Test Data, for test specifics such as total amount of water sprayed, spray gun identification, and air pressure regulation. The vehicle soak continued for an additional 30 minutes minimum but no more than 40 minutes after the windshield was sprayed.

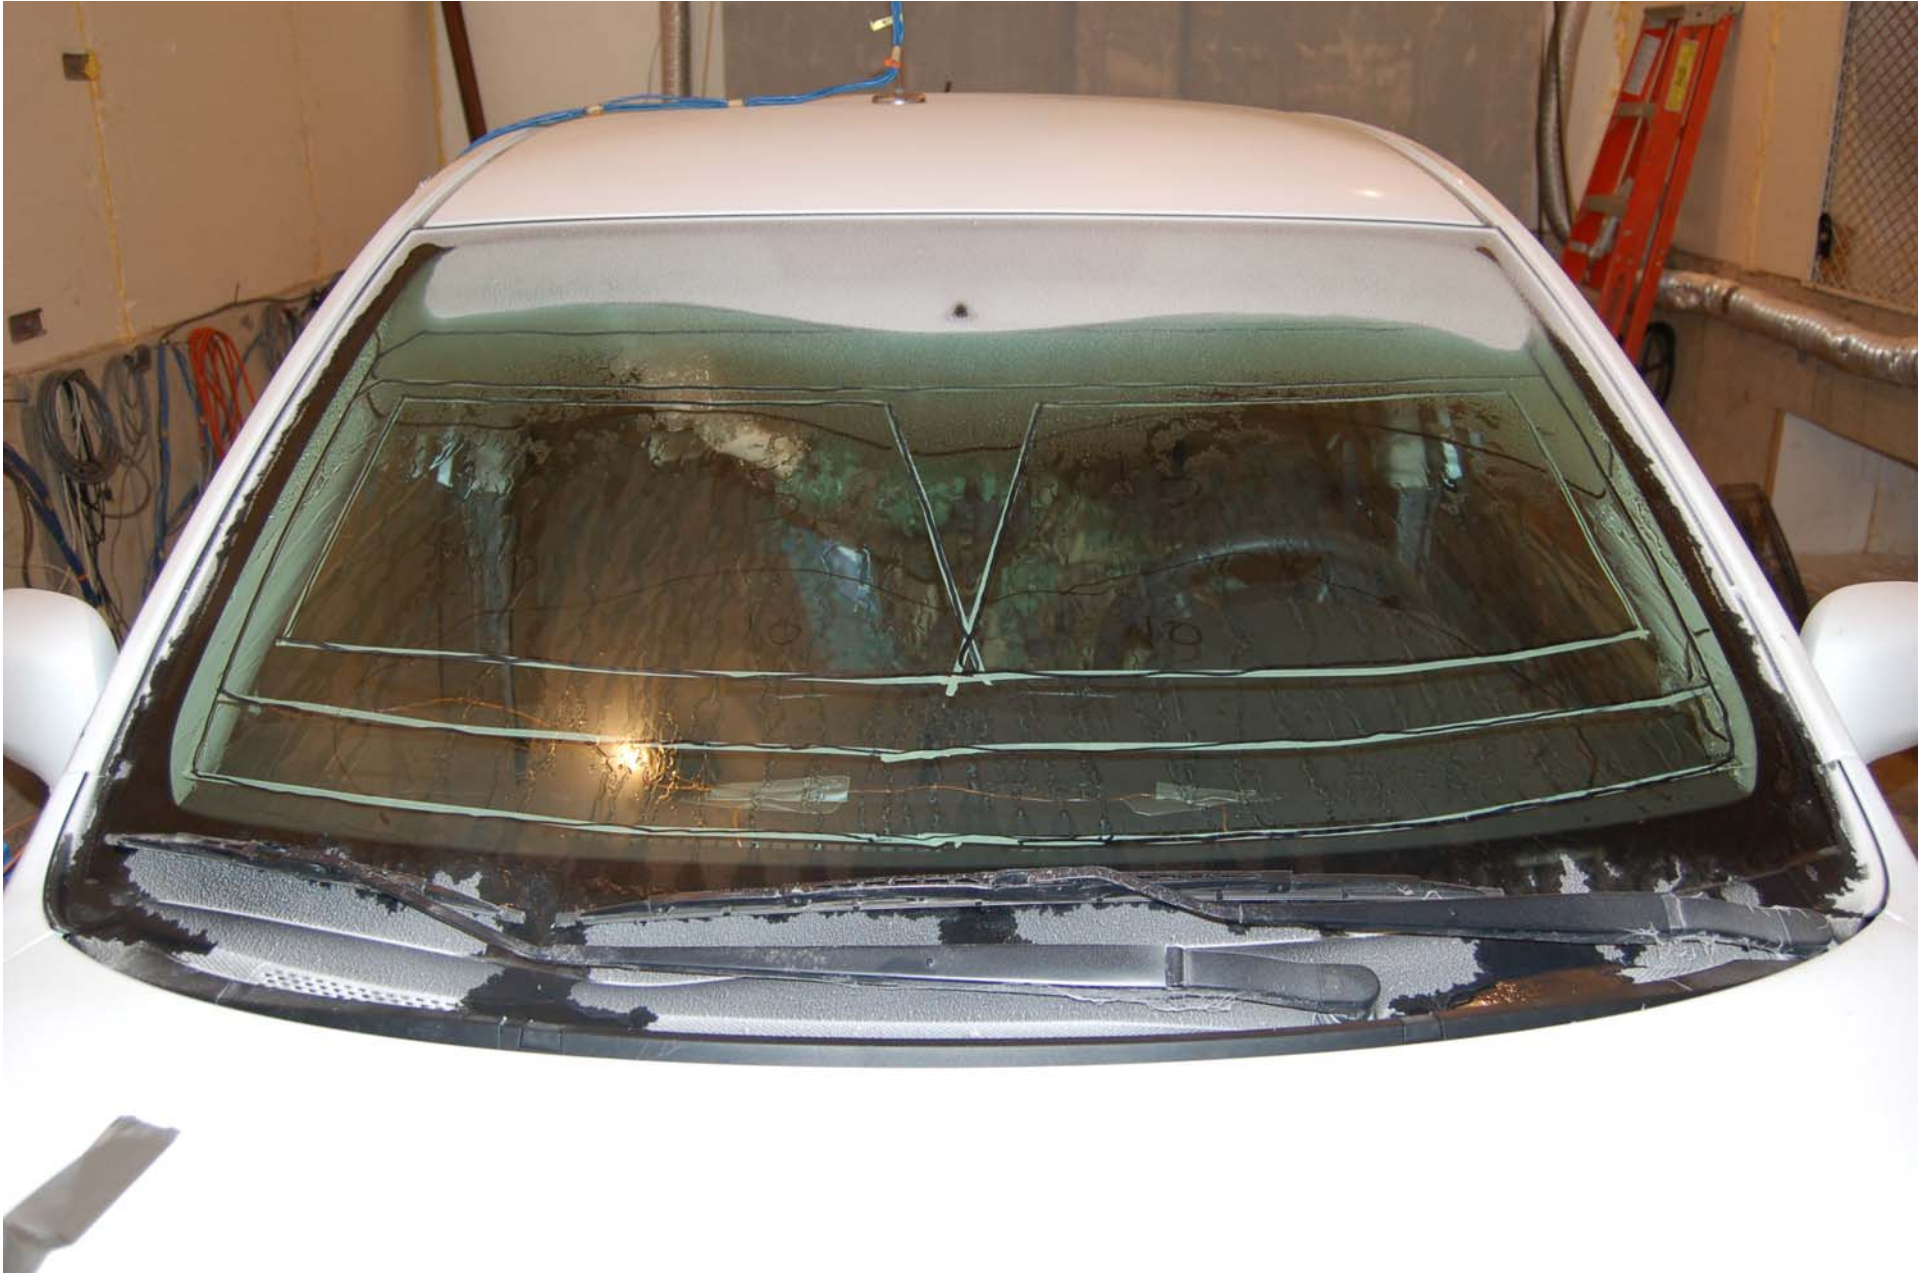
FIGURE 5.10
DEFROSTED AREA AT 20 MINUTES TEST #1

TIME FROM START (minutes)	MOTOR VOLTAGE (volts)	TEMPERATURE, °F					DEFROSTED AREA, %		
		TEST ROOM	ENGINE WATER	HEATER WATER IN	DEFROSTER AIR		A	C	D
					DRVR	PSGR			
0	13.5	-1.9	-.7	-.5	-1.1	-.5	0%	0%	0%
5	14.8	-1.7	27.8	64.7	54.5	59.4	0%	0%	0%
10	14.7	-.4	70.5	97.2	84.1	86.5	27.4%	21.3%	22.4%
15	14.7	0.0	95.0	102.1	99.7	101.8	74.1%	87.2%	91.2%
20	14.6	-1.1	106.3	107.7	107.3	107.3	99.7%	100%	100%
25	14.6	.5	116.8	115.6	115.7	117.3	100%	100%	100%

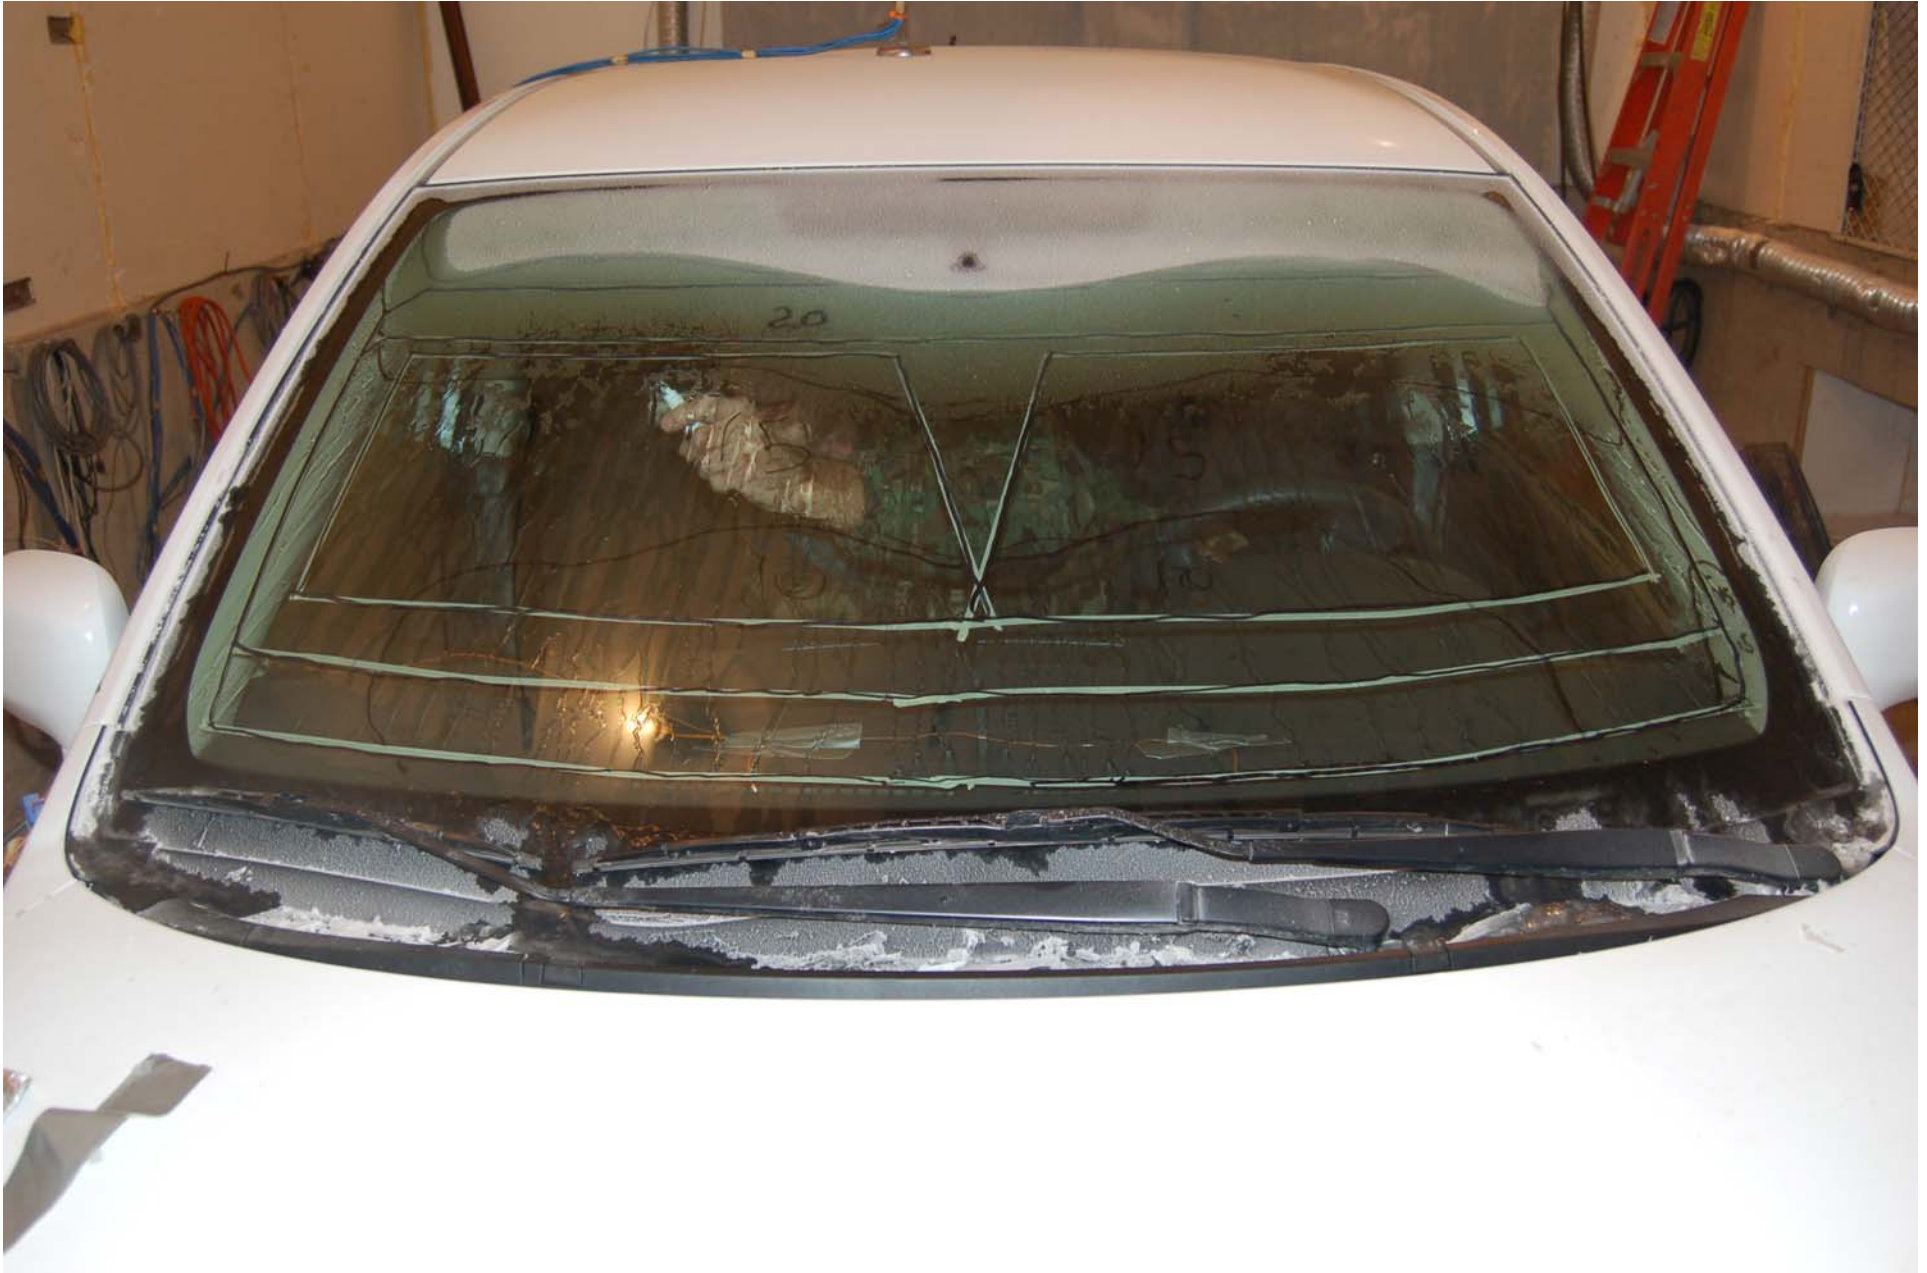
FIGURE 5.14
DEFROSTED AREA AT 20 MINUTES TEST #2

TIME FROM START (minutes)	MOTOR VOLTAGE (volts)	TEMPERATURE, °F					DEFROSTED AREA, %		
		TEST ROOM	ENGINE WATER	HEATER WATER IN	DEFROSTER AIR		A	C	D
					DRVR	PSGR			
0	13.5	0.0	-1.0	-0.7	-0.8	-0.5	0%	0%	0%
5	14.8	-1.9	27.9	64.7	53.9	56.2	0%	0%	0%
10	14.7	-1.0	70.3	91.8	83.0	85.4	30.8%	19.6%	21.8%
15	14.7	0.0	95.2	99.2	97.2	98.4	73.3%	84.1%	91.2%
20	14.6	0.0	107.1	114.0	105.7	107.8	99.5%	100%	100%
25	14.6	.5	117.1	111.5	114.4	116.3	100%	100%	100%
