REPORT NUMBER 114-GTL-09-005

SAFETY COMPLIANCE TESTING FOR FMVSS NO. 114 THEFT PROTECTION

GENERAL MOTORS CORP.
2009 CHEVROLET COBALT, PASSENGER CAR
NHTSA NO. C90103

FINAL REPORT

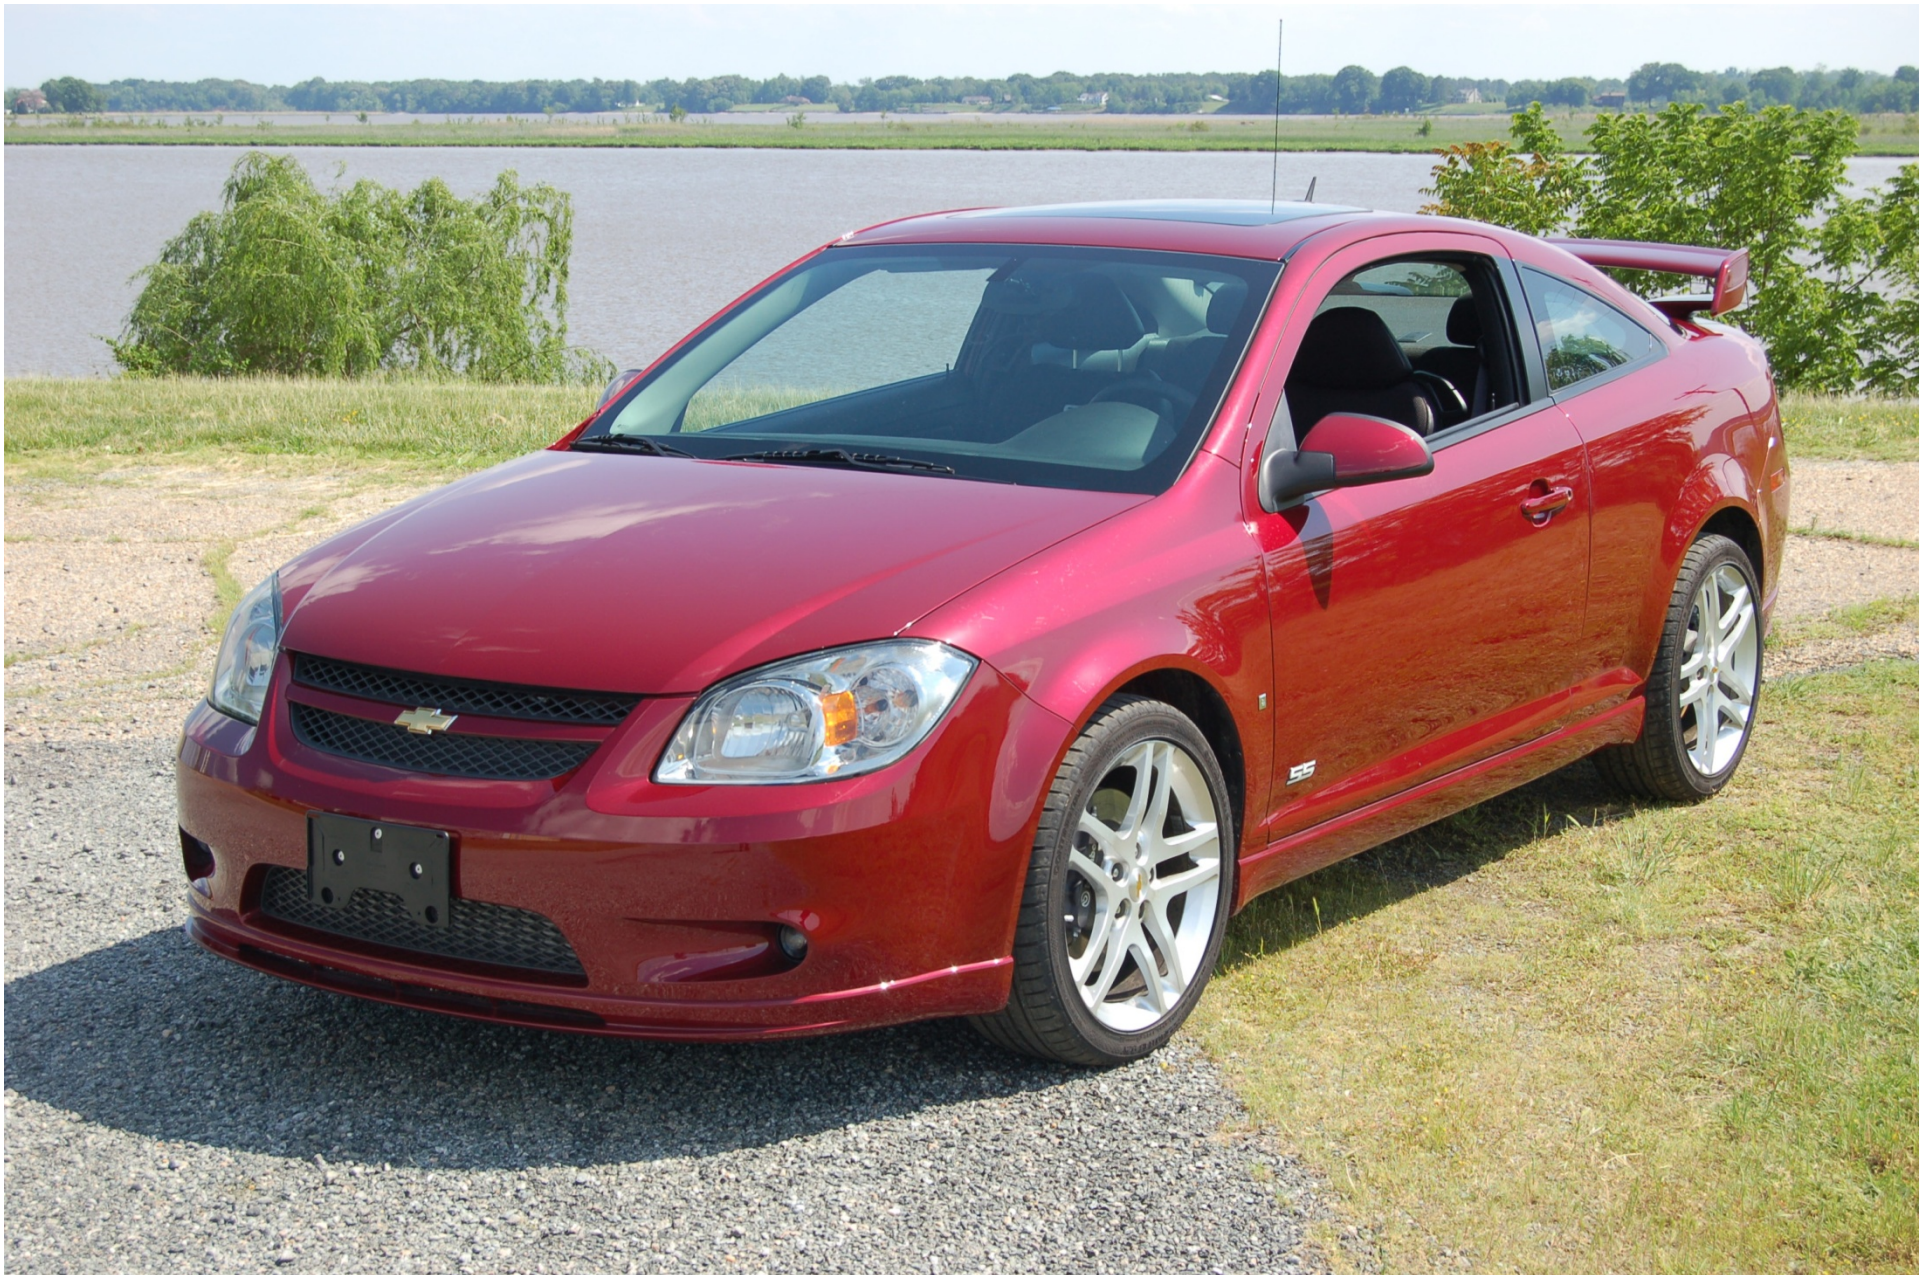
FIGURE 5.1
¾ FRONTAL VIEW FROM LEFT SIDE OF VEHICLE

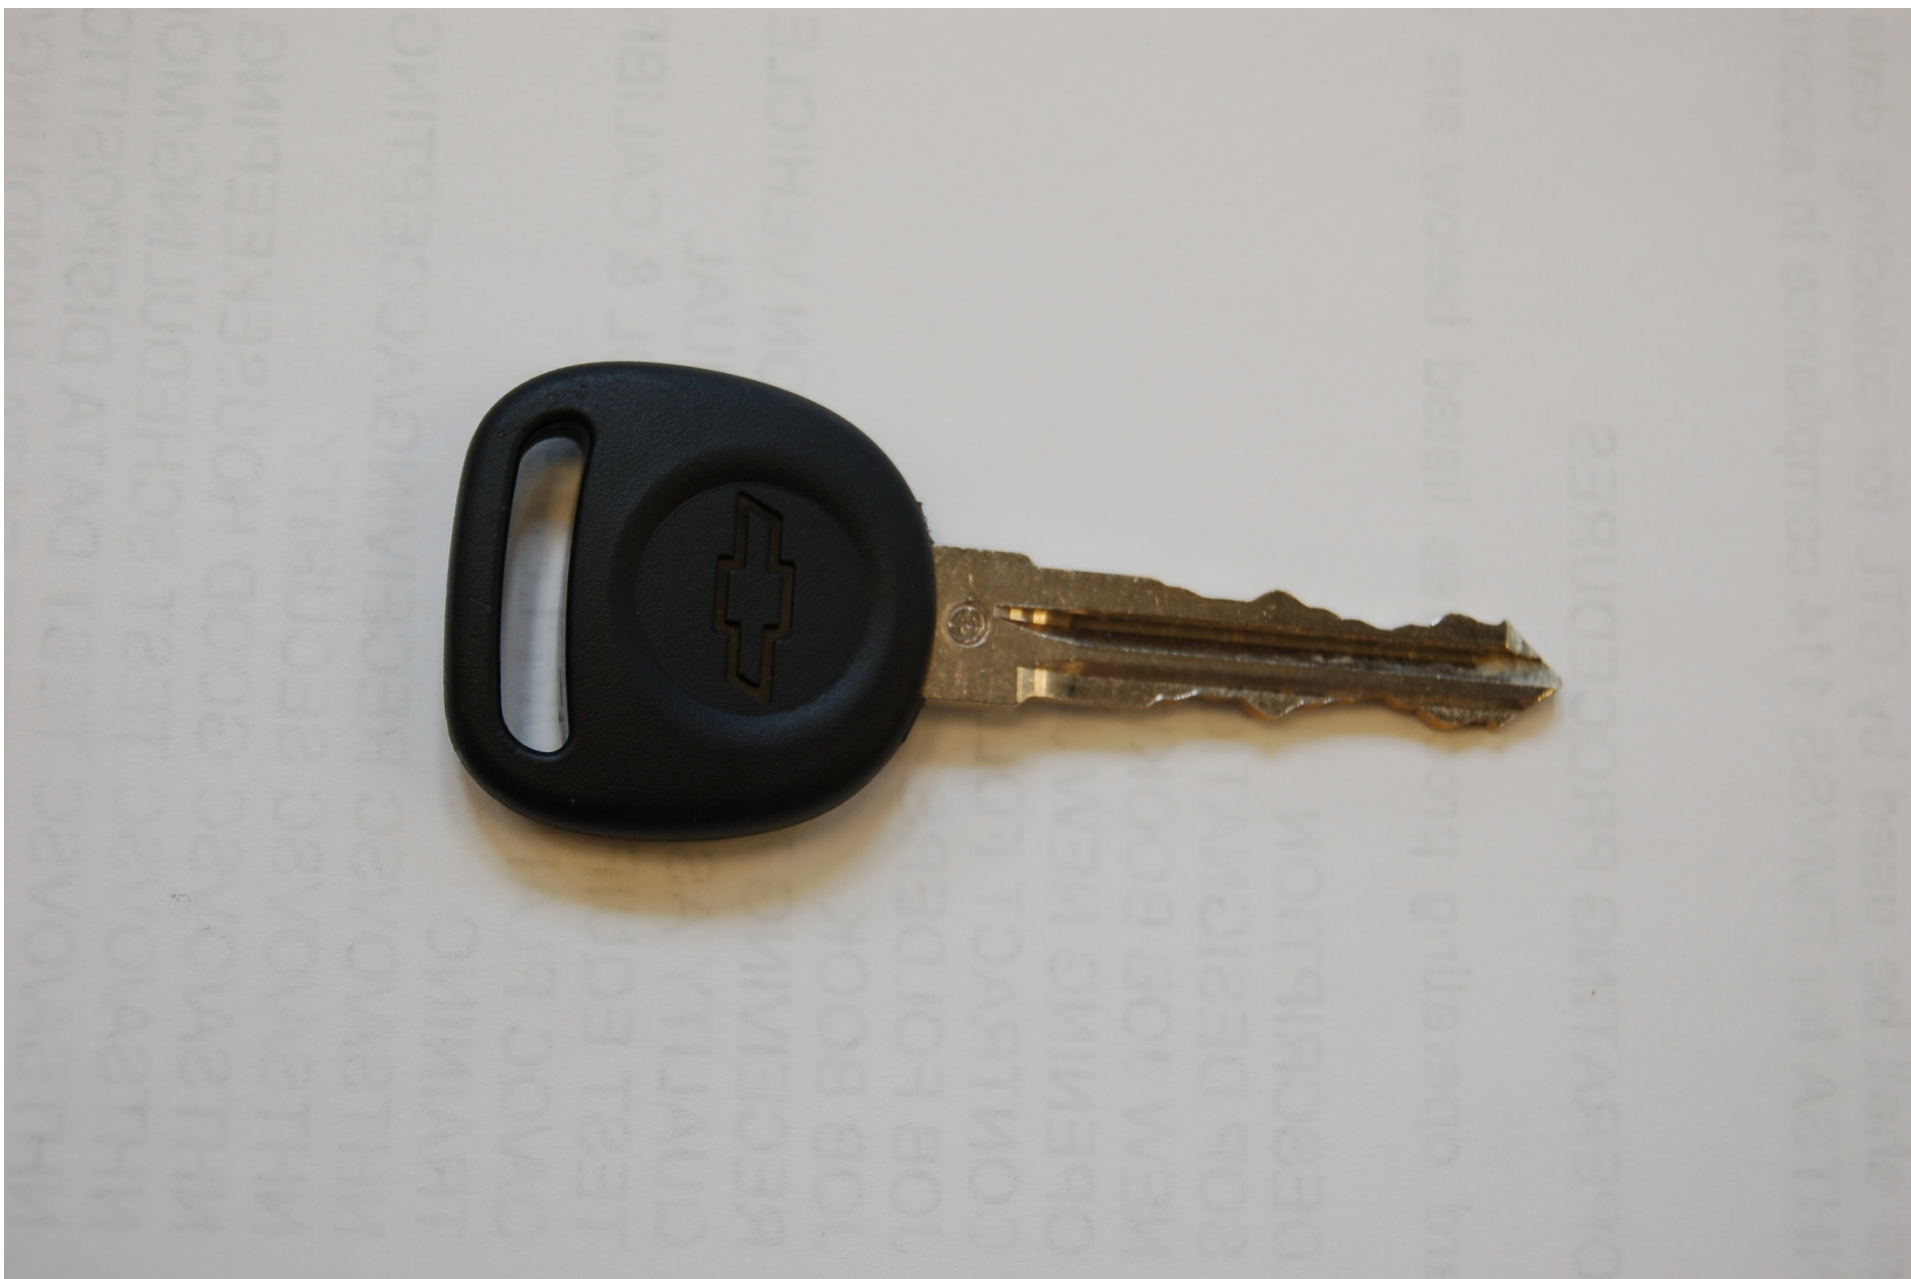
Description of the key:
Normal traditional metal key

Radio frequency chip in key must match decoder in vehicle to start engine.

FIGURE 5.4
CLOSE-UP VIEW OF IGNITION KEY

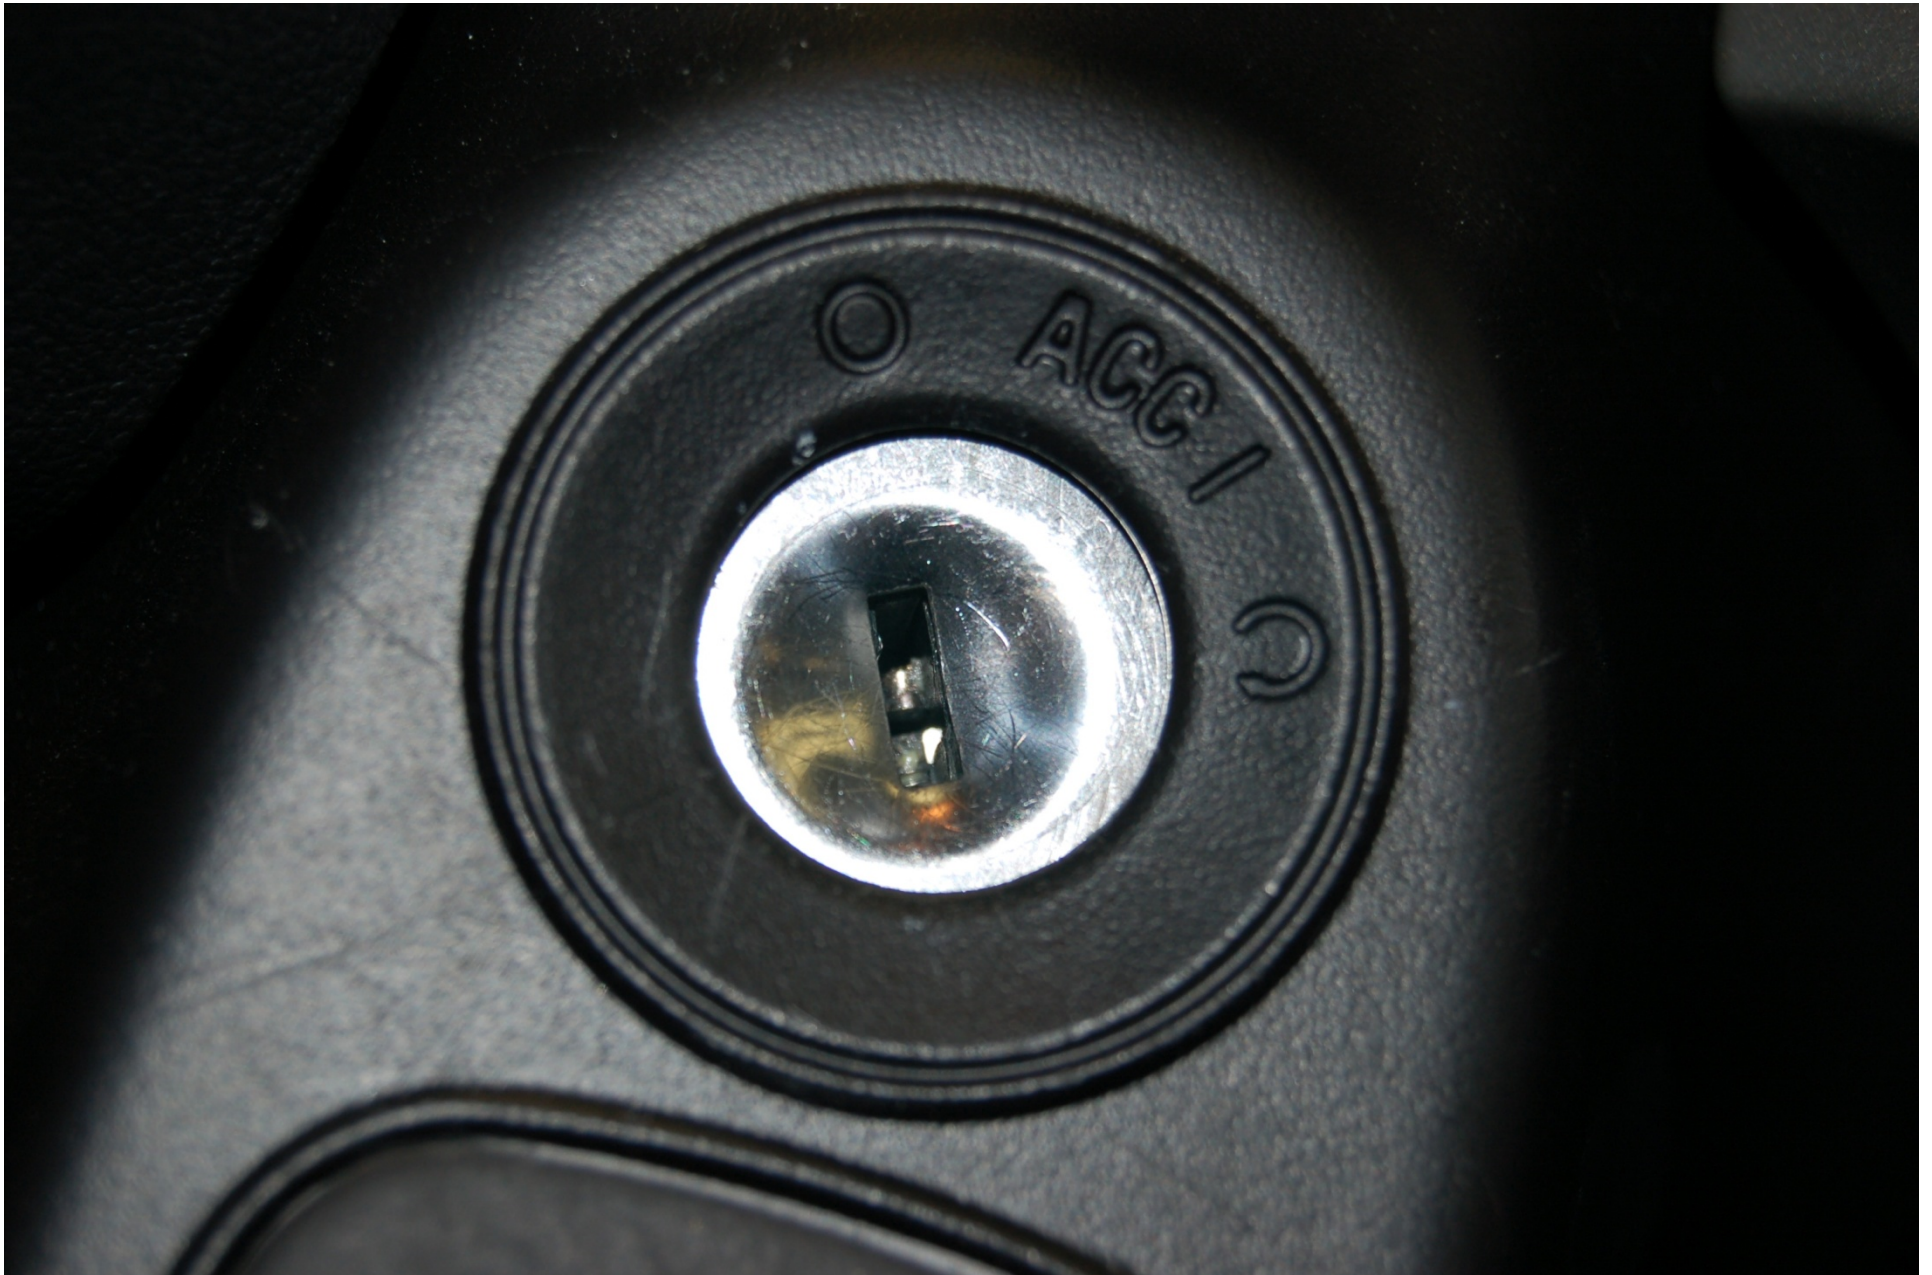
Location of the starting system:
On Right Side of Steering Column

Selectable settings:
Lock/Off, Accessory, On/Run, Start

Explain how the system is activated:
Insert key and turn clockwise

FIGURE 5.5
STARTING SYSTEM CONTROL

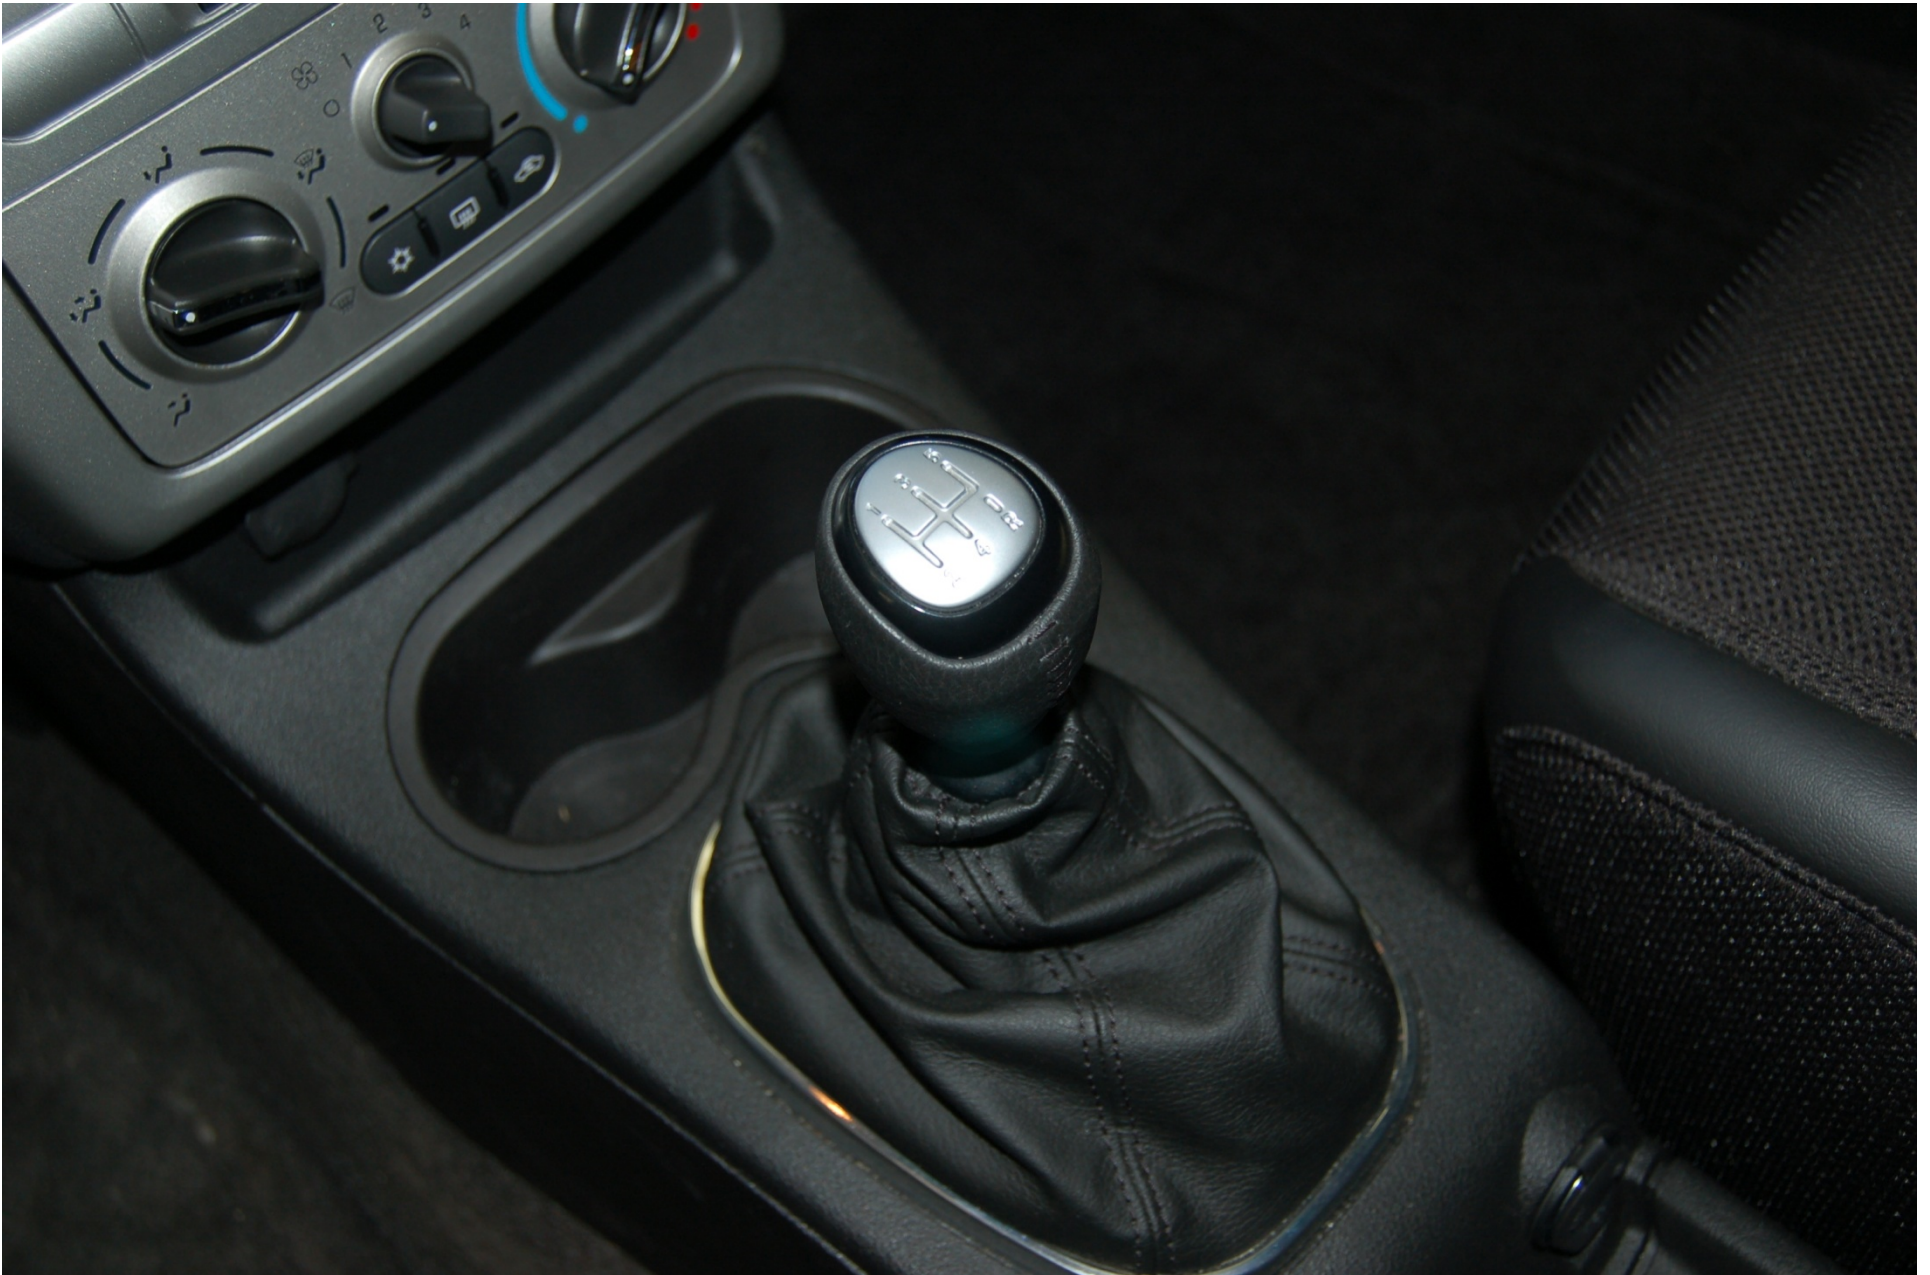
5 speed manual stick shift in center console

Standard "H" pattern with right hand

1st, 2nd, 3rd, 4th, 5th, Reverse

FIGURE 5.6
TRANSMISSION GEAR SELECTION CONTROL
