Report No. 217-NVS-04-09

FMVSS No. 217
"BUS EMERGENCY EXITS AND WINDOW RETENTION AND RELEASE"

Compliance Test Report for a 2004 Orlon V, 29 Passenger Transit Bus NHTSA No. C40808

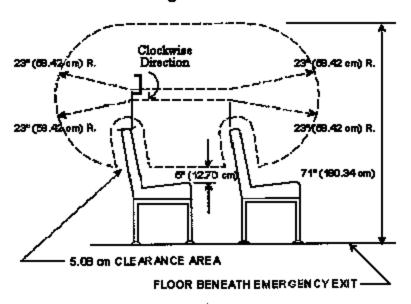
Access Regions for Low Force

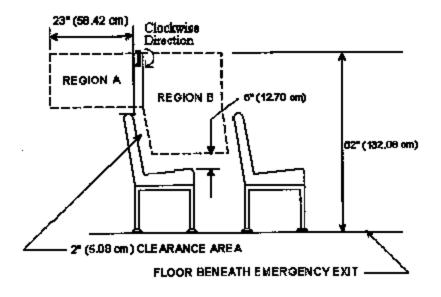
Access Regions for High Force
