REPORT NUMBER 104-GTL-07-003

# SAFETY COMPLIANCE TESTING FOR FMVSS NO. 104 WINDSHIELD WIPING AND WASHING SYSTEMS

HONDA MOTOR CO. 2007 HONDA FIT, PASSENGER CAR NHTSA NO. C75300

FINAL REPORT

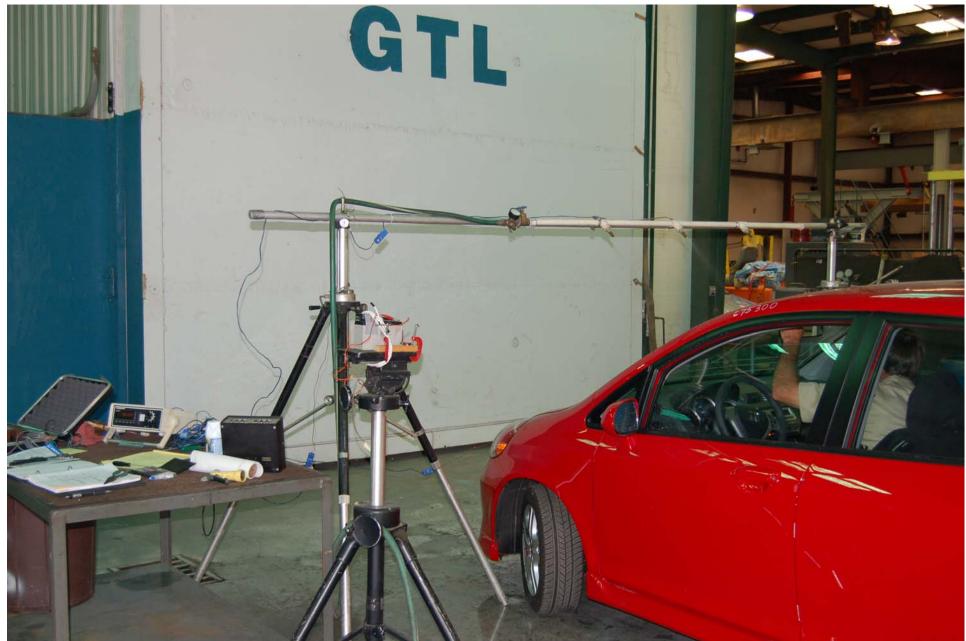
FIGURE 5.7 INSTRUMENTATION AND EQUIPMENT SET-UP

The 2007 Honda Fit passenger car, NHTSA No. C75300 was subjected to FMVSS No. 104 tests on October 9-10, 2007. The selected portions of FMVSS No. 104 tests used were as amplified in the following subparagraphs. The test vehicle was positioned in the test system with three water spray nozzles suspended in line with the center of the longitudinal axis of the windshield and horizontal left/right center of the windshield to provide an even distribution of spray to the entire windshield. The height of the nozzles was approximately 22 inches above the glazing surface.

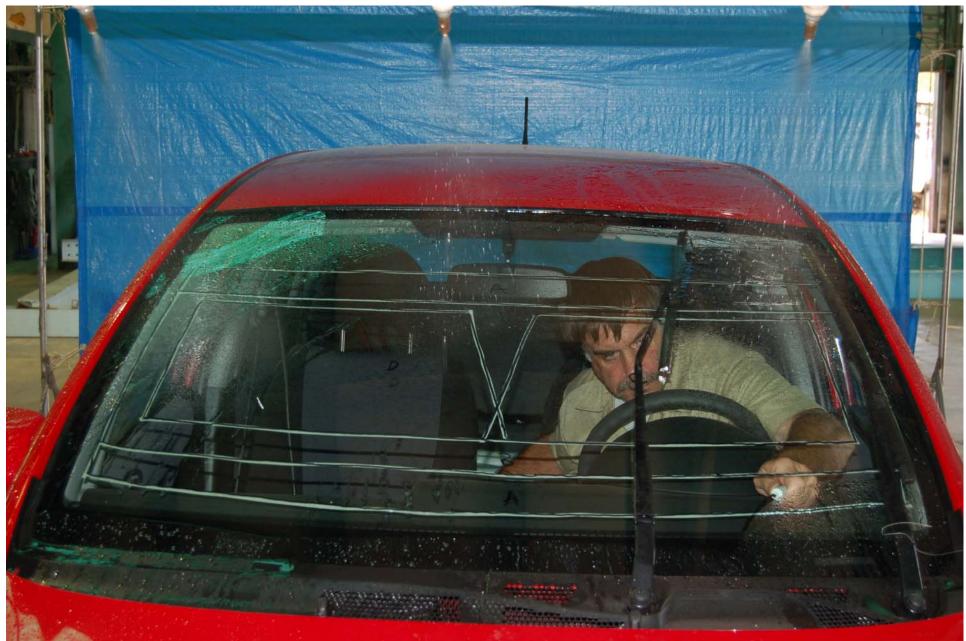
FIGURE 5.8 WIPED AREA TEST IN PROGRESS

The test was conducted with the windshield wiper system operating at the high speed setting, engine at idle RPM and the spray nozzles spraying water at a minimum of 50 cubic inches per minute. The wiper blade wipe pattern was outlined on the glazing surface and then transferred to a windshield pattern. The wiped area was determined for areas A, B and C from the windshield pattern.

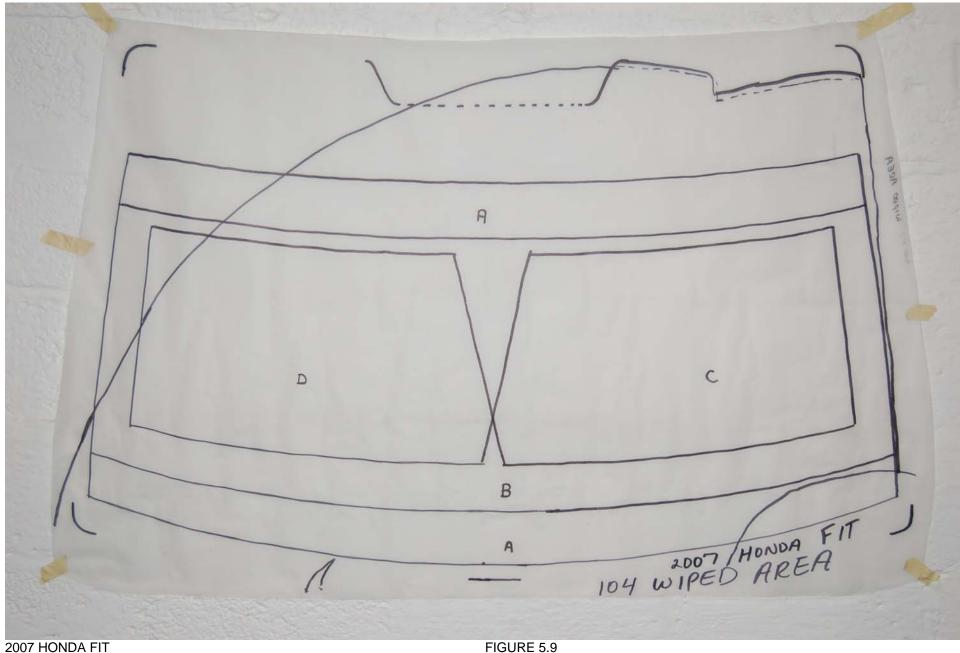
FIGURE 5.9 WIPED AREA TEST PATTERN

PERCENT WIPED					
WINDSHIELD AREA	ACTUAL	REQUIRED	PASS	FAIL	
А	92.3%	80%	Х		
В	95.4%	94%	Х		
С	100%	99%	Х

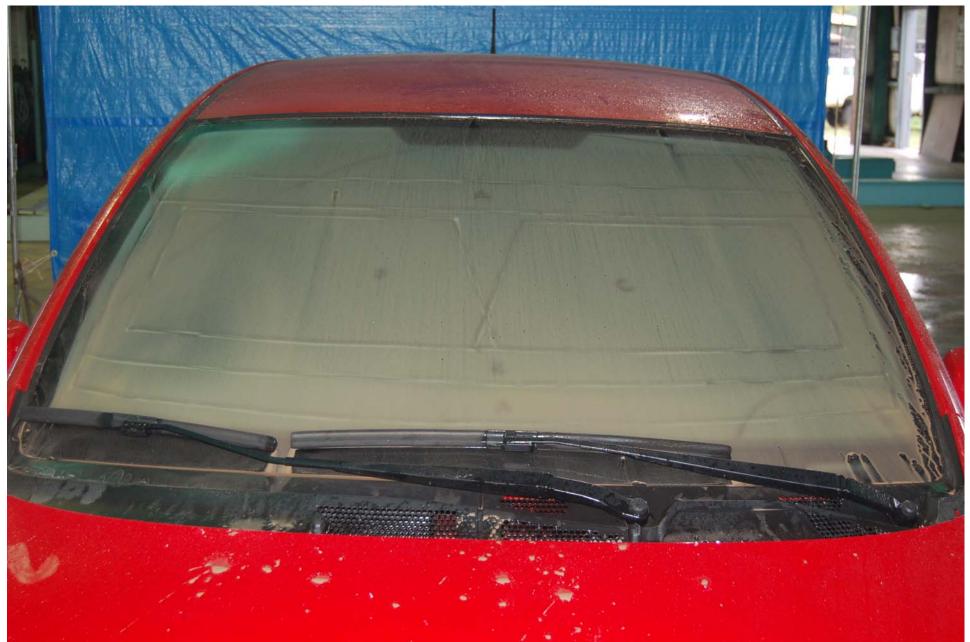
FIGURE 5.10 CAPABILITY TEST #1 PRE-COATED WINDSHIELD

The windshield glazing surface was coated with a mixture of water and fine grade test dust. Within 15 seconds following application of the water-dust mixture, the windshield wiper and washing system was activated in the high speed mode for ten complete cycles. The vehicle's engine was operating at idle RPM. The cleared areas of the windshield were marked on the inside windshield surface. After ten complete cycles the system was deactivated and the wiped area transferred to a windshield pattern.

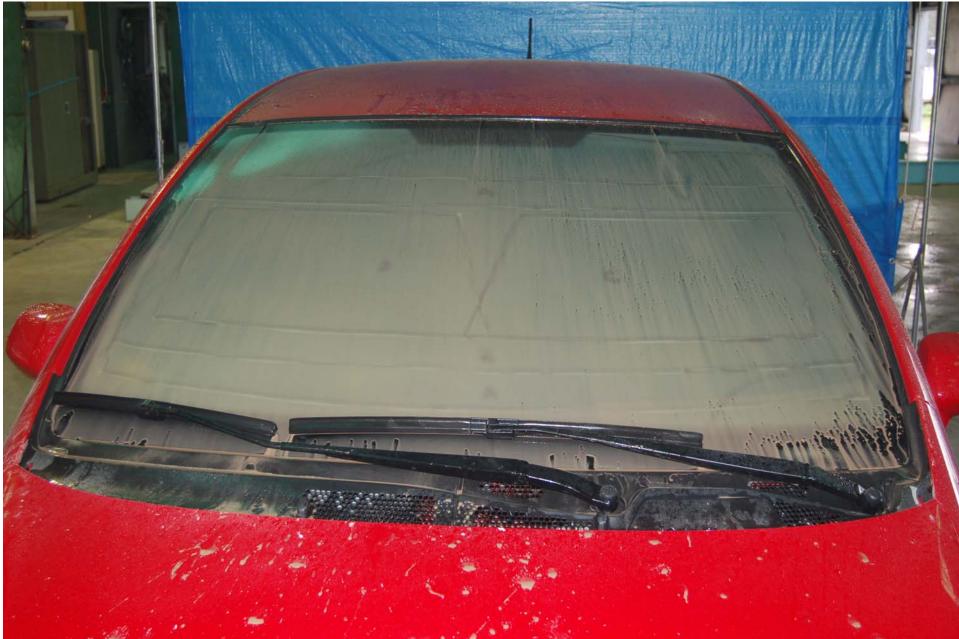
FIGURE 5.12 CAPABILITY TEST #2 PRE-COATED WINDSHIELD

The glazing surface was cleaned and dried. The water dust mixture was re-applied and the test repeated.

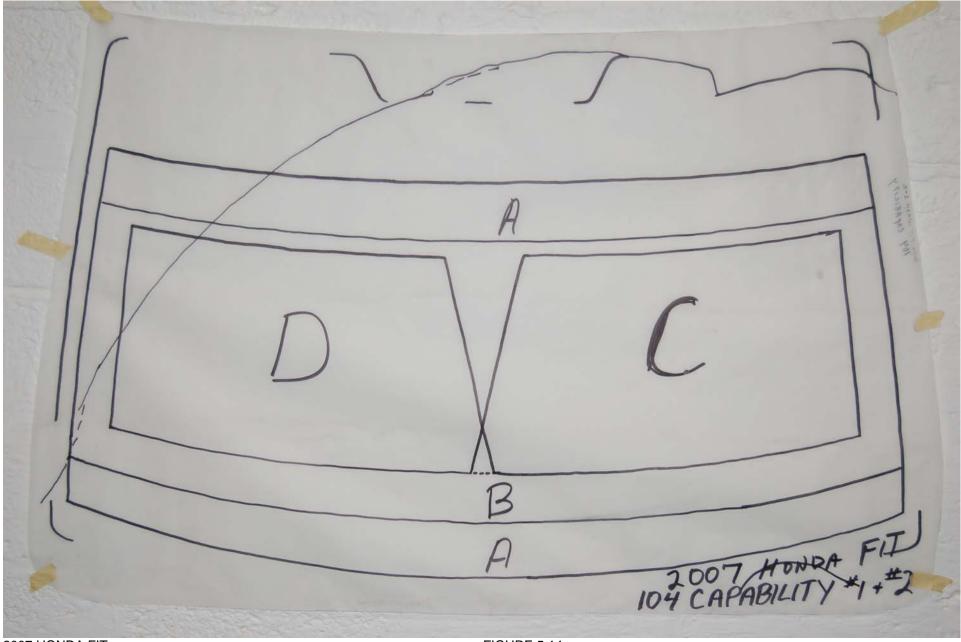
FIGURE 5.14 CAPABILITY TEST #1 AND #2 PATTERN

CLEARED AREA PERCENTAGES							
WINDSHIELD AREA	TEST 1	TEST 2	AVG	REQ'D*	PASS	FAIL	
А	93.7	93.7	93.7	75%	Х		
В	94.8	94.6	94.7	75%	Х		
С	100	100	100	75%	Х
