# Case Report

CASE # 2003-079-057

Vehicle one, a 1998 Ford Mustang, was traveling north in the number four lane of a six lane, physically divided, concrete, level, dry highway. Vehicle two, a 1995 Chevy Camaro, was traveling north in the number five lane of the same highway. Vehicle three, a 2003 Volvo XC90, was traveling north in the number five lane of the same highway. As vehicle one negotiated a lane change, from number five to number six, its left front plane contacted the right rear plane of vehicle three. Vehicle one spun counter clockwise then it's right rear contacted the right plane of vehicle two as vehicle two veered to the left to attempt to avoid the crash. Vehicle three, after being contacted by vehicle one on its right rear plane then spun clockwise and rolled over about six quarter turns, landing on its roof. Vehicle one was towed with moderate damage.

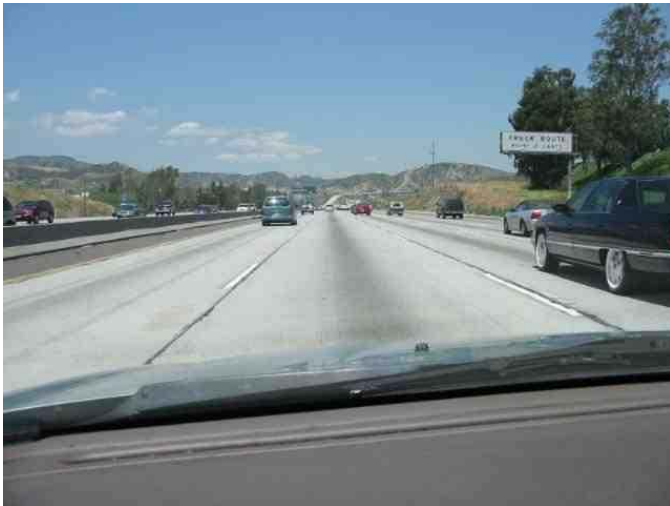
**CRASH SCENE**  
Vehicle Point of Impact - #

**ROLL OVER AREA OF V-3 AND FINAL REST (ID=210209247)**

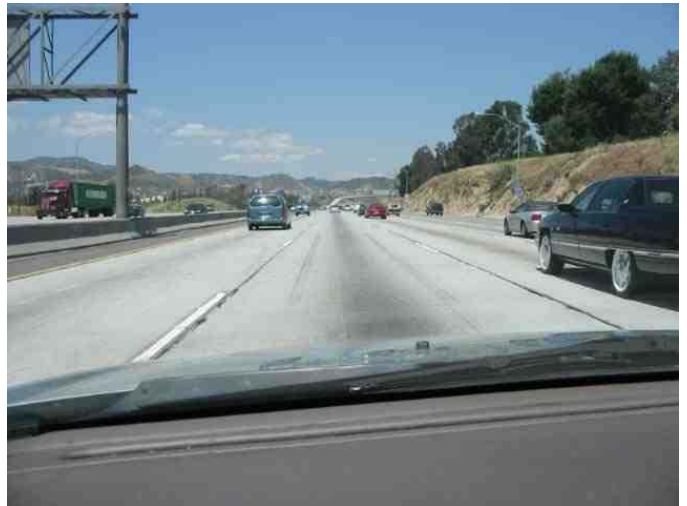
**CRASH SCENE**  
MISCELLANEOUS VIEWS

**SKIDS FROM OTHER VEHICLE'S AT TIME OF CRASH (ID=210209245)**

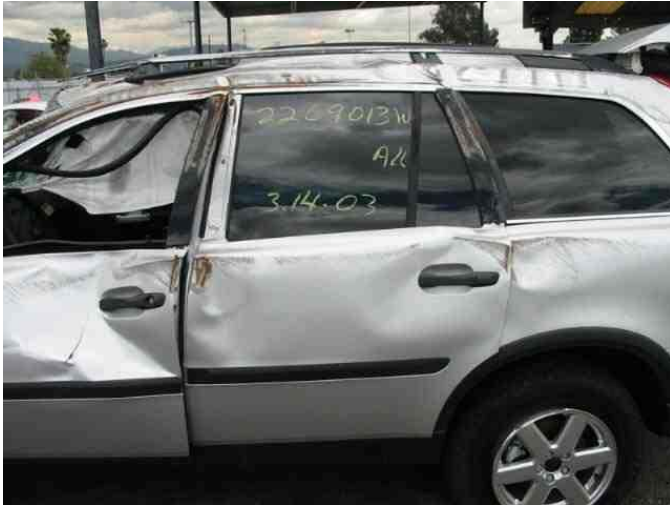
VEHICLE 3  
LEFT

LEFT REAR DOOR AREA

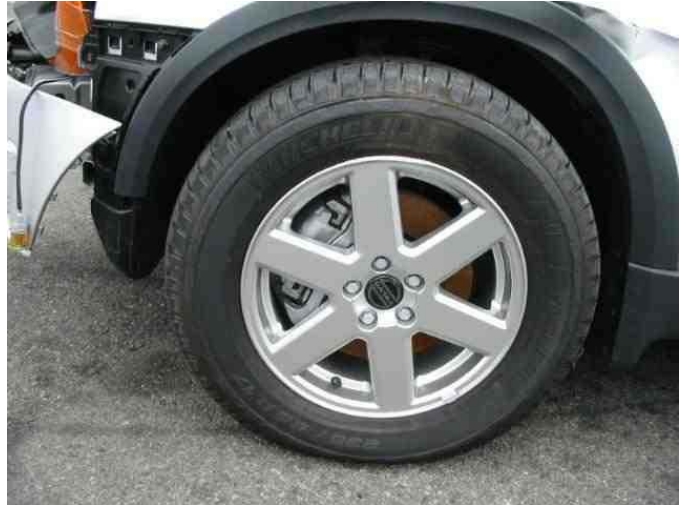
VEHICLE 3  
LEFT

LEFT FRONT TIRE AND WHEEL

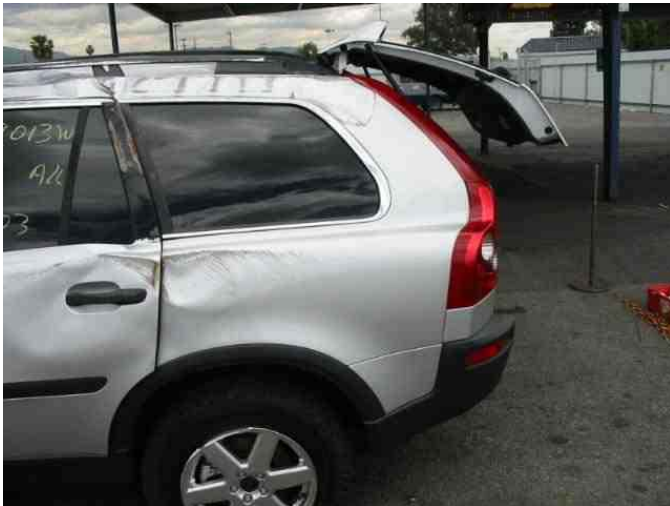
VEHICLE 3  
LEFT

LEFT REAR AREA

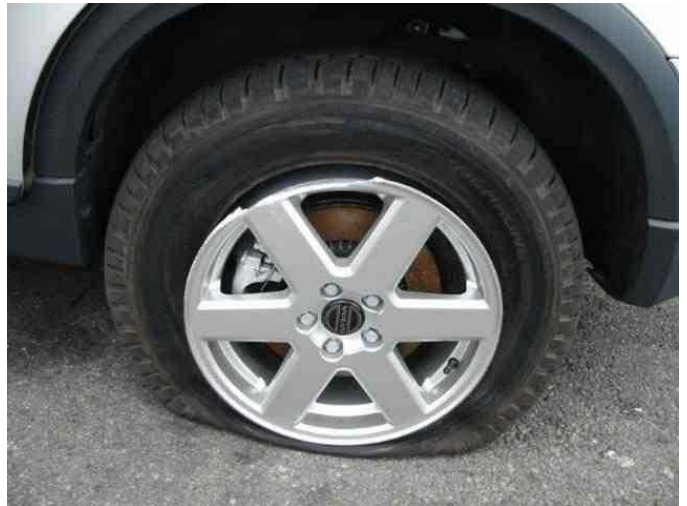
VEHICLE 3  
LEFT

LEFT REAR TIRE AND WHEEL

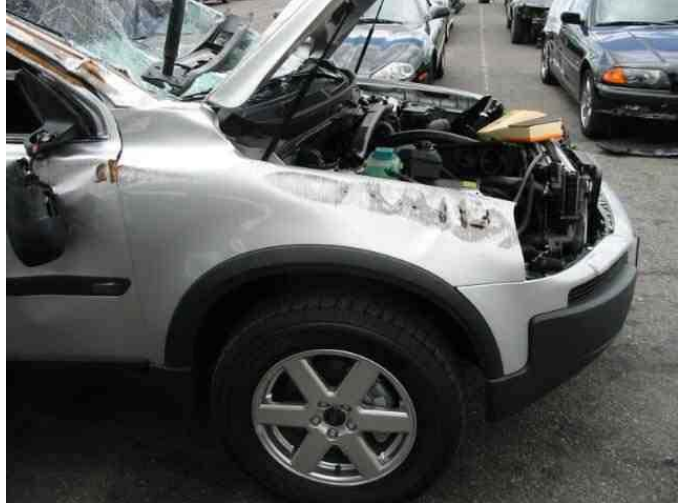
RIGHT FRONT AREA

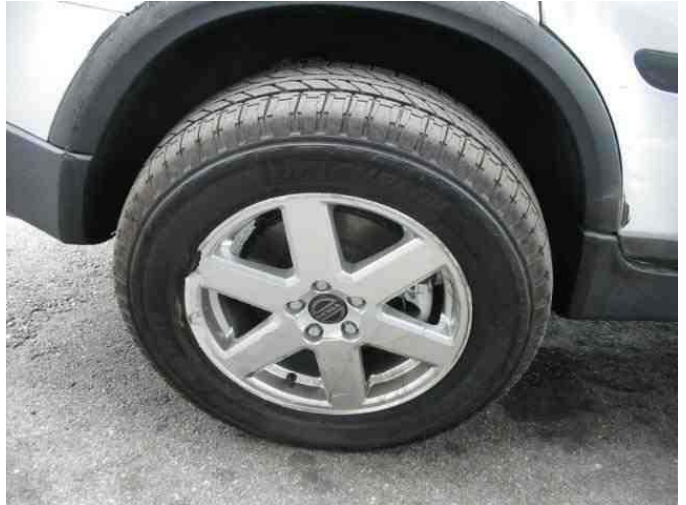
RIGHT REAR TIRE AND WHEEL

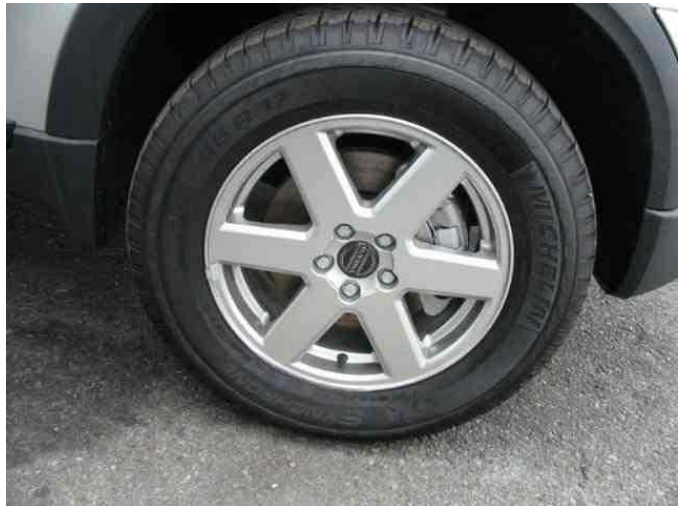
RIGHT FRONT TIRE AND WHEEL

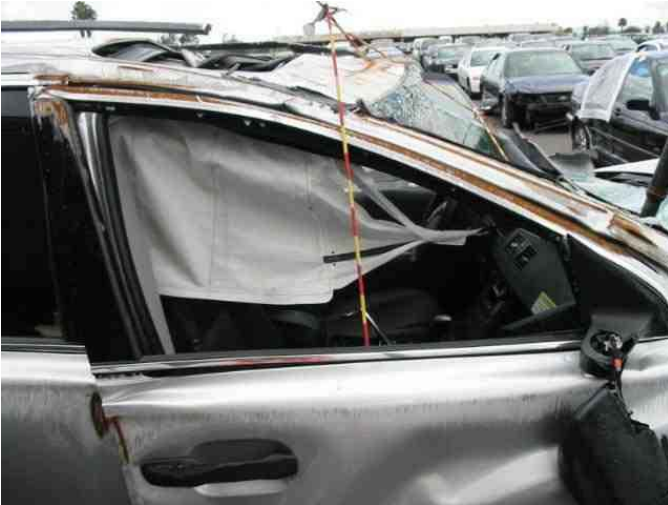
RIGHT FRONT DOOR AREA MID (ID=210206488)

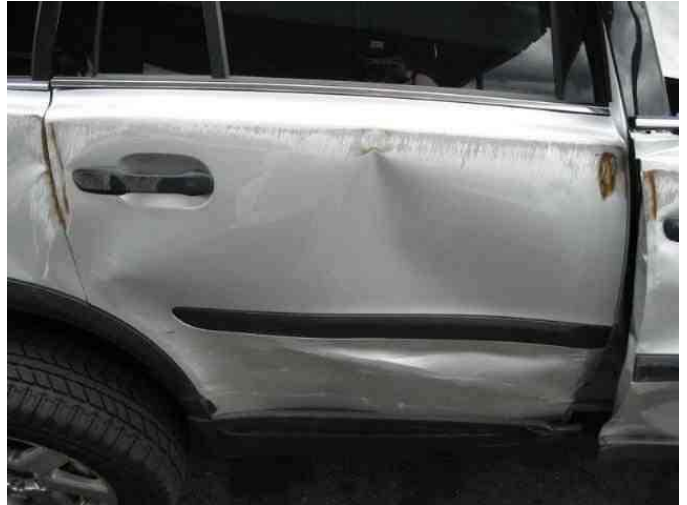
RIGHT REAR DOOR

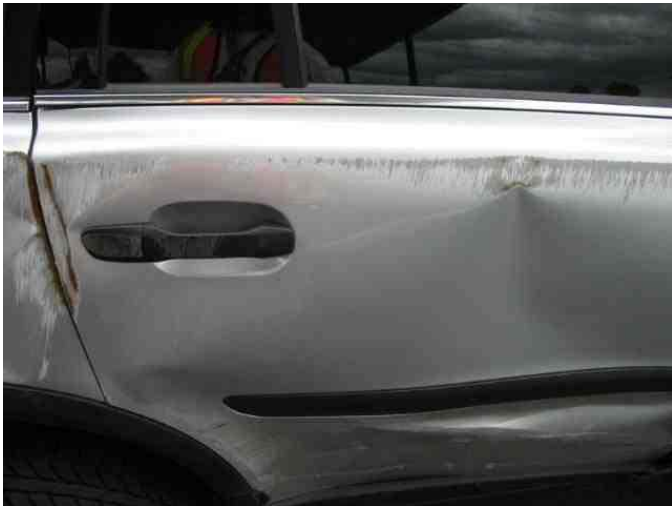
RIGHT REAR DOOR

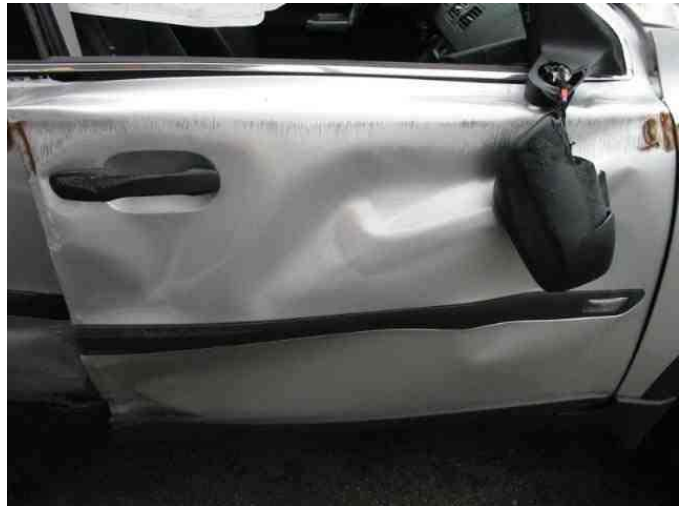
RIGHT FRONT DOOR

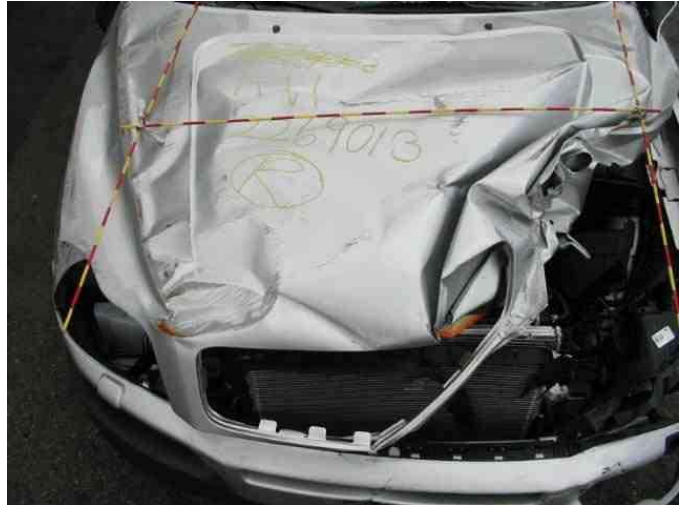
HOOD AREA

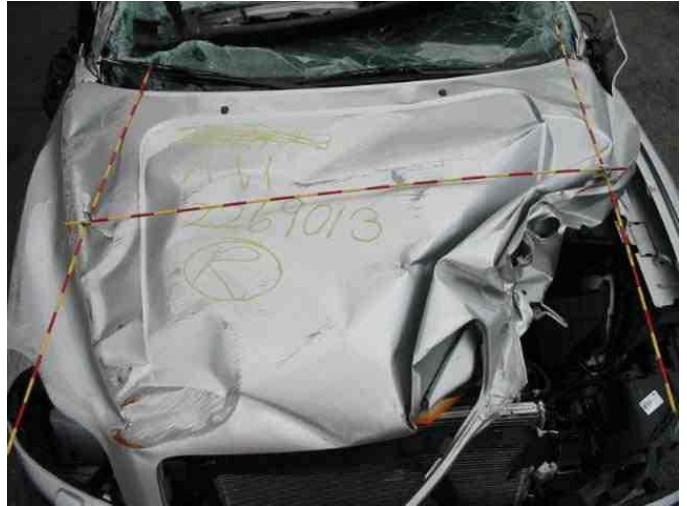
HOOD AREA

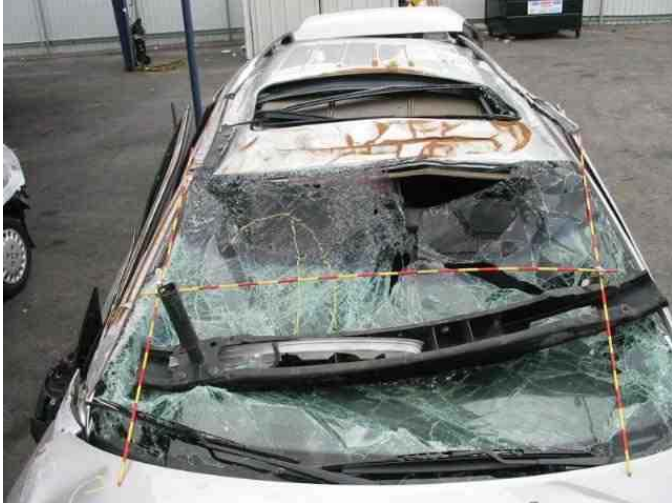
WINDSHIELD AREA

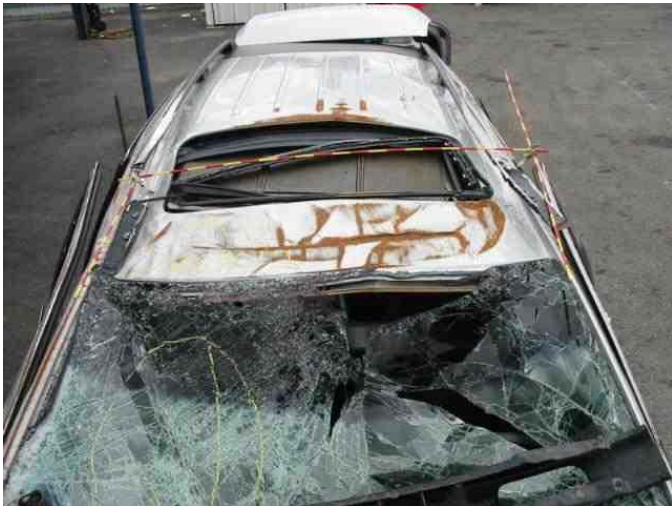
FRONT ROOF AREA

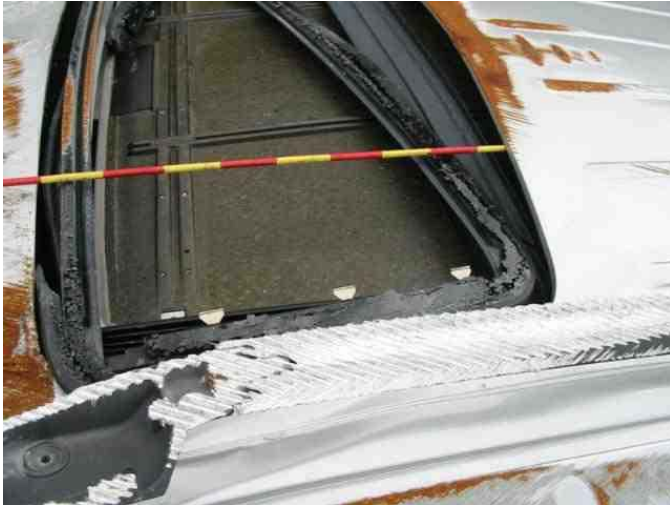
SUN ROOF

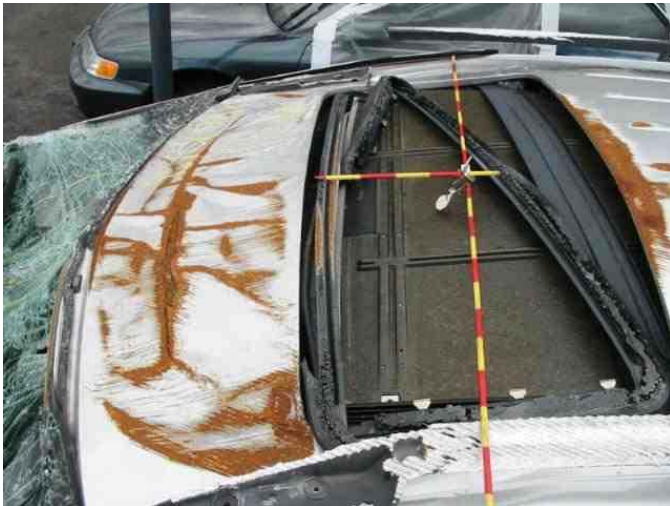
SUN ROOF

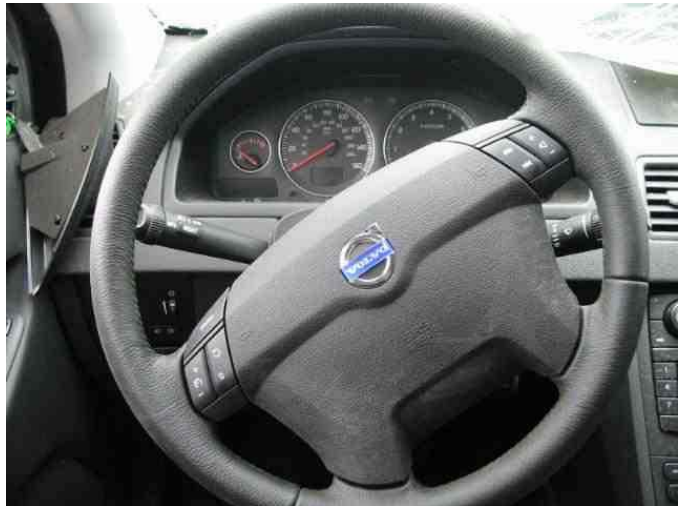
NON DEPLOYED AIR BAG IN  
STEERING WHEEL

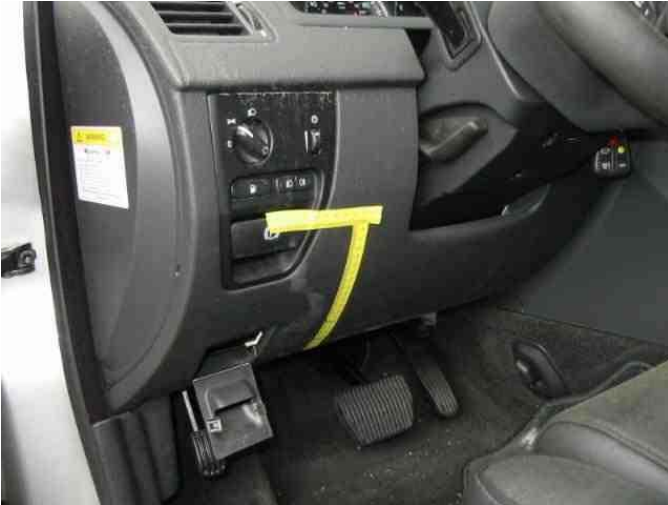
CONTACT ON DRIVERS LEFT SIDE (ID=210206641)

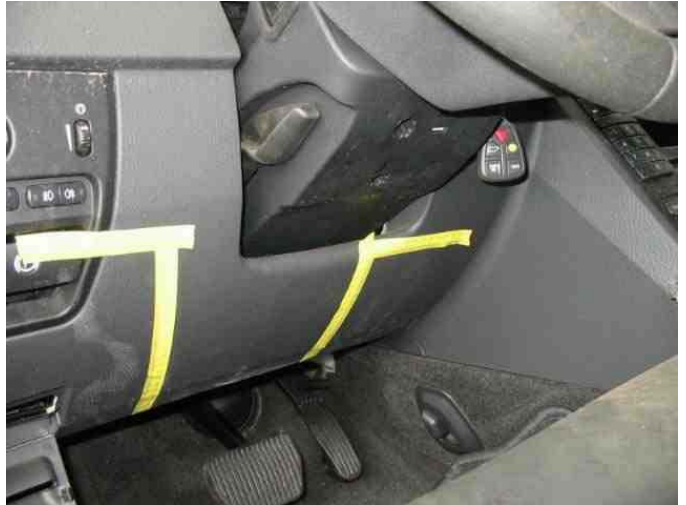
CONTACT ON DRIVER LEFT SIDE (ID=210206642)

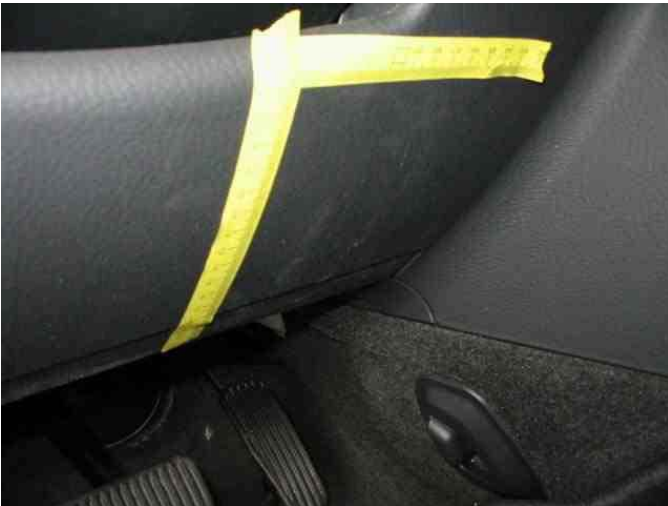
CONTACT ON DRIVERS LEFT AND RIGHT LOWER (ID=210206644)

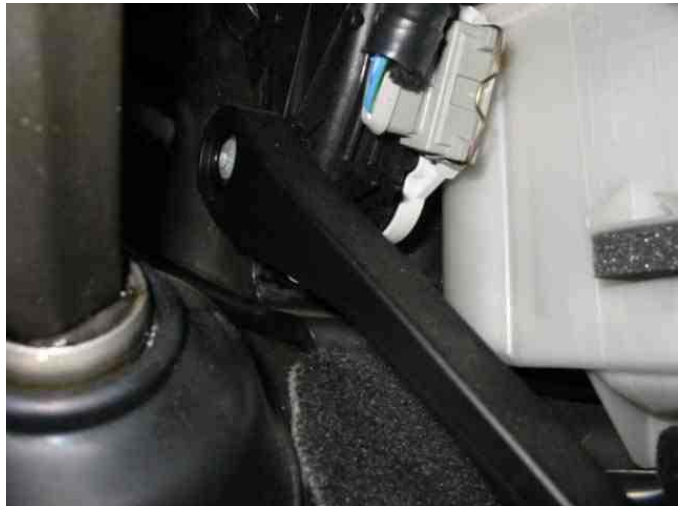
CONTACT ON DRIVERS RIGHT SIDE (ID=210206643)

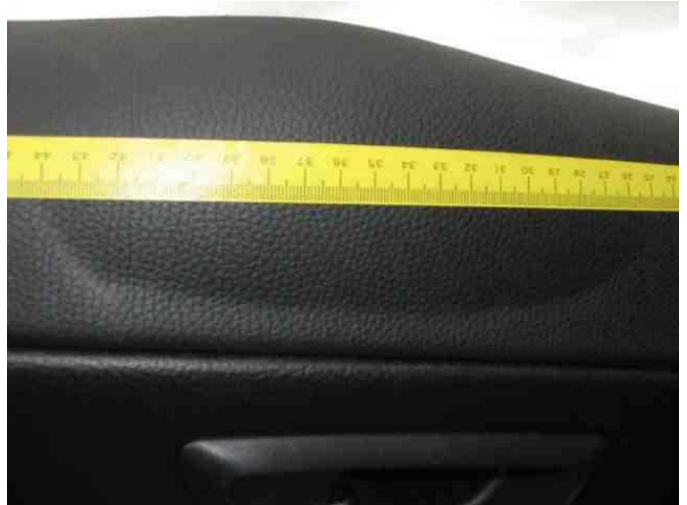
VEHICLE 3  
INTERIOR 1ST ROW

CONTACT ON DRIVERS DOOR

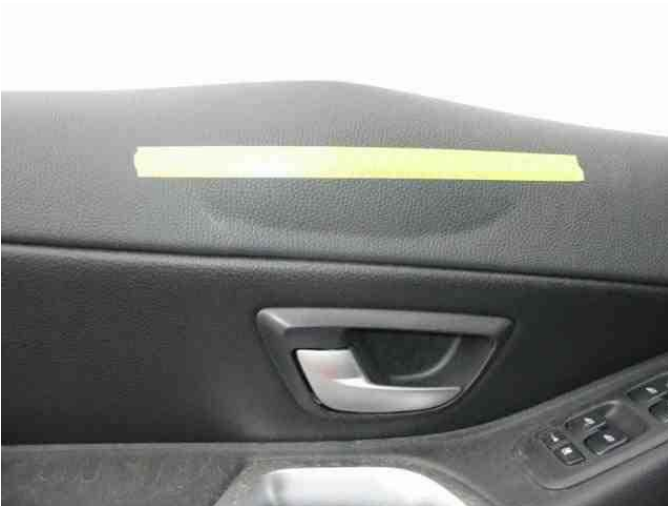
VEHICLE 3  
INTERIOR 1ST ROW

CONTACT ON DRIVERS DOOR

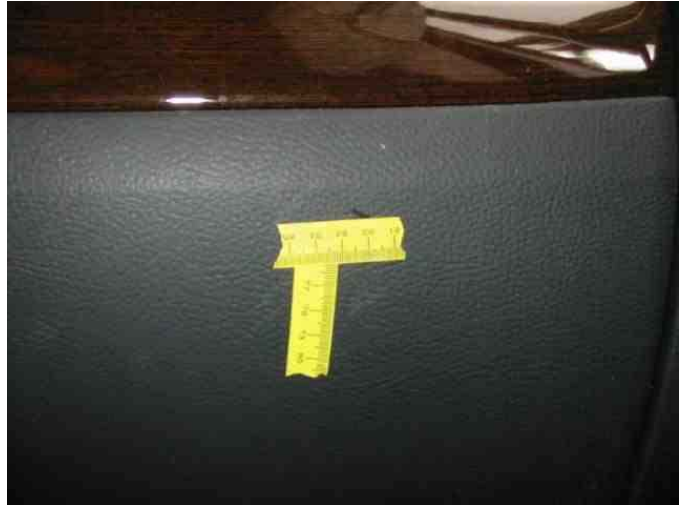
VEHICLE 3  
INTERIOR 1ST ROW

CONTACT ON PASSENGER SIDE (ID=210206652)

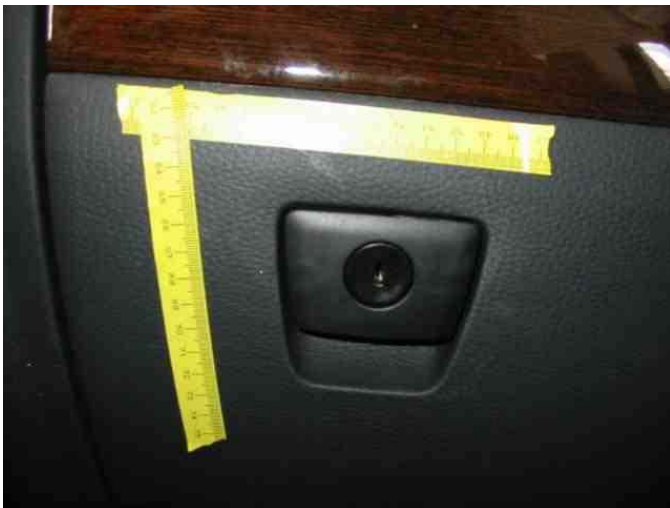
VEHICLE 3  
INTERIOR 1ST ROW

CONTACT ON PASSENGER SIDE (ID=210206651)

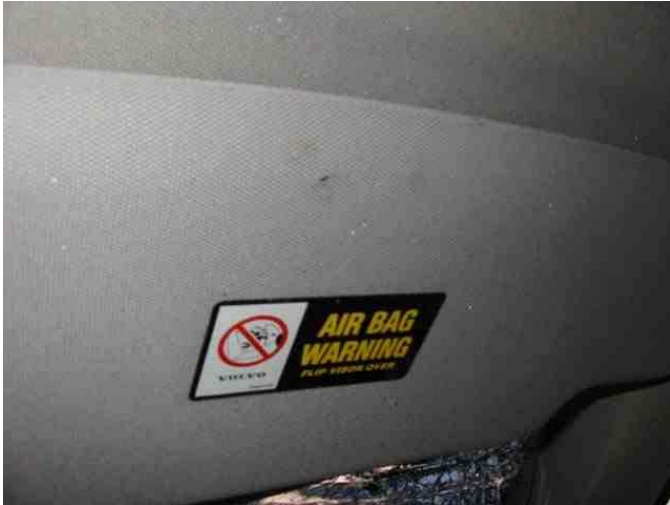
VEHICLE 3  
INTERIOR 1ST ROW

AIR BAG INFO IN VISOR

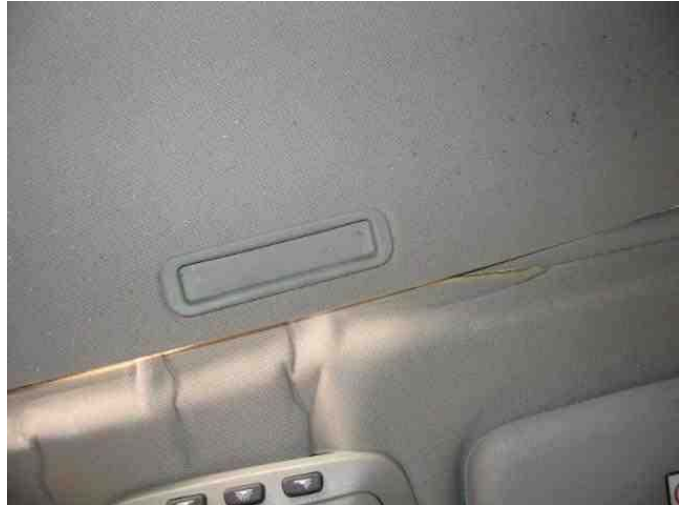
VEHICLE 3  
INTERIOR 1ST ROW

SUN ROOF SLIGHTLY OPEN

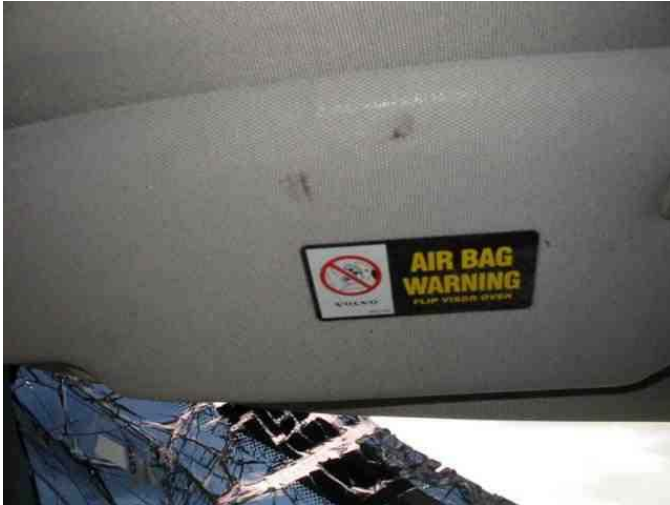
VEHICLE 3  
INTERIOR 1ST ROW

POSSIBLE CONTACT SPOTS ON  
DRIVERS VISOR (ID=210206659)

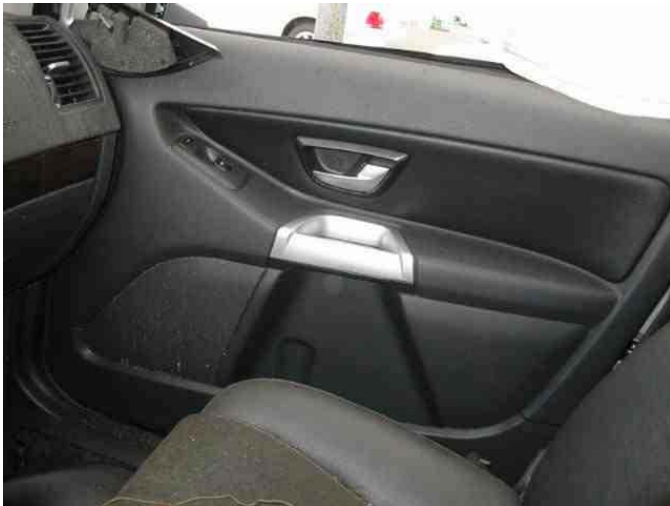
VEHICLE 3  
INTERIOR 1ST ROW

RIGHT DOOR PANEL / NO CONTACT (ID=210206661)

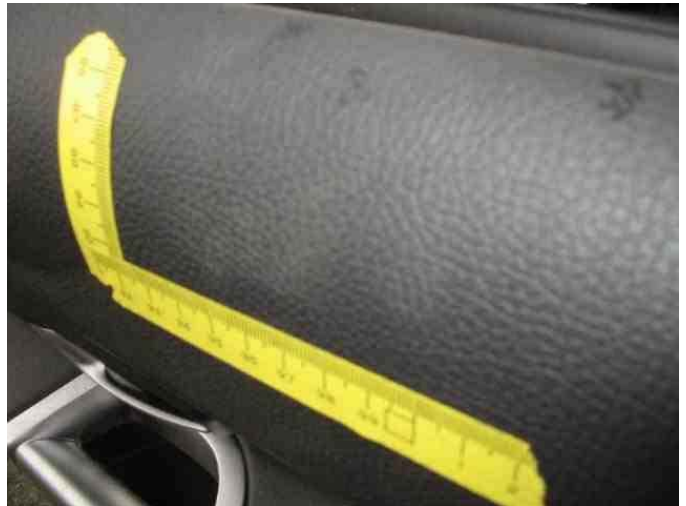
VEHICLE 3  
INTERIOR 1ST ROW

CONTACT ON DRIVERS DOOR (ID=210206663)

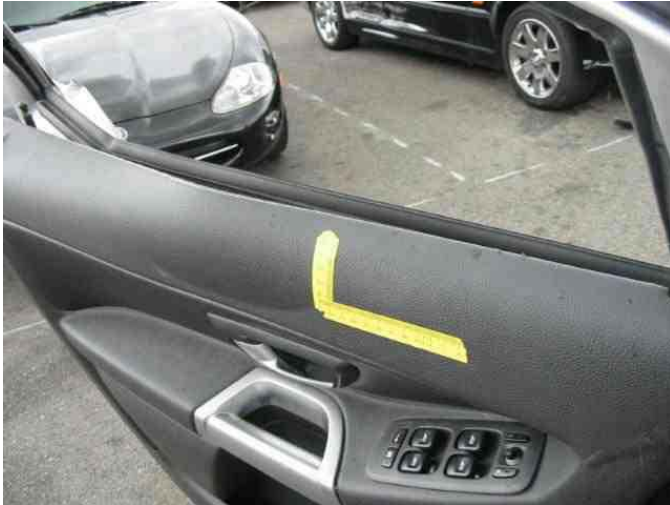
VEHICLE 3  
INTERIOR 1ST ROW

CONTACT ON DRIVERS DOOR (ID=210206664)

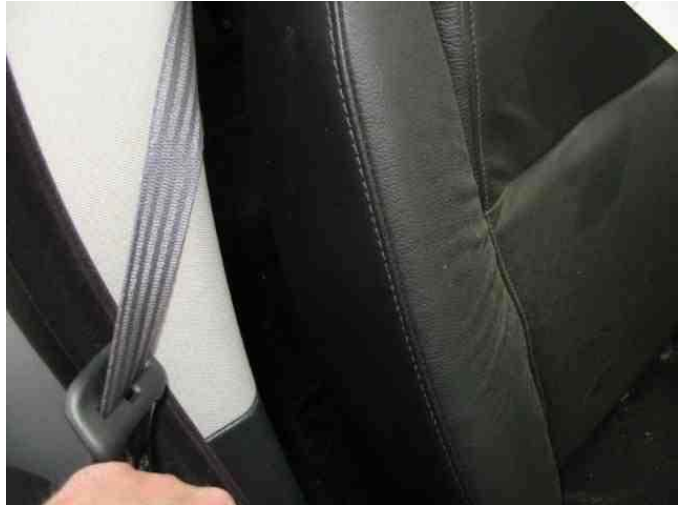
VEHICLE 3  
INTERIOR 1ST ROW

RIGHT SEAT BACK / NO SIGN OF AIR BAG (ID=210206667)

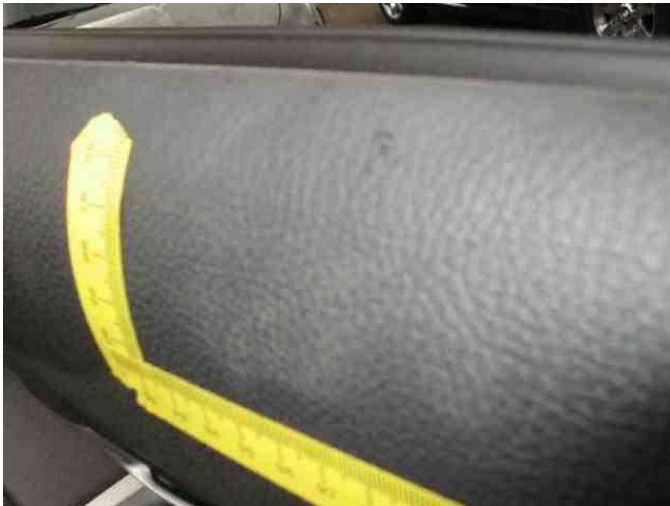
VEHICLE 3  
INTERIOR 1ST ROW

CONTACT ON DRIVERS DOOR (ID=210206665)

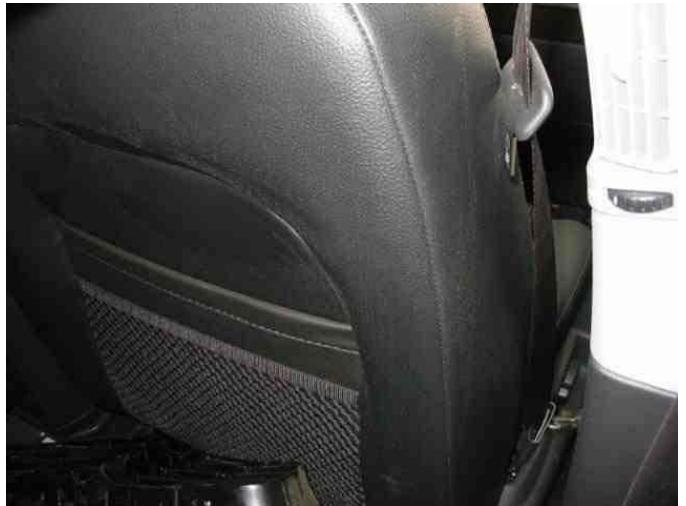
VEHICLE 3  
INTERIOR 1ST ROW

RIGHT SIDE SEAT BACK / NO SIGN OF AIR BAG (ID=210206668)

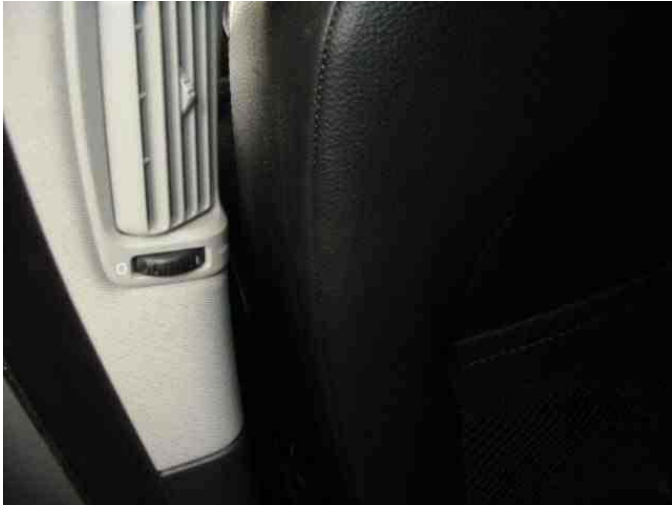
VEHICLE 3  
INTERIOR 1ST ROW

LEFT SEAT BACK NO SIGN OF AIR BAG (ID=210206669)

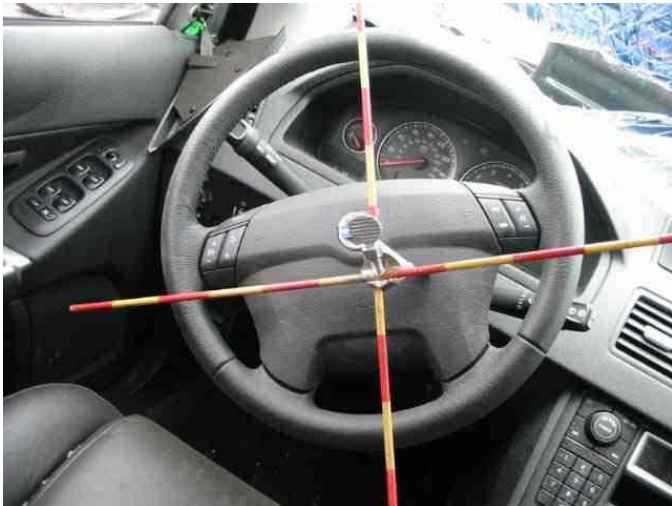
VEHICLE 3  
Int 1st Row - Driver Air Bag

NON DEPLOYED IN STEERING WHEEL (ID=210206517)

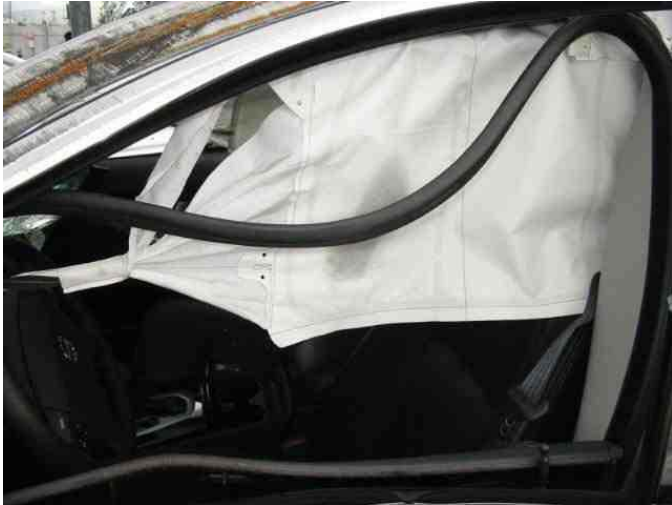
VEHICLE 3  
Int 1st Row - Driver Air Bag

CONTACT ON LEFT FRONT CURTAIN (ID=210206637)

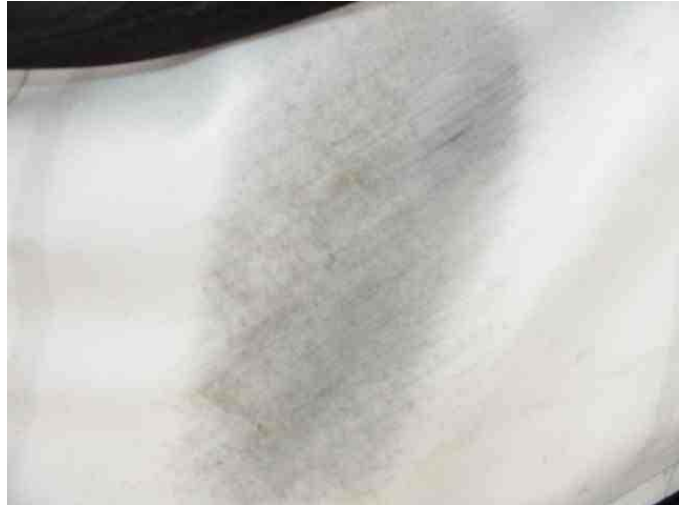
VEHICLE 3  
Int 1st Row - Driver Air Bag

CLOSE UP OF CONTACT ON LEFT FRONT CURTAIN (ID=210206639)

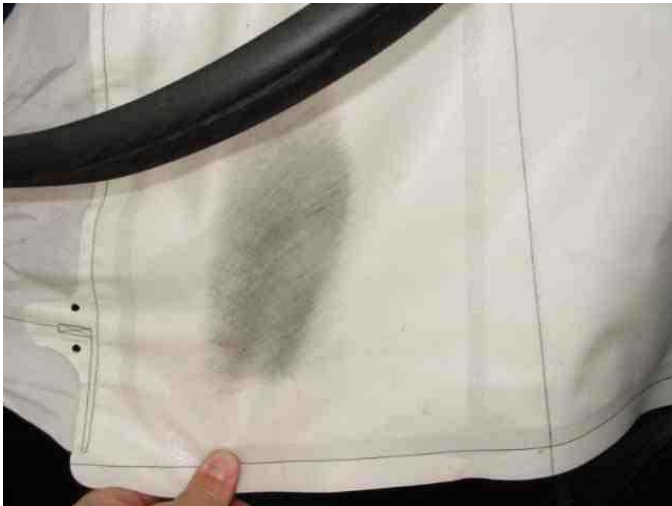
VEHICLE 3  
Int 1st Row - Driver Air Bag

CLOSE UP OF CONTACT ON LEFT FRONT CURTAIN (ID=210206638)

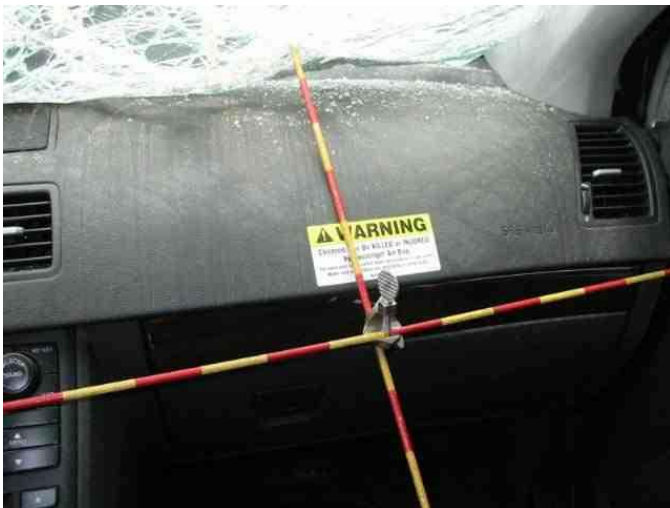
VEHICLE 3  
Int 1st Row - Passenger Air Bag

AIR BAG NON DEPLOYED

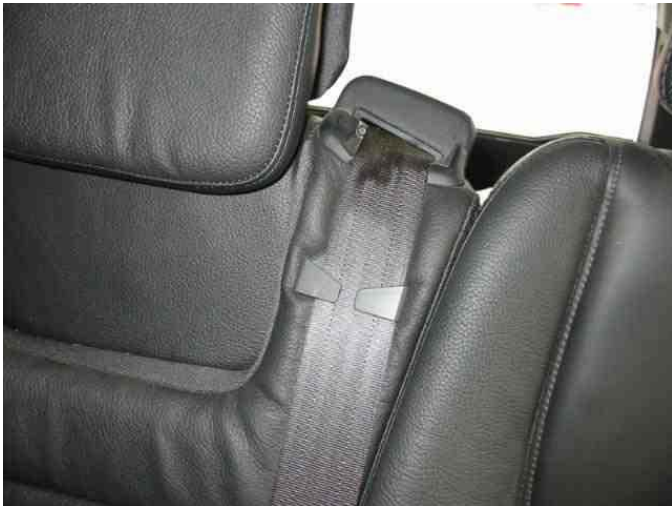
VEHICLE 3  
INTERIOR 2ND ROW

RIGHT PRETENSIONER DEPLOYED

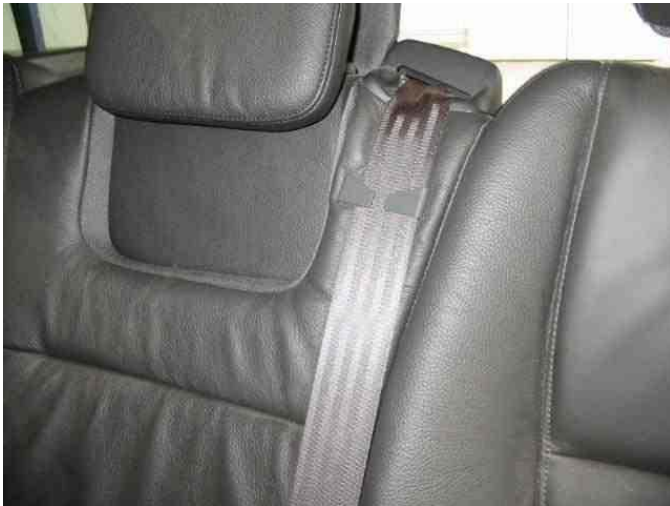
VEHICLE 3  
INTERIOR 2ND ROW

CENTER SEAT BELT PRETENSIONER (ID=210206588)  
DEPLOYED

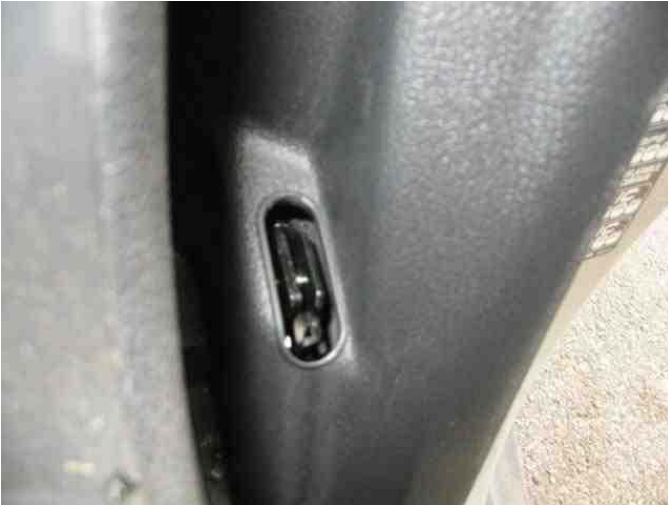
VEHICLE 3  
INTERIOR 2ND ROW

LEFT SEAT BELT LOWER FASTENER (ID=210206589)  
REMOVED

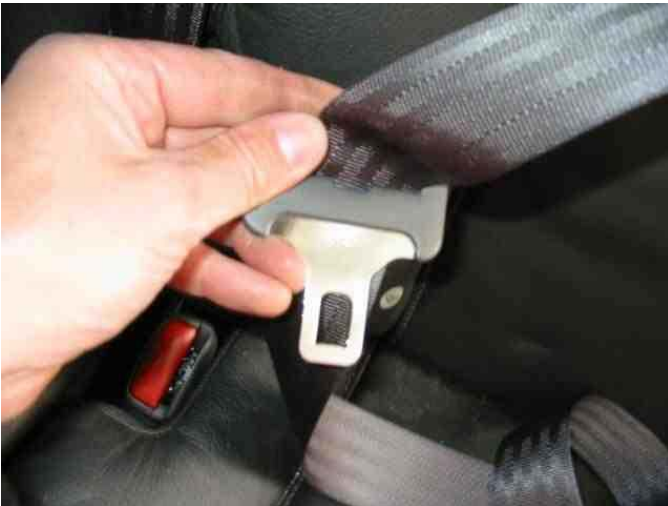
VEHICLE 3  
INTERIOR 2ND ROW

LEFT SEAT BELT LOWER FASTENER (ID=210206592)  
DISCONNECTED / PSB

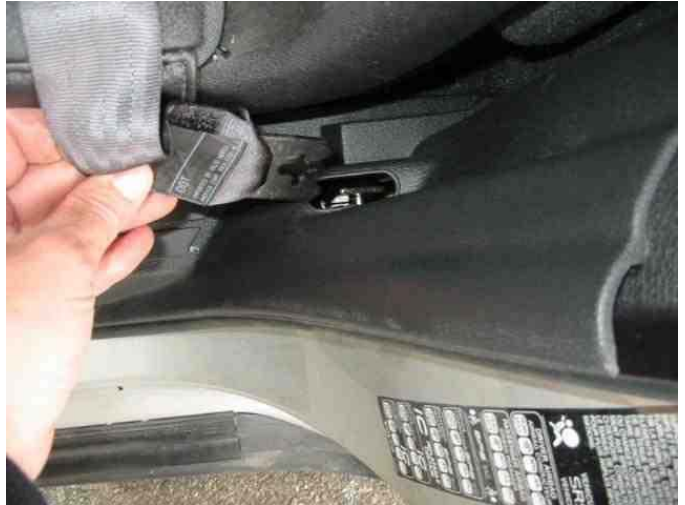
VEHICLE 3  
INTERIOR 2ND ROW

LEFT SEAT BELT LOWER LATCH (ID=210206594)  
DISCONNECTED / PSB

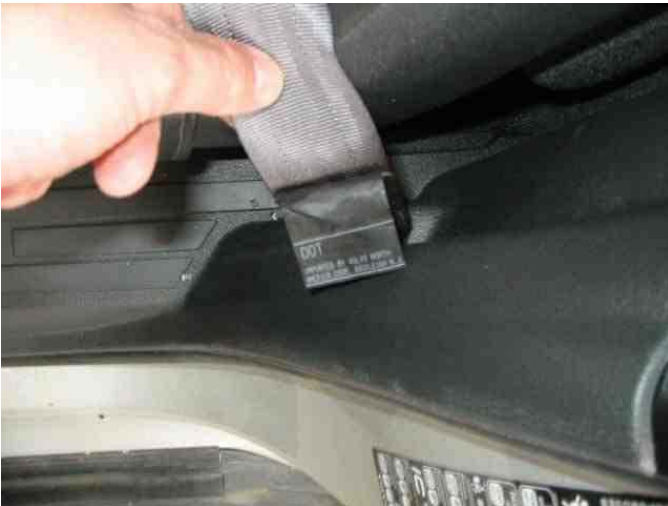
VEHICLE 3  
INTERIOR 2ND ROW

LEFT LOWER SEAT BELT SHOULD (ID=210206596)  
BE FASTENED

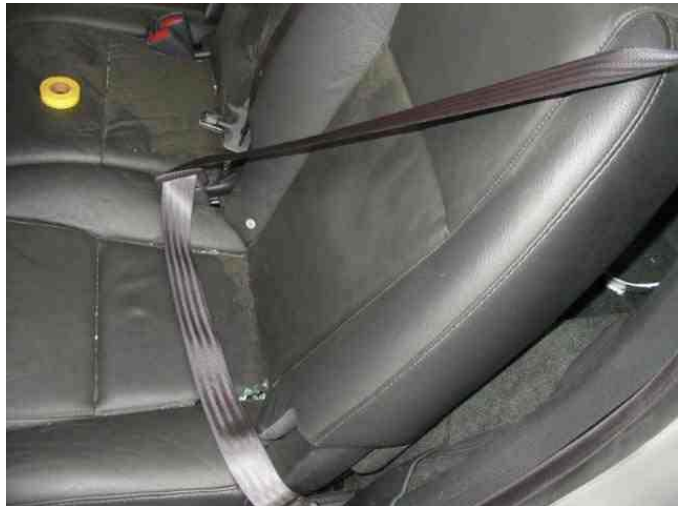
VEHICLE 3  
INTERIOR 2ND ROW

LEFT LOWER SEAT BELT SHOULD (ID=210206595)  
BE FASTENED

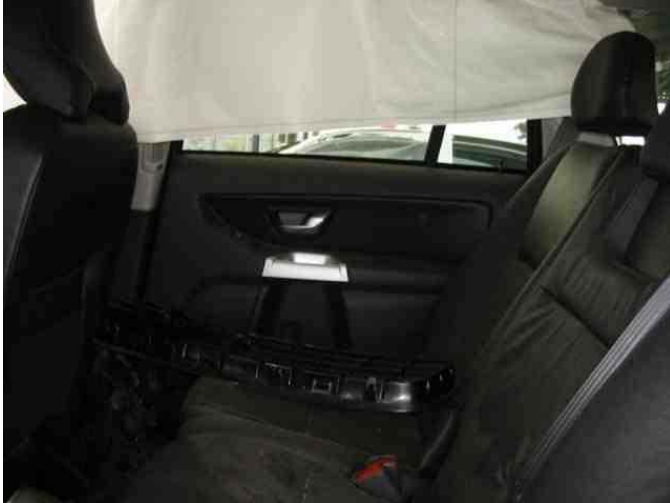
VEHICLE 3  
INTERIOR 2ND ROW

LOOKING INTO LEFT REAR DOOR (ID=210206601)  
WITH DEPLOYED CURTAIN

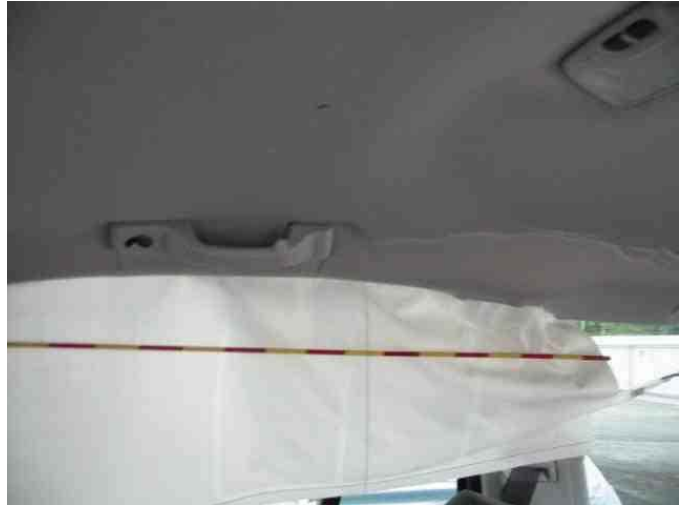
RIGHT SIDE CURTAIN (ID=210206560)

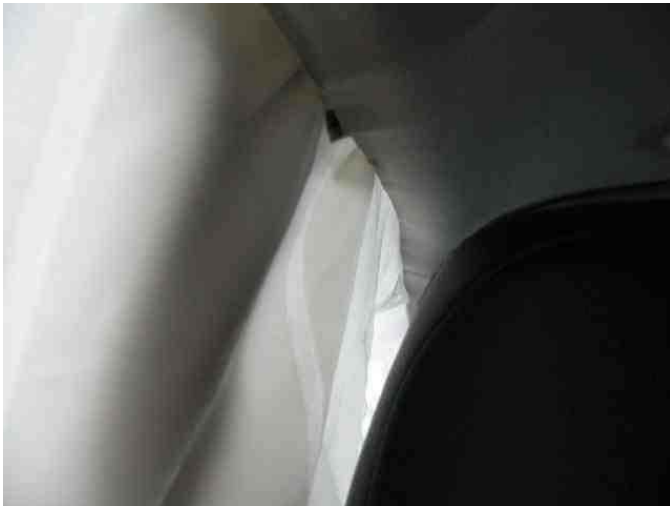
SIDE AIR BAG CURTAIN COMING OUT  
OF ROOF (ID=210206559)

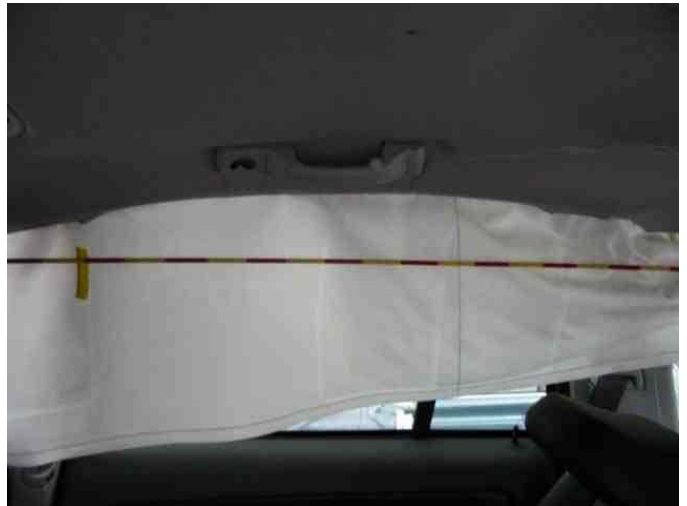
RIGHT SIDE CURTAIN (ID=210206561)

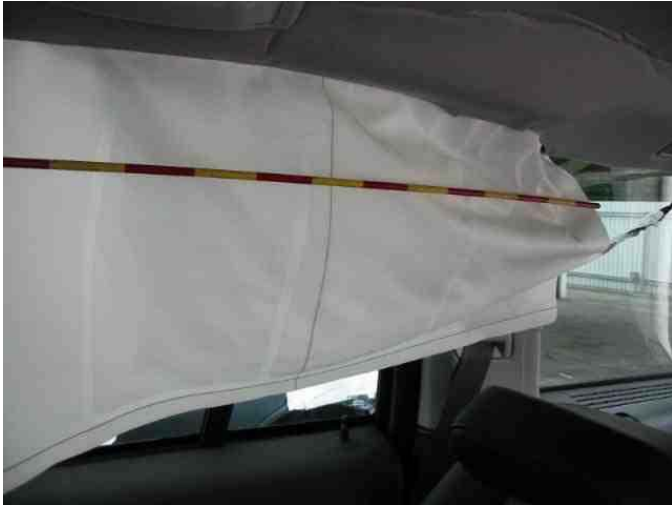
RIGHT SIDE CURTAIN

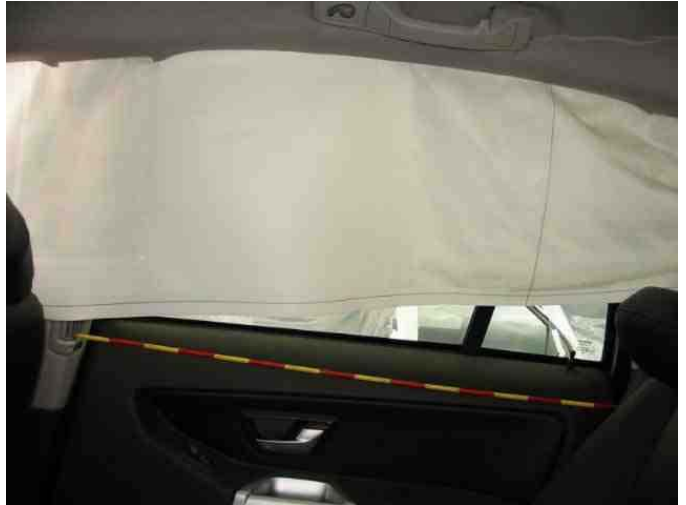
RIGHT SIDE CURTIAN

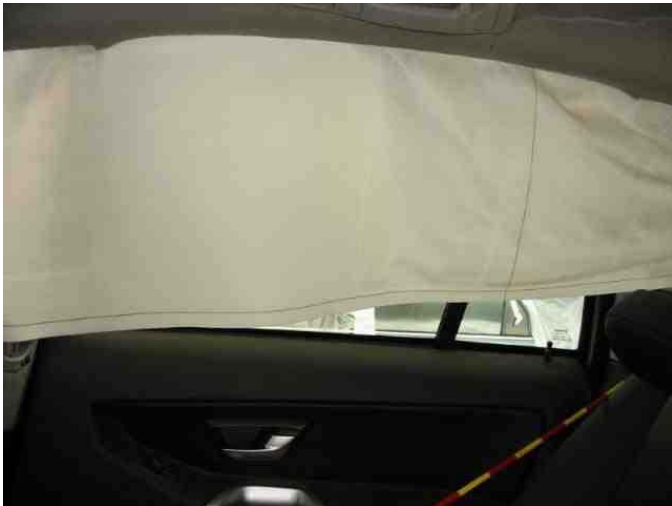
RIGHT SIDE CURTAIN

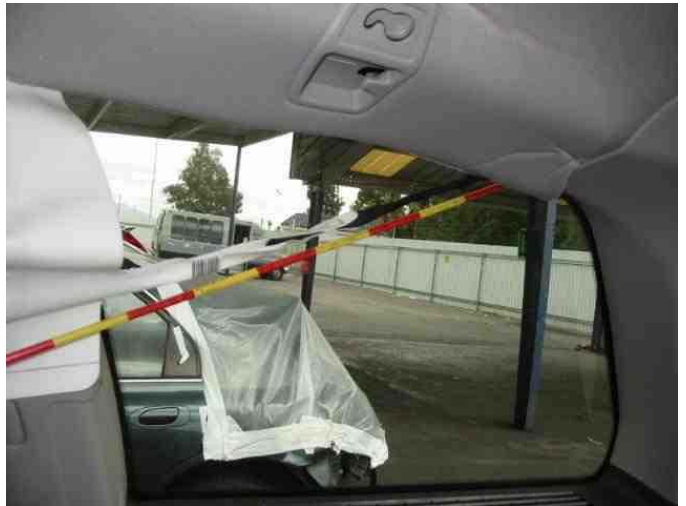
RIGHT SIDE REAR TETHER

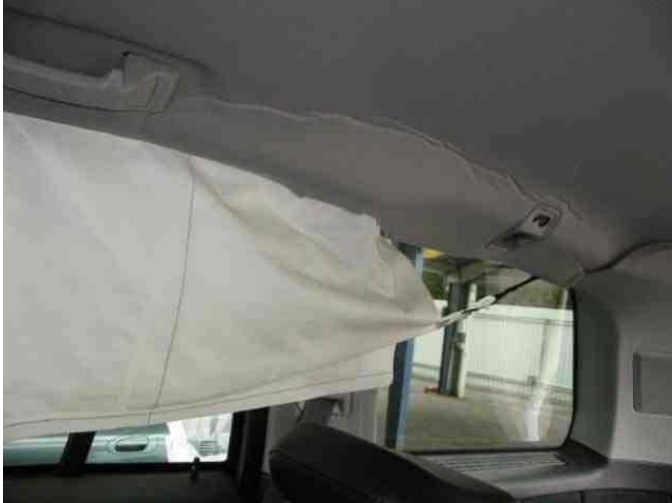
RIGHTSIDE REAR CURTAIN TO TETHER (ID=210206568)

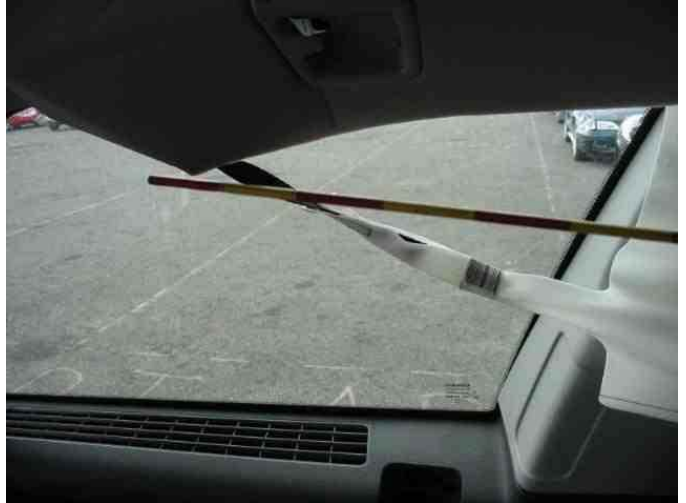
LEFT REAR TETHER (ID=210206613)

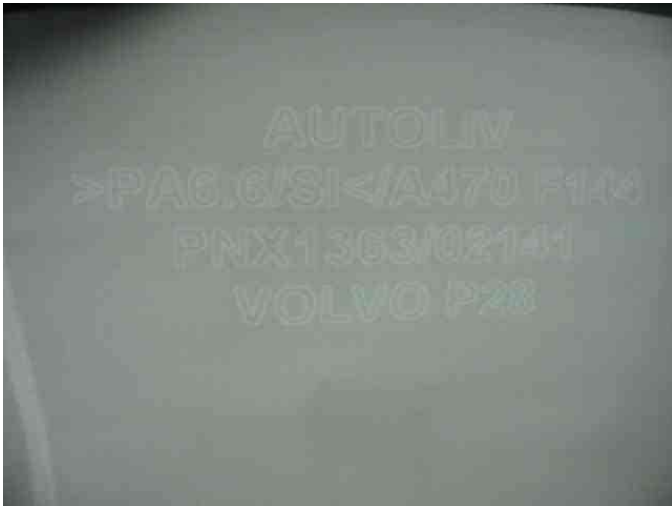
WRITING ON LEFT SIDE CURTAIN (ID=210206612)

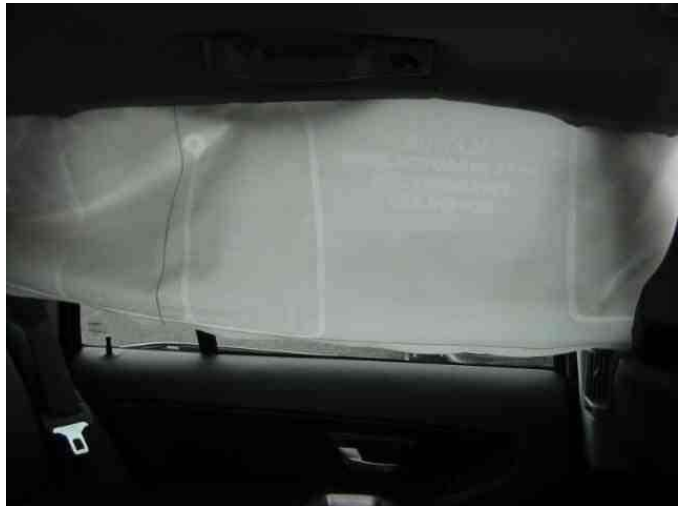
LEFT CURTAIN (ID=210206615)

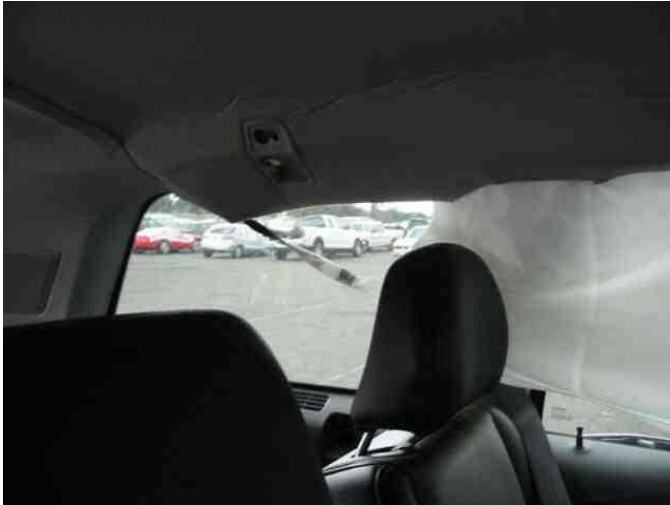
LEFT REAR TETHER

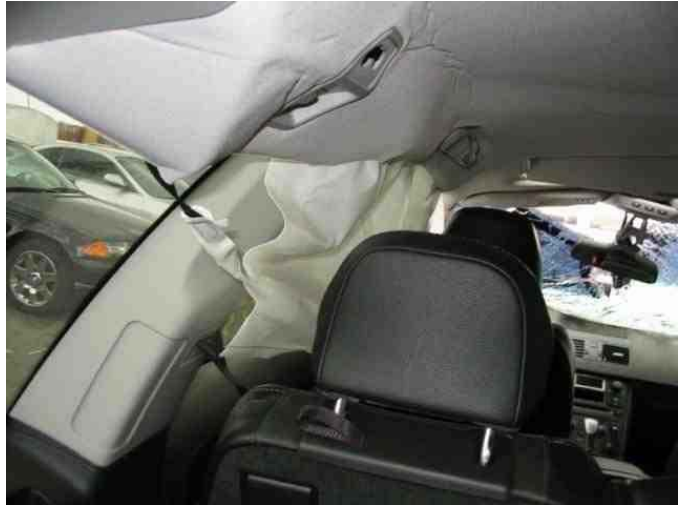
BACK TO FRONT OF LEFT CURTAIN (ID=210206627)
