# Case Report

CASE # 2003-079-057

Vehicle one, a 1998 Ford Mustang, was traveling north in the number four lane of a six lane, physically divided, concrete, level, dry highway. Vehicle two, a 1995 Chevy Camaro, was traveling north in the number five lane of the same highway. Vehicle three, a 2003 Volvo XC90, was traveling north in the number five lane of the same highway. As vehicle one negotiated a lane change, from number five to number six, its left front plane contacted the right rear plane of vehicle three. Vehicle one spun counter clockwise then it's right rear contacted the right plane of vehicle two as vehicle two veered to the left to attempt to avoid the crash. Vehicle three, after being contacted by vehicle one on its right rear plane then spun clockwise and rolled over about six quarter turns, landing on its roof. Vehicle one was towed with moderate damage.

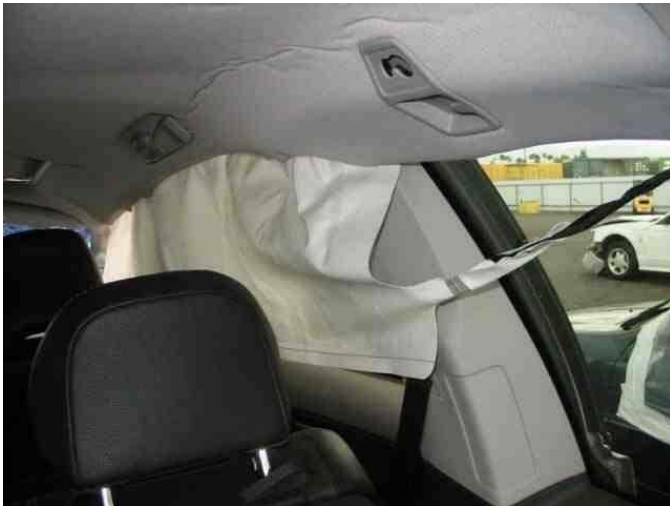
BACK TO FRONT OF RIGHT CURTAIN (ID=210206626)

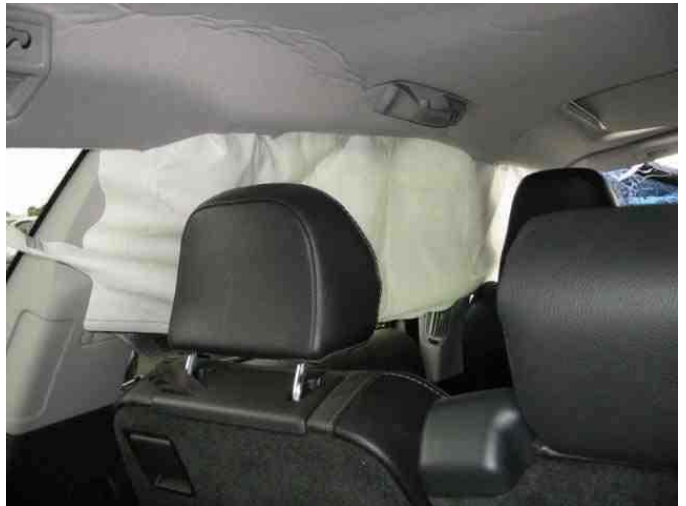
BACK TO FRONT OF LEFT CURTAIN (ID=210206628)

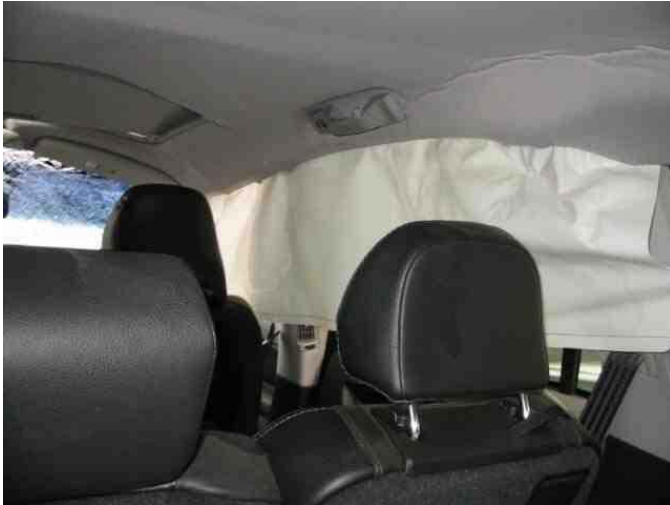
BACK TO FRONT OF RIGHT CURTAIN (ID=210206629)

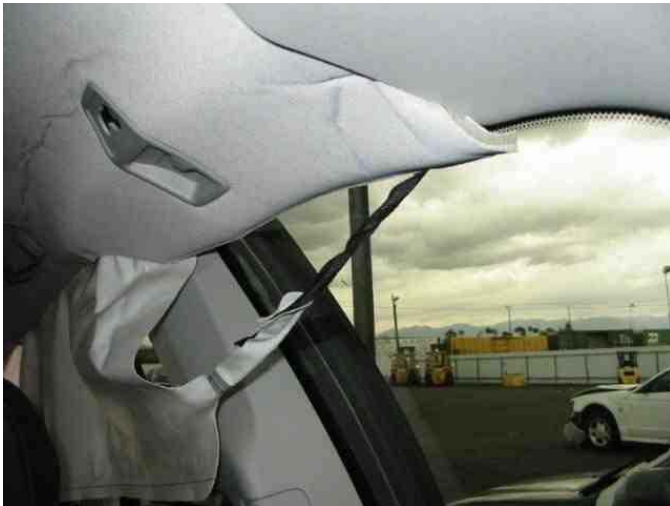
RIGHT REAR TETHER (ID=210206630)
