## Case 391 : Narrative

Case Vehicle (A): 1999 Chevrolet	Vehicle (B): 2002 Dodge
Type: Metro, 2-door hatchback	Type: Stratus ES, 4-door sedan
Driver: 20-year-old male	Driver: 76-year-old female
CDC: 01-FDEW-3	CDC: 11-FLEW-1

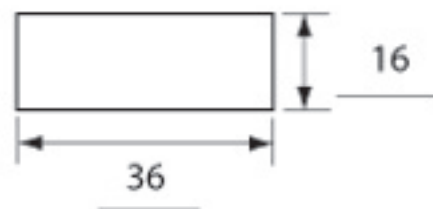
Passenger Airbag Door

Single Door
