Case 443 : Narrative

Case Vehicle (A): 2002 Buick	Vehicle (B): 2003 Pontiac
Type: Century Custom, 4-door sedan	Type: Grand Am SE, 4-door sedan
Driver: 34-year-old male	Driver: 82-year-old female
CDC: 11-FYEW-2	CDC: 01-FDEW-2

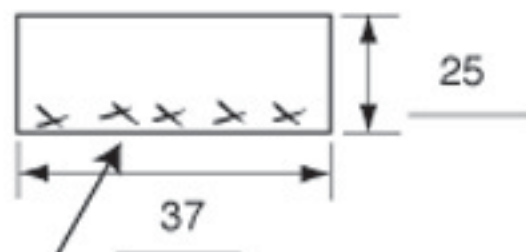
Passenger Airbag Doors

scuffs from hitting windshield
