Case 444 : Narrative

Case Vehicle (A): 2000 Mazda	Vehicle (B): 2002 Ford
Type: Miata MX-5, 2-door convertible	Type: Econoline E150, 4 x 2, van
Driver: 21-year-old male	Driver: 36-year-old male
CDC: 02-FDEW-2	CDC: 10-LYEW-3, 12-FCEN-1

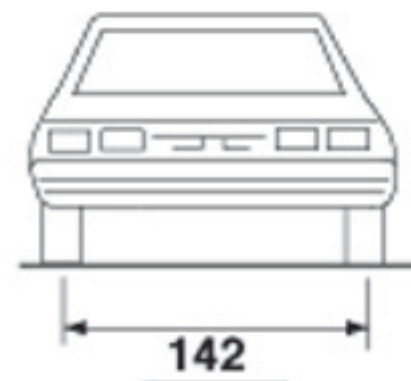
Bumper shift to left

Max. crush to center front bumper
