Case 455 : Narrative

Case Vehicle (A): 1999 Chevrolet	Vehicle (B): 1983 Ford
Type: Suburban LS, 4x4, 4-door SUV	Type: E150 Club wagon, 4x2
Driver: 38-year-old male	Driver: 37-year-old male
CDC: 12-FYEW-3	CDC: 99-0000-0

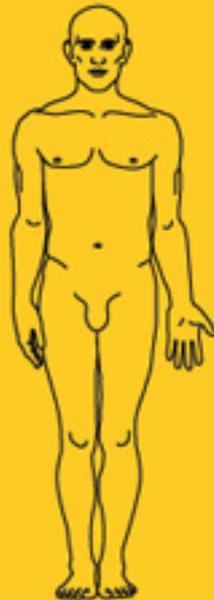
Contusions to unspecified
body regions (1)
