Case 464 : Narrative

Case Vehicle (A): 2004 Saturn	Vehicle (B): 1998 Pontiac
Type: Ion, 4-door sedan	Type: Trans Sport, 4x2, 4-door minivan
Driver: 35-year-old male	Driver: 18-year-old female
CDC: 12-FDEW-3	CDC: 06-BDEW-3

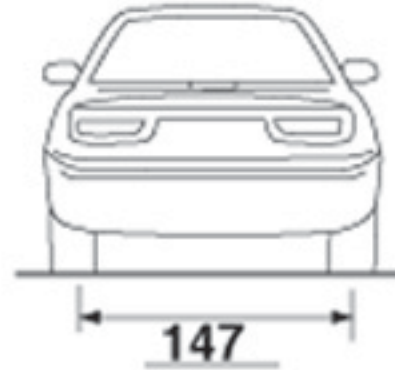
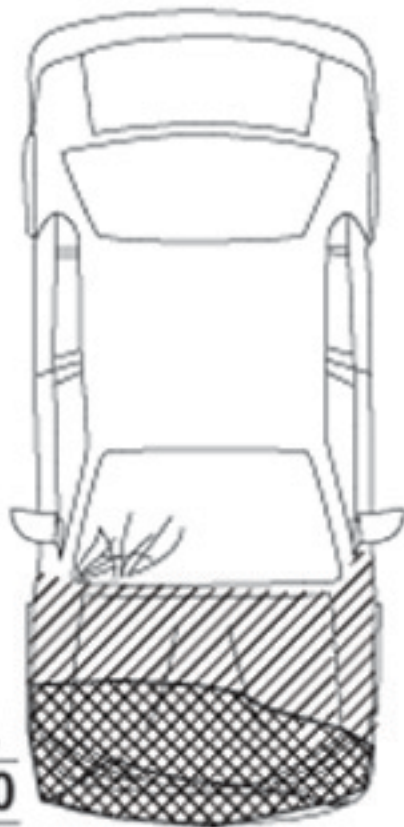
Max. crush to front at right bumper
