CALSPAN ON-SITE AIR BAG DEPLOYMENT/ PEDESTRIAN CRASH
INVESTIGATION

CALSPAN CASE NO. 94-17

VEHICLE #1 - 1993 SATURN SR2 (AIR BAG-EQUIPPED)

CRASH DATE - [REDACTED], 1993

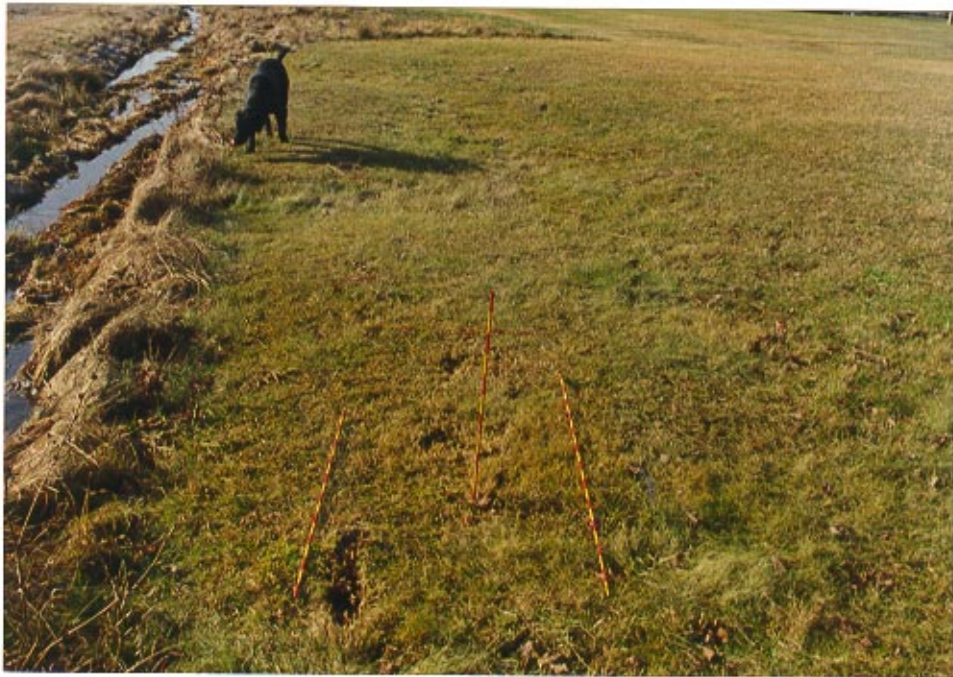
11. Close-up of lawn contact by pedestrian, with gouging and grass scuffing in the direction of the pedestrian's trajectory.

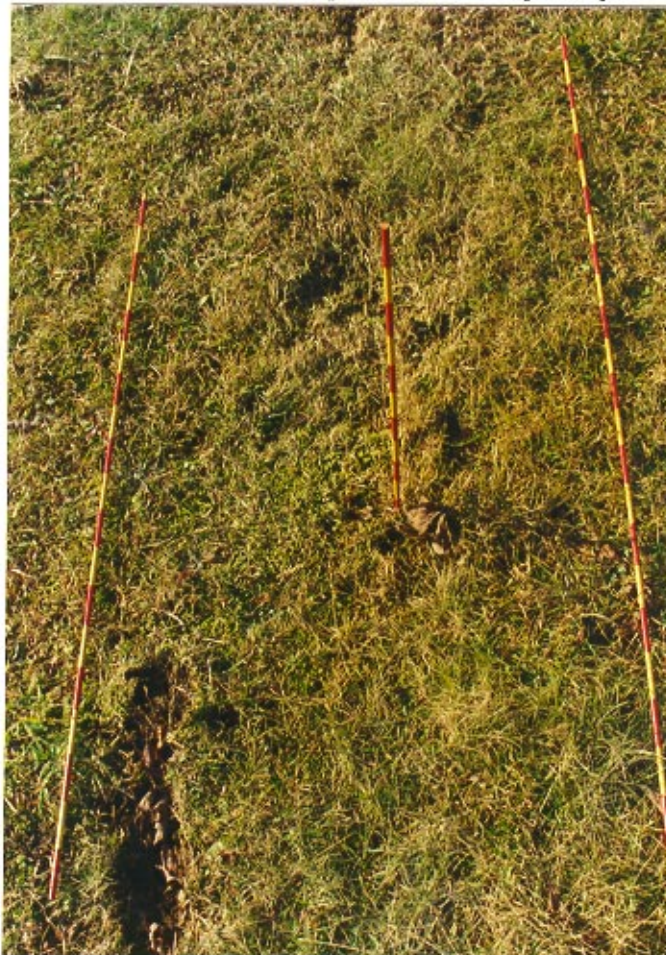
12. Overhead close-up view of the pedestrian's initial contact with the ground.

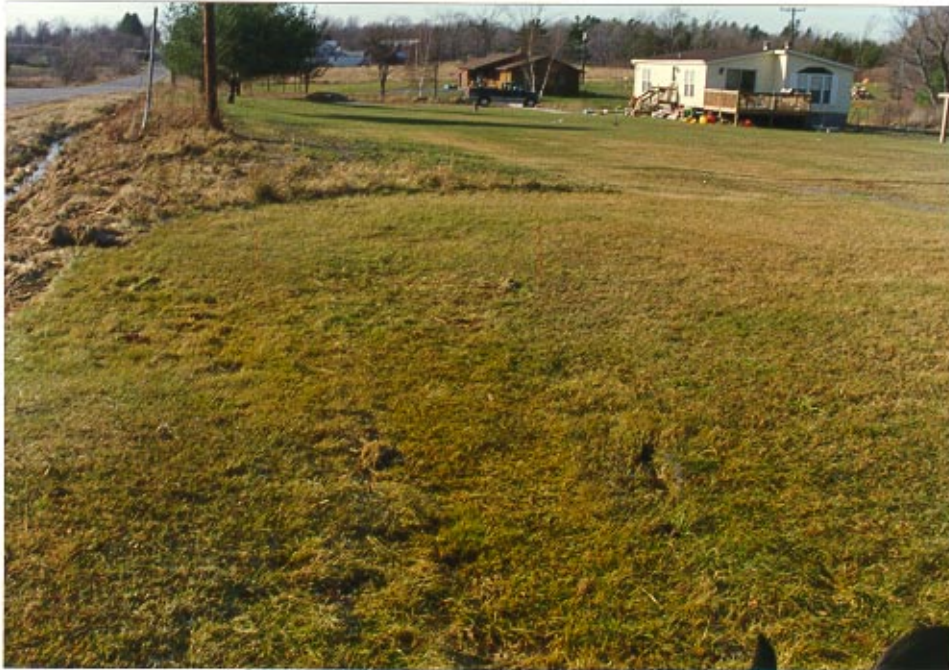
13. View of the pedestrian's trajectory from the initial contact with the ground and her final rest position (FRP).

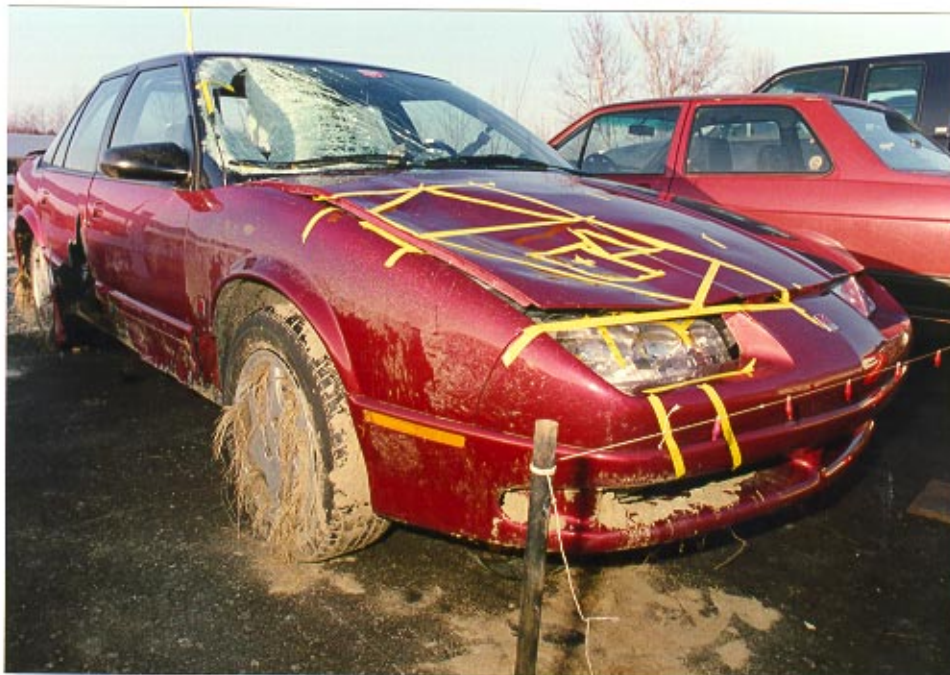
42. View of right front corner.

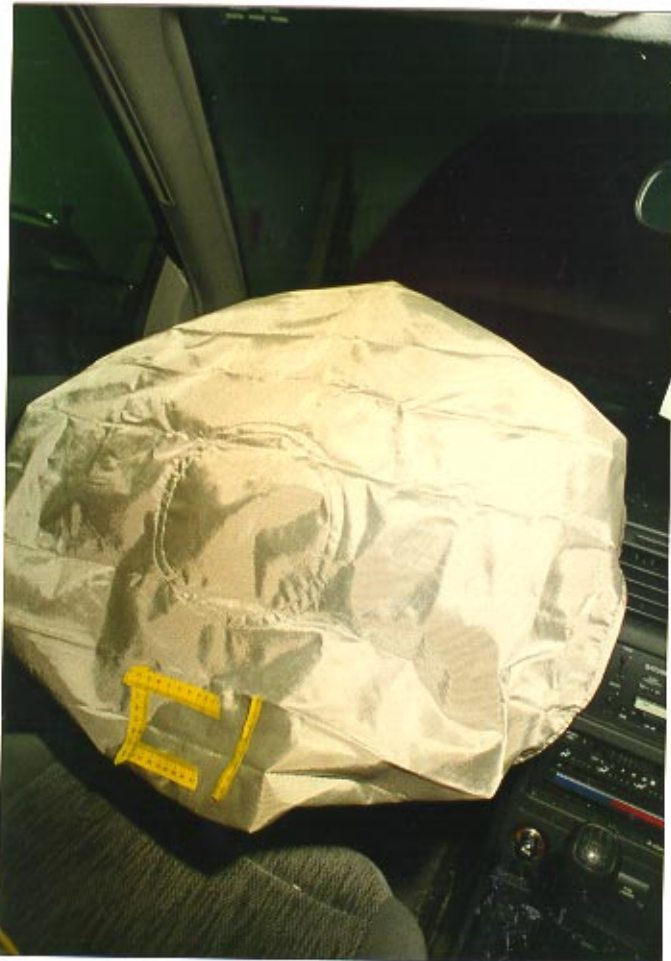
46. Overall view of tethered air bag.

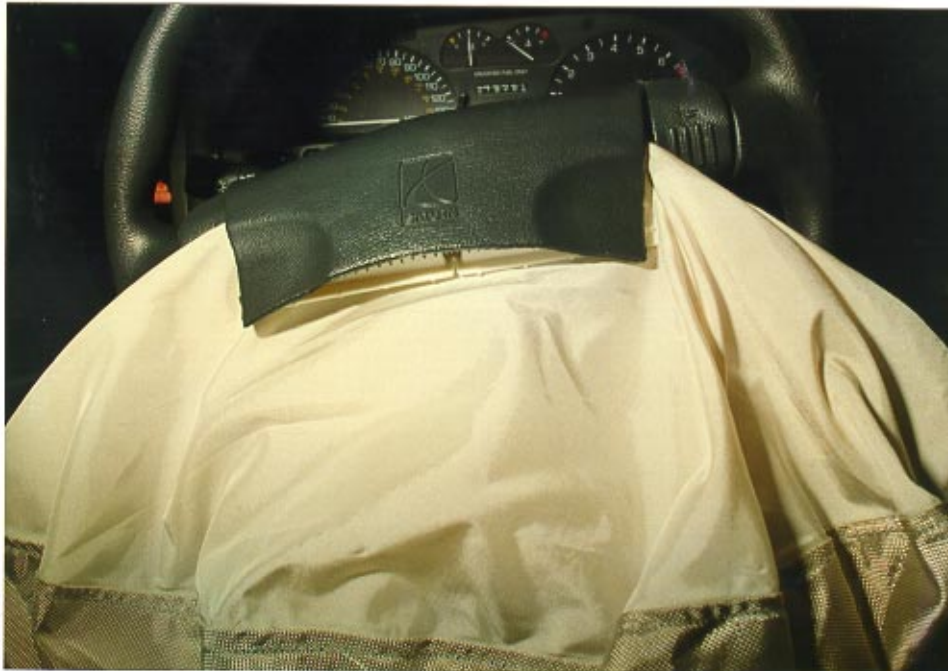
48. View of the upper flap of the air bag module cover.

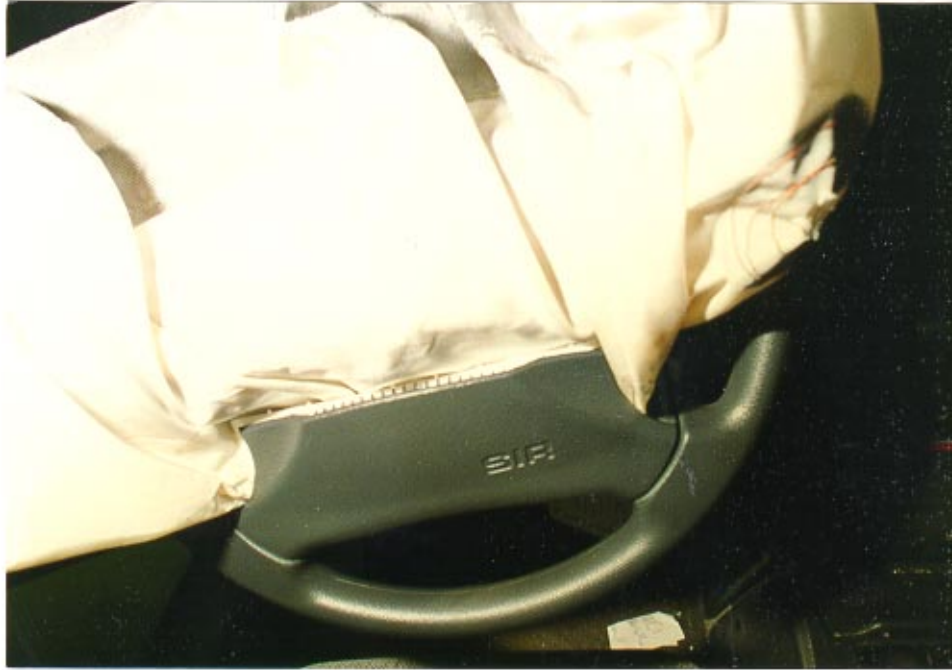
49. View of lower flap of the air bag module cover.
