REPORT NUMBER: 201P-CAL-07-01

**SAFETY COMPLIANCE TESTING FOR FMVSS 201
RIGID POLE SIDE IMPACT TEST**

DAIMLERCHRYSLER CORPORATION
2007 JEEP COMPASS
SUV

NHTSA NUMBER: C70311

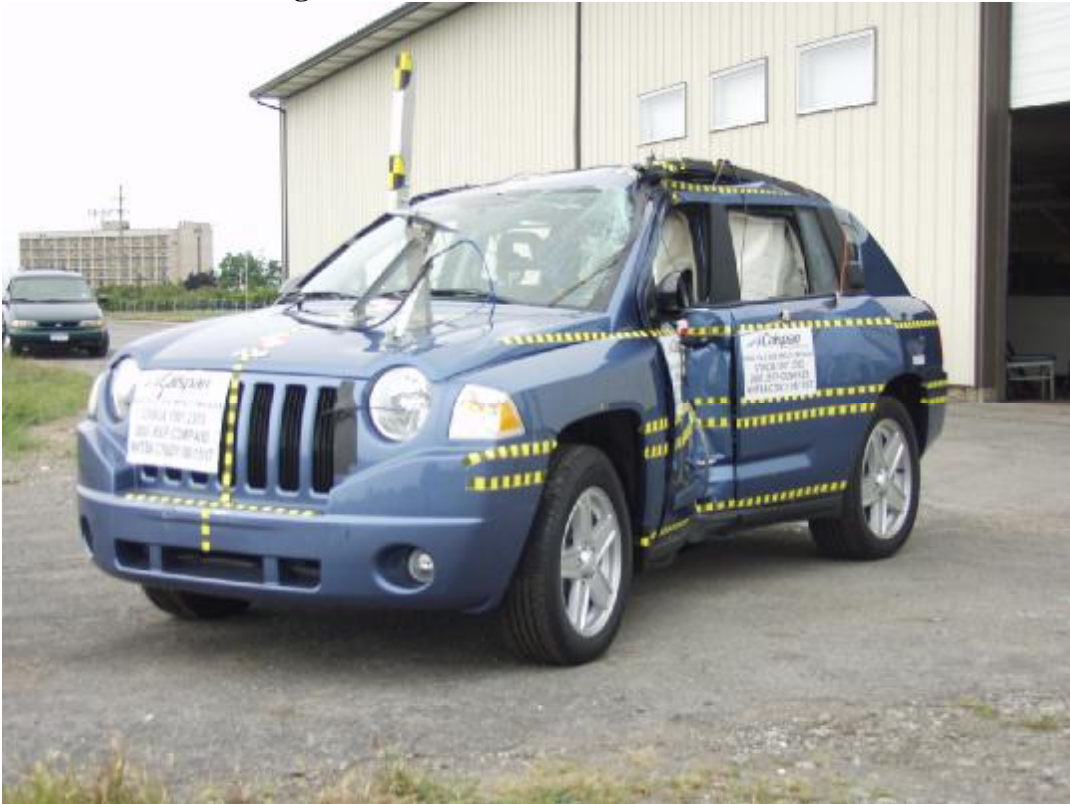
Figure A-8: Post-Test Left Front 3/4 View

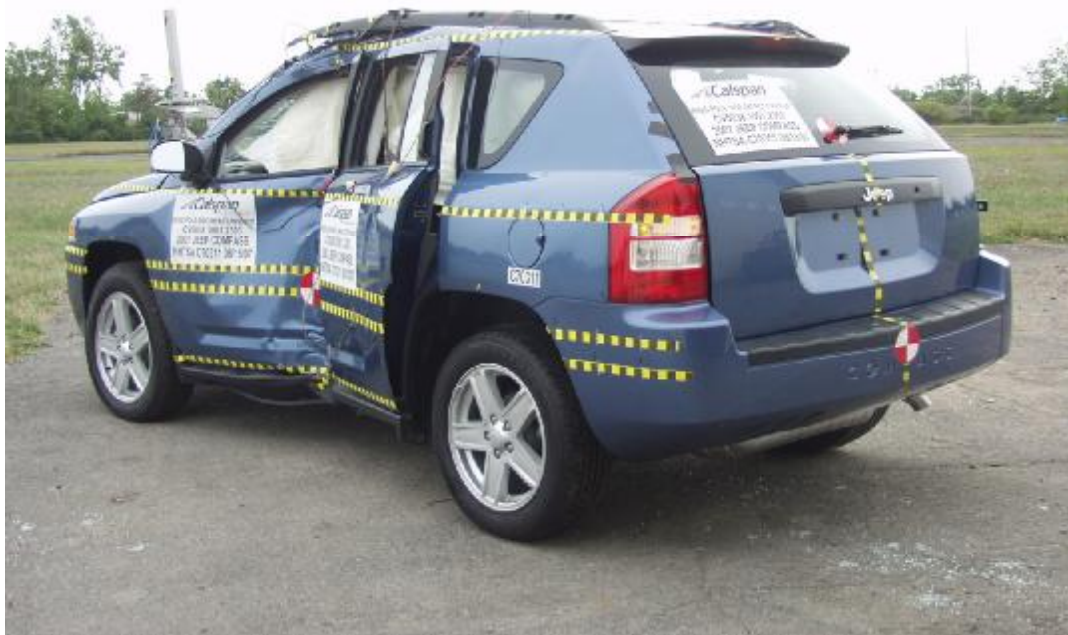
Figure A-12: Post-Test Left Rear 3/4 View

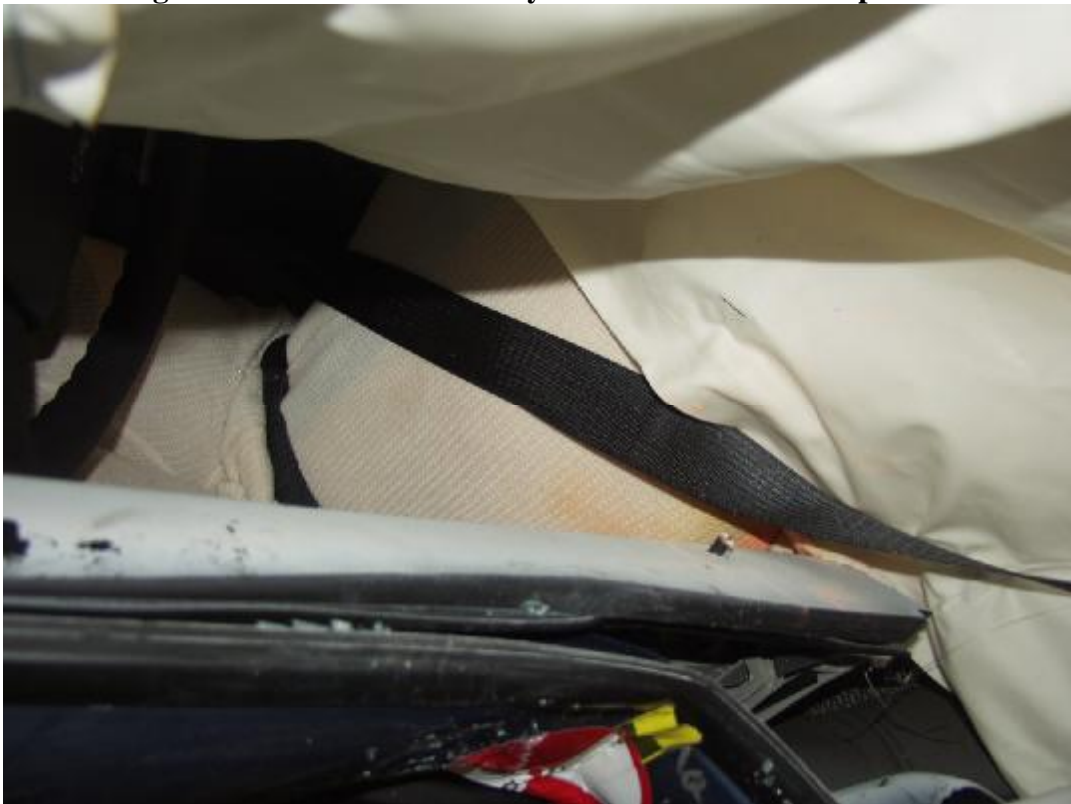
Figure A-33: Post-Test Dummy Shoulder and Door Top View

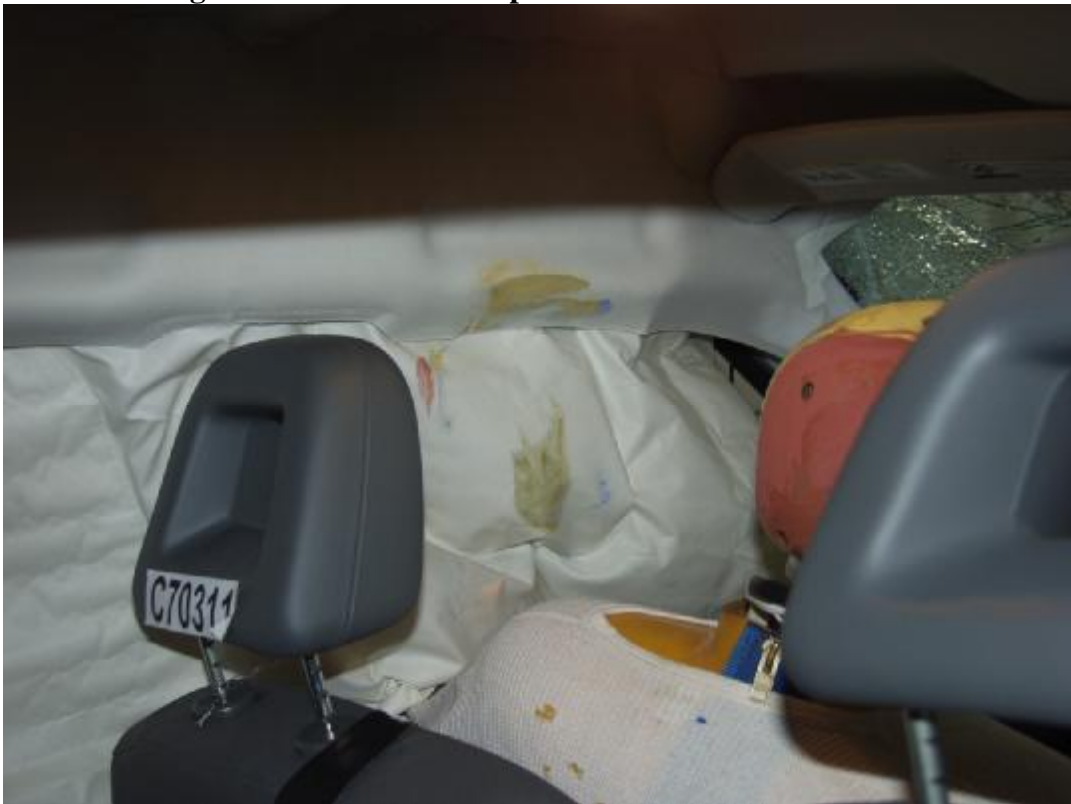
Figure A-35: Post-Test Impact Side Front Interior Trim

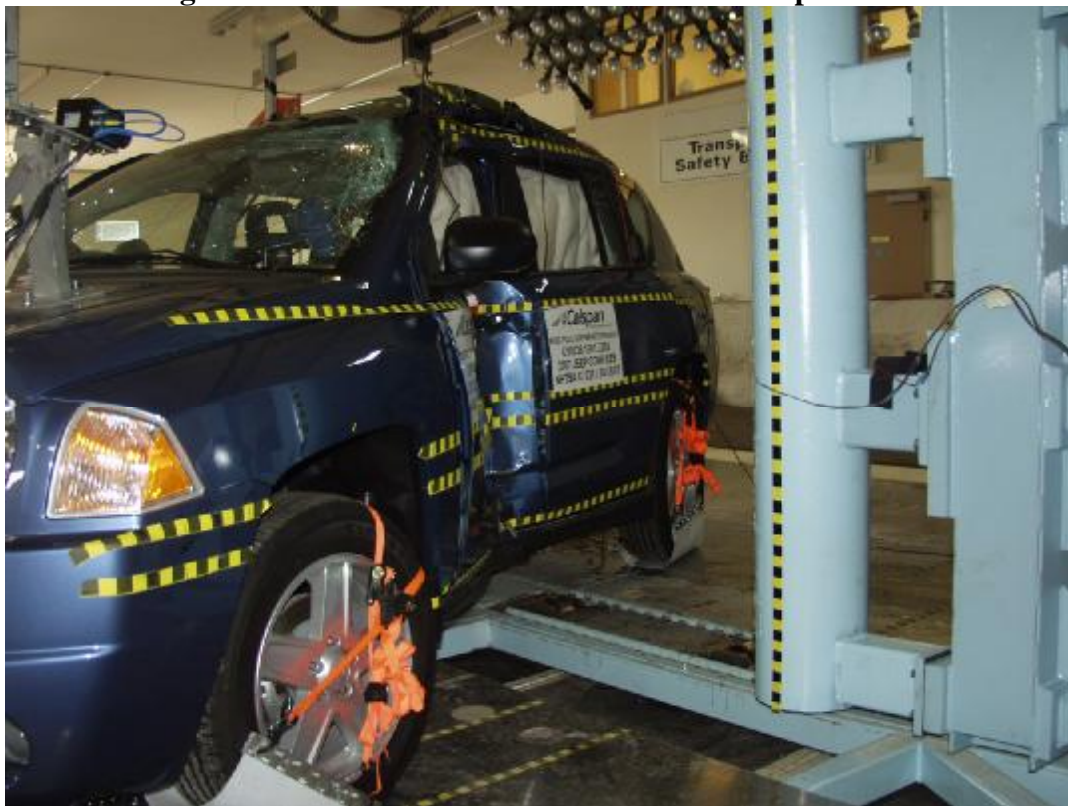
Figure A-37: Post-Test Left Front $\frac{3}{4}$ View of Impact Zone
