REPORT NUMBER: 201-MGA-2009-001

**SAFETY COMPLIANCE TESTING FOR FMVSS 201
RIGID POLE SIDE IMPACT TEST**

**GENERAL MOTORS CORPORATION
2009 CHEVROLET MALIBU 1LS
NHTSA NUMBER: C90110**

**PREPARED BY:
MGA RESEARCH CORPORATION
5000 WARREN ROAD
BURLINGTON, WI 53105**

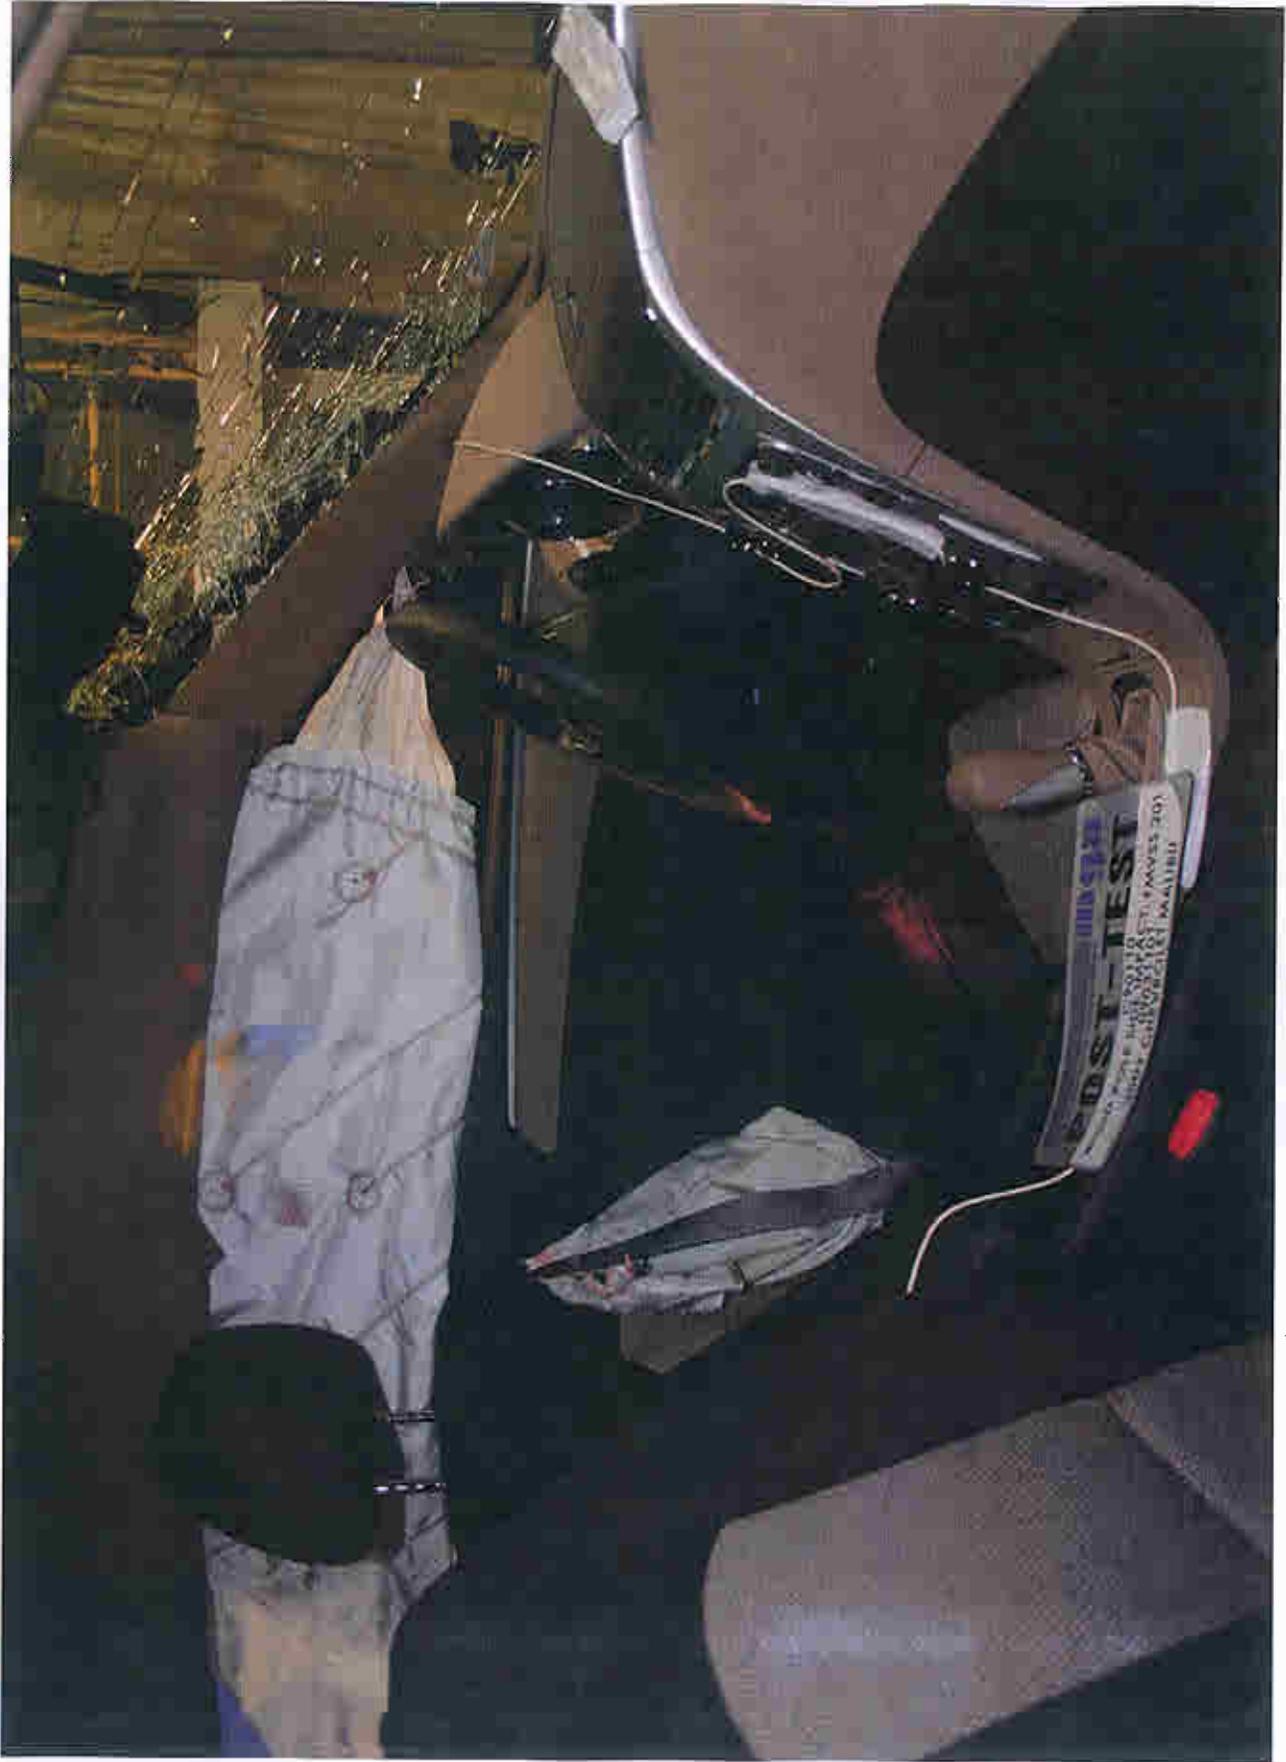
Post-Test Driver Dummy Lower Thorax Contact

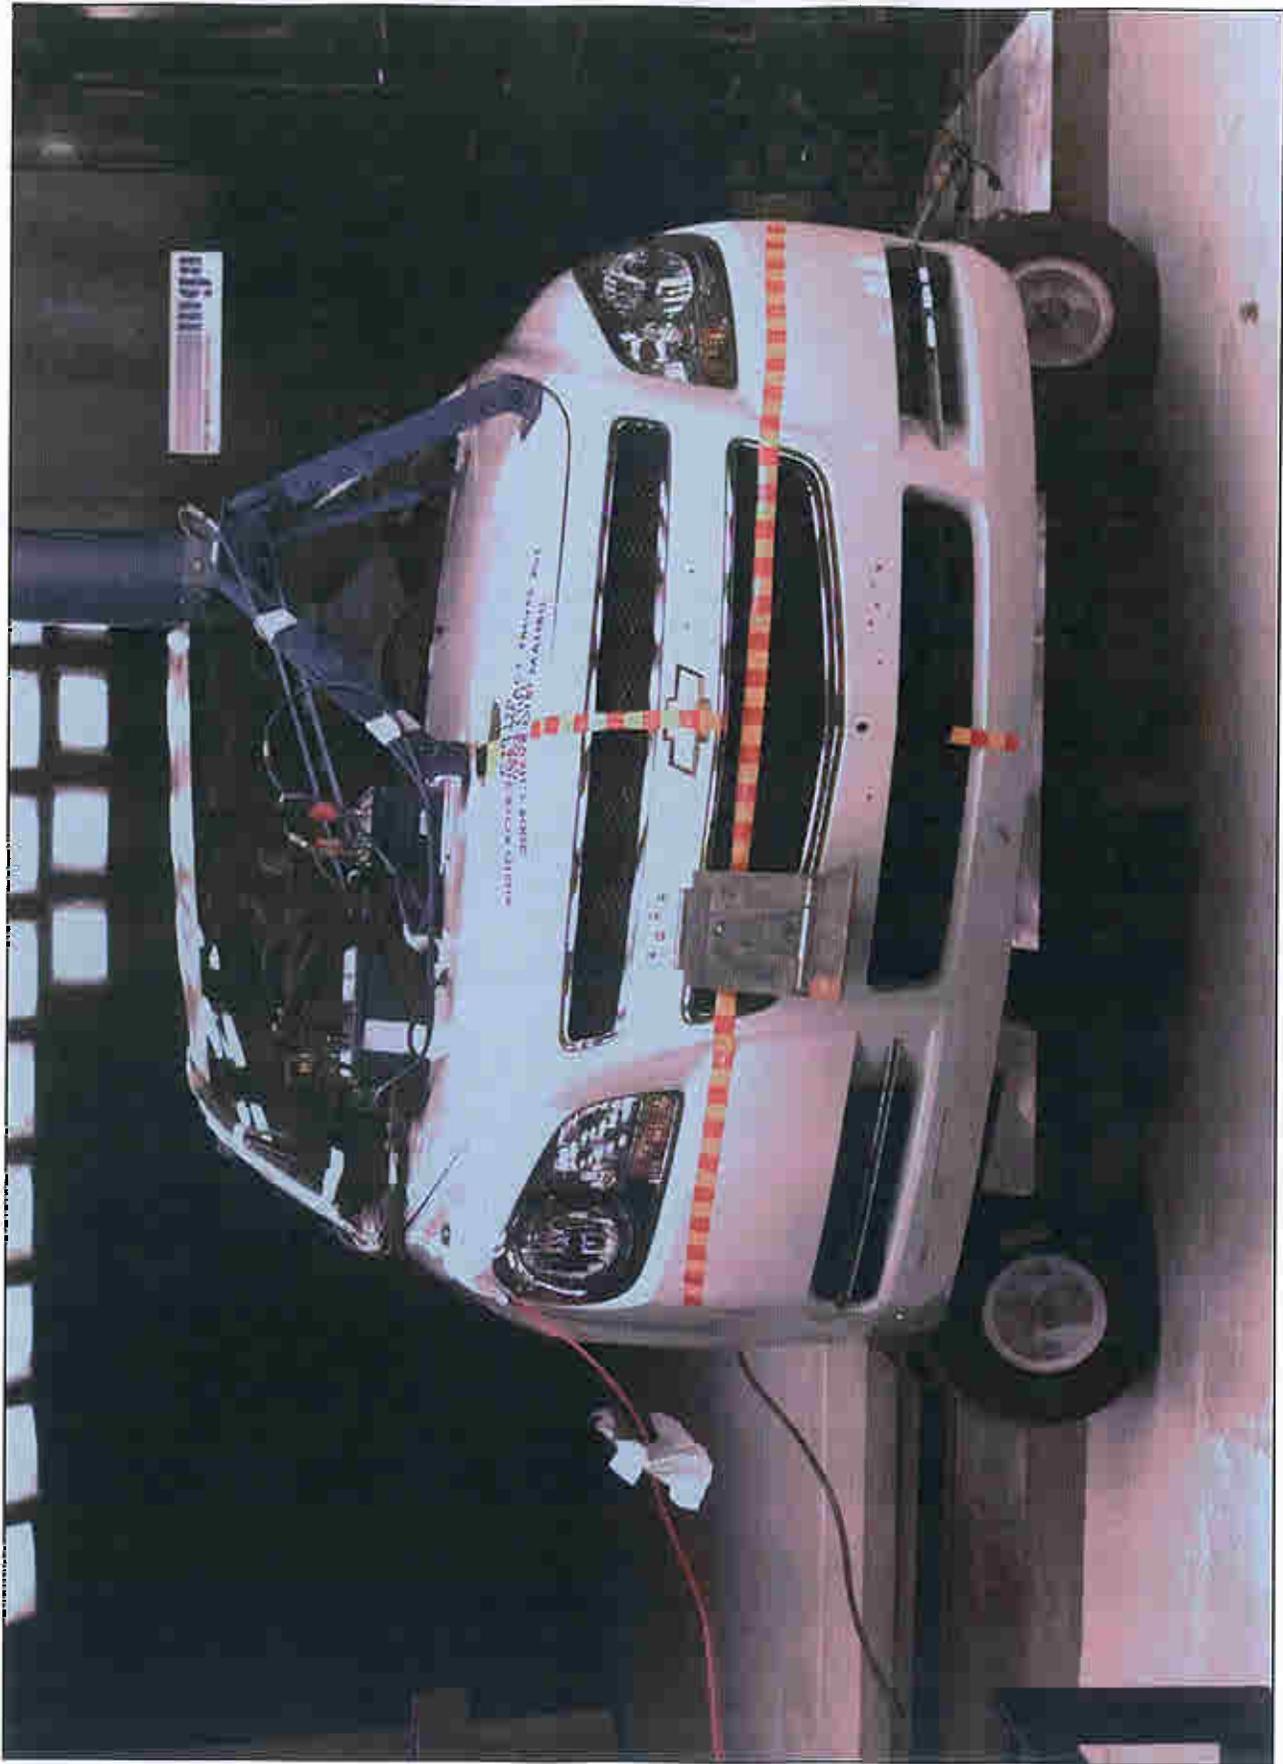
Post-Test Impact Zone Close-up View
